## **Drumshanbo Town Centre Regeneration**

# **Structural Assessment Survey and Site Investigation Report**

**for former Bank of Ireland Building, Early's Building  
and Adjacent Derelict Building, Drumshanbo, Co  
Leitrim**

**December 2023**

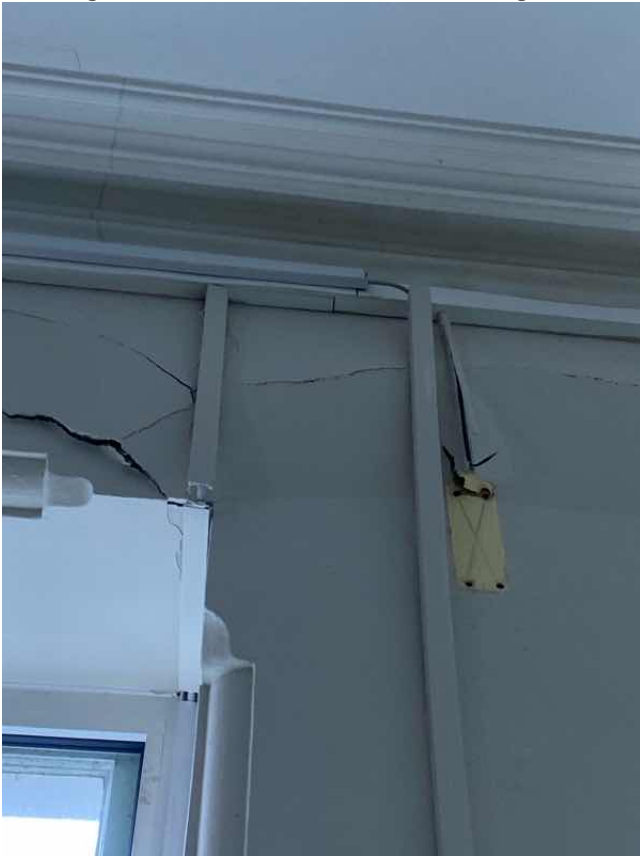
1

Cracking to window heads could indicate damage to the existing lintels that needs to be repaired

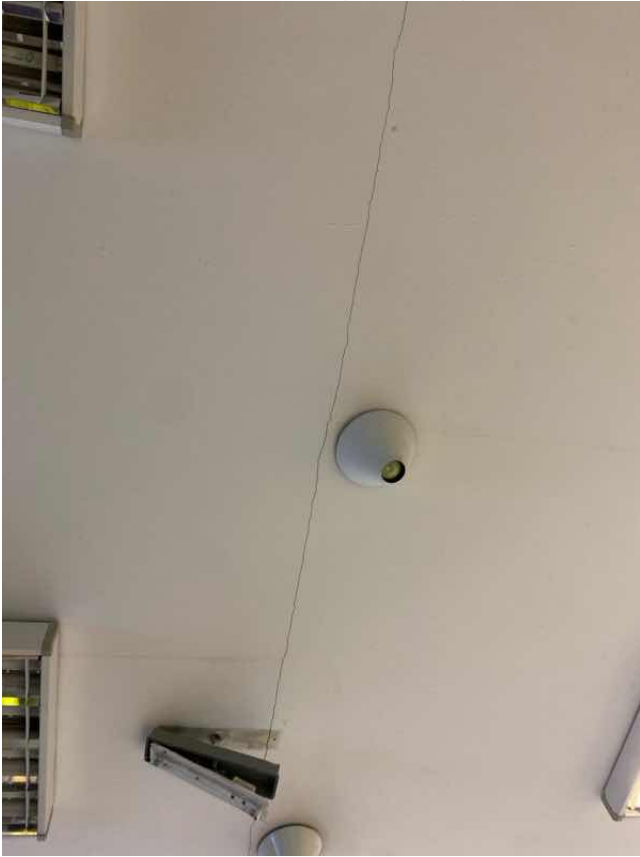
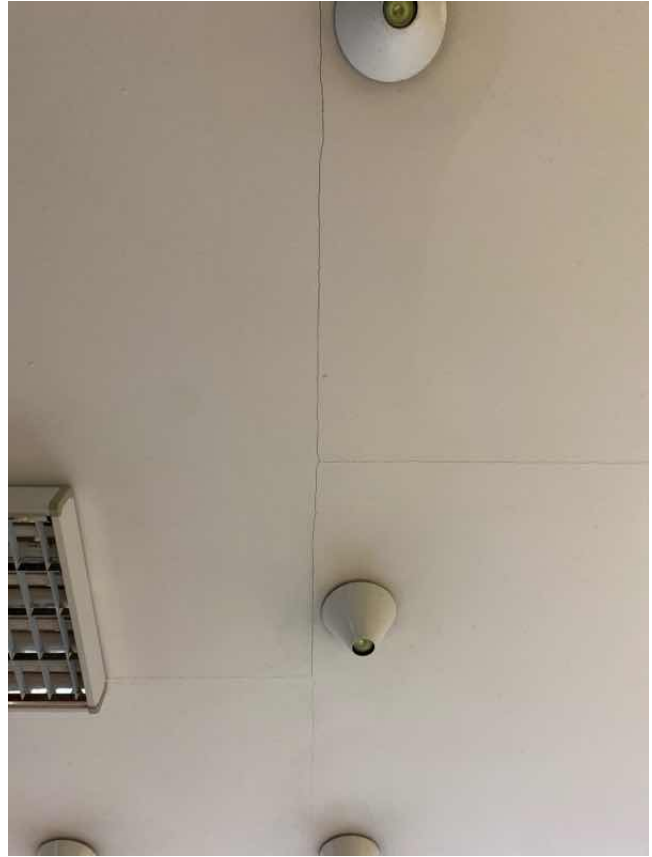
5

Number of fine cracks traversing the ceiling

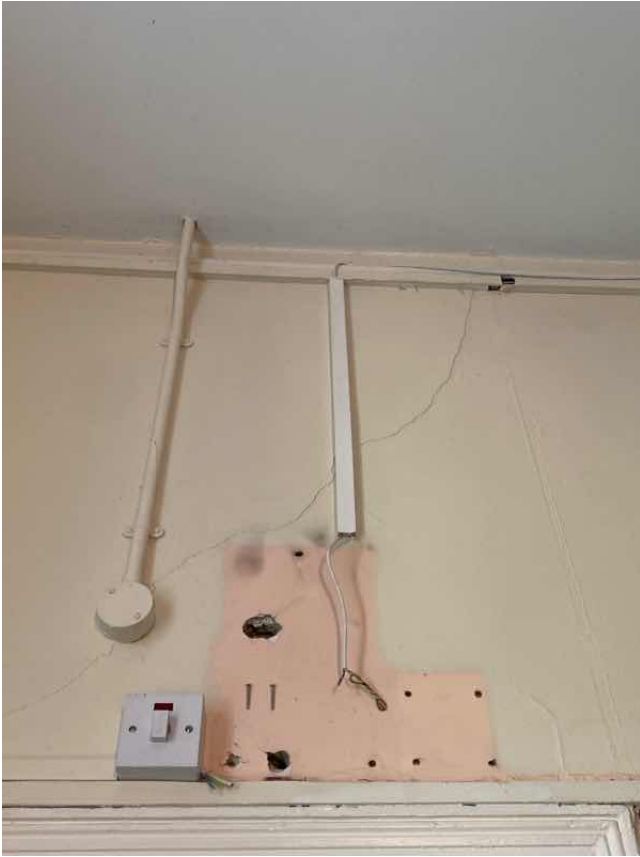
9

Hairline crack above door

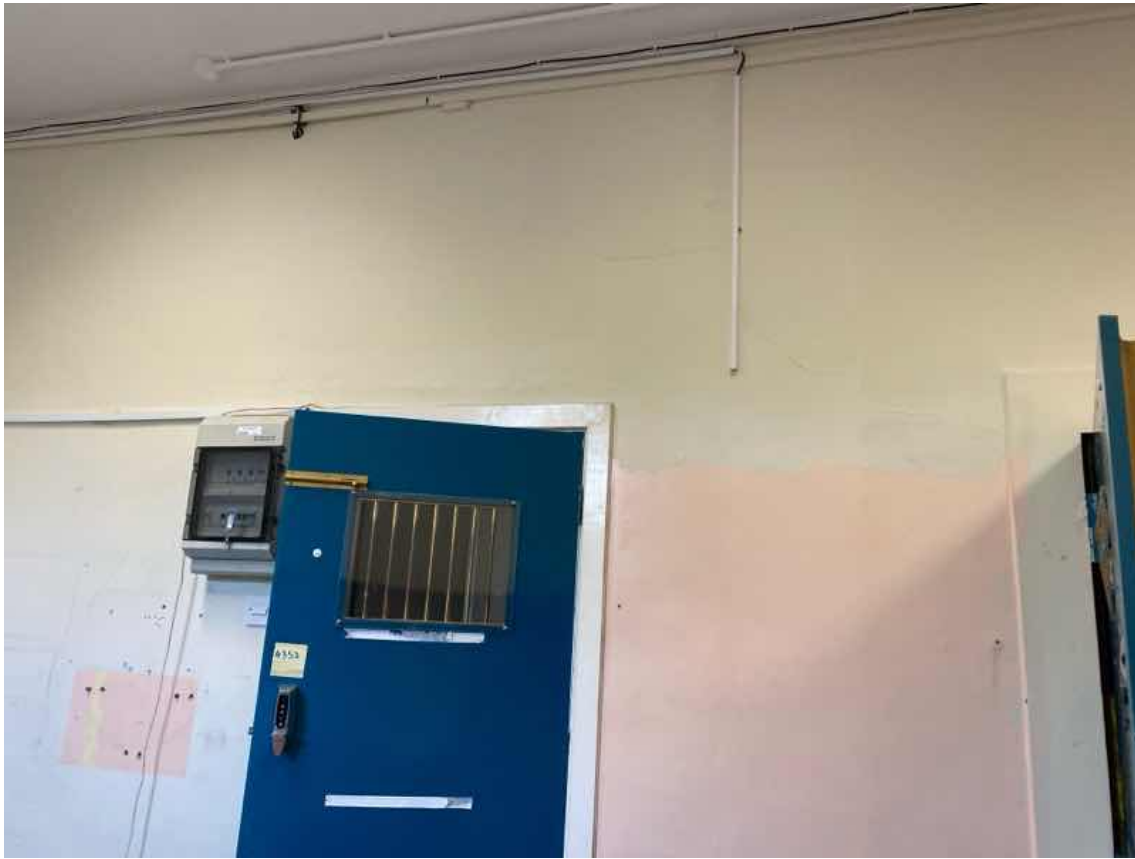
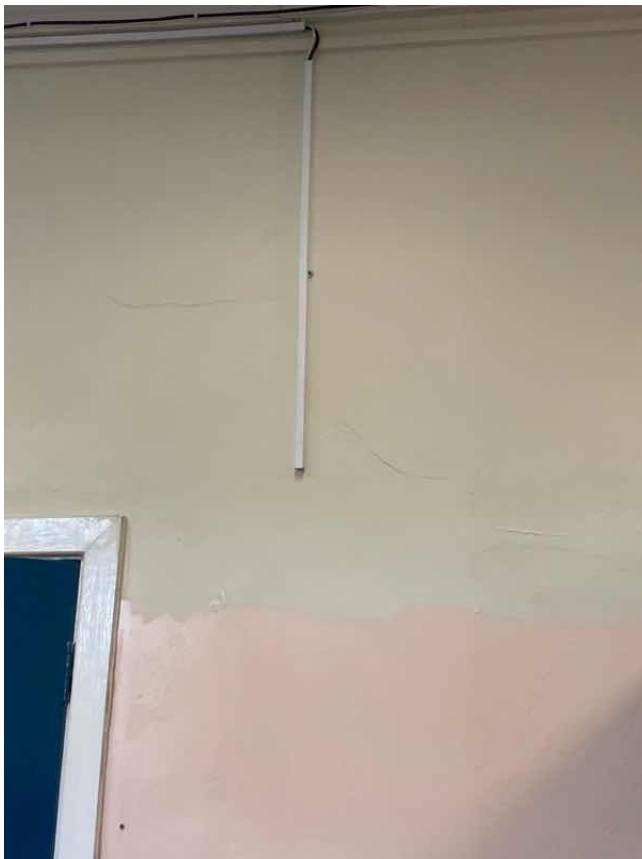
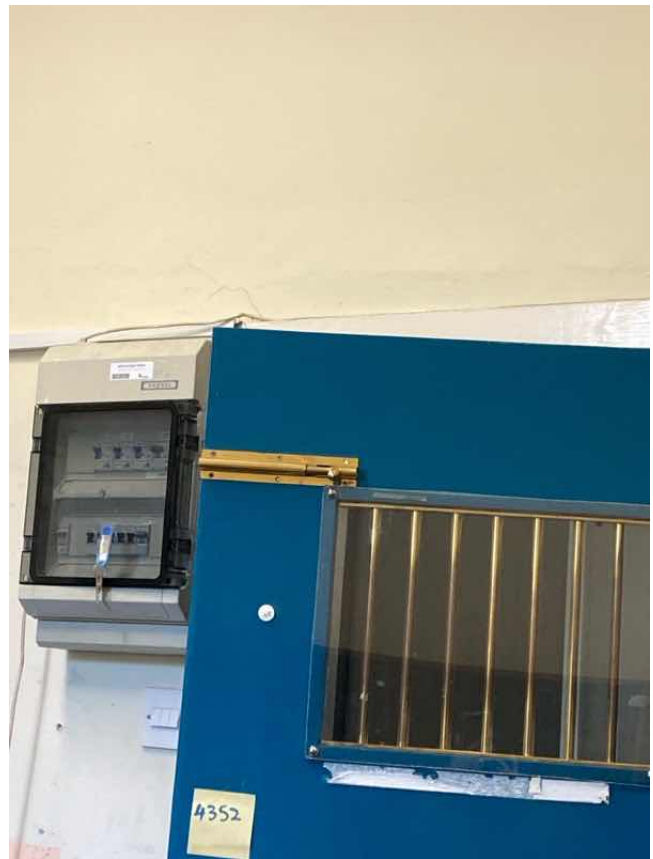
11

Hairline cracks on walls

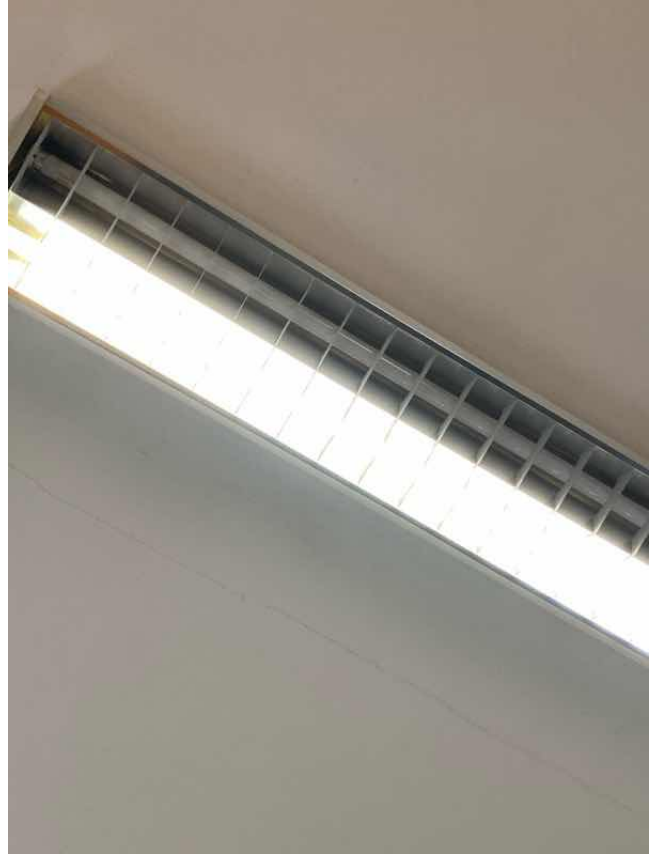
12

Ceiling generally in good condition, hairline cracks observed at the centre of ceiling

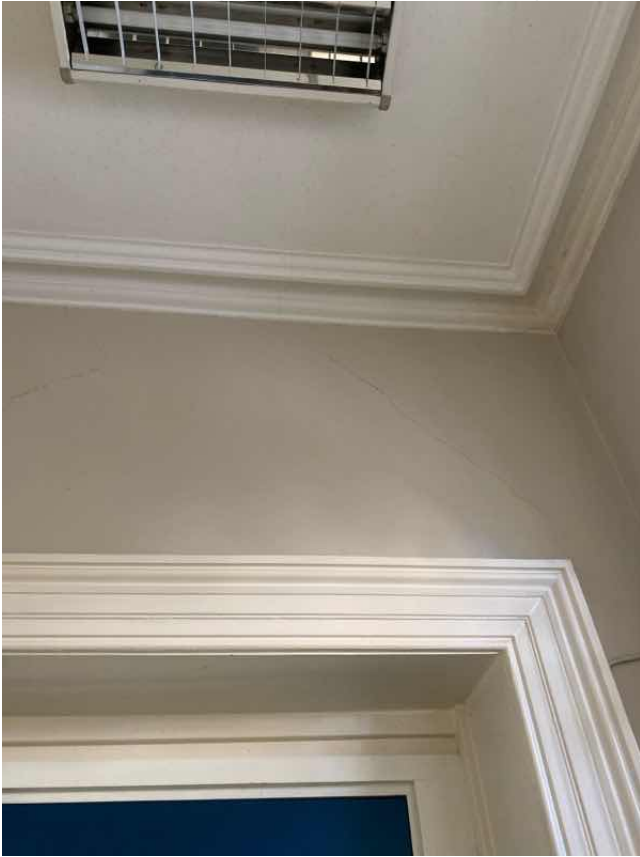
14

Evidence of cracking to the head of door. Opening up will be required to confirm the condition of the existing lintels

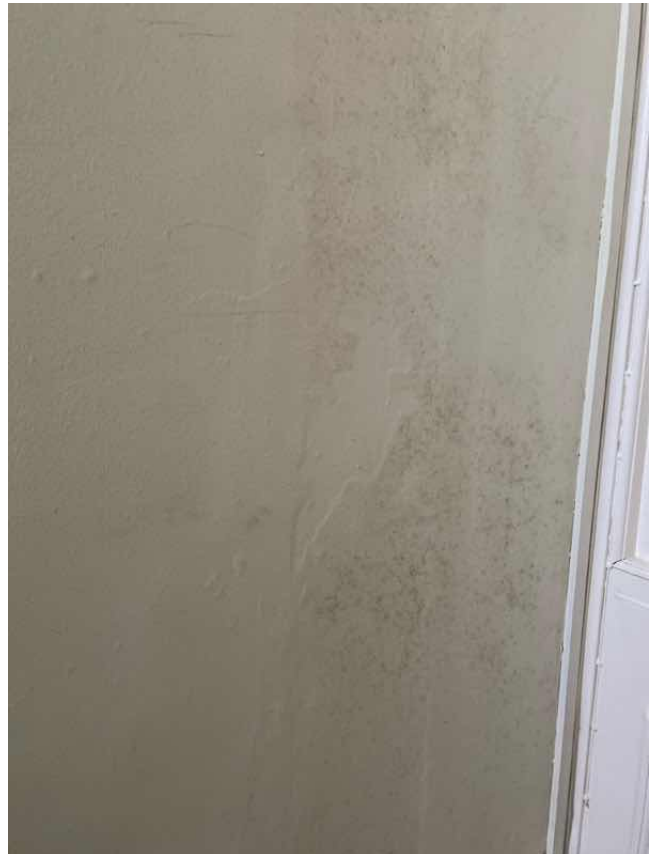
17

Surface mould growth on walls

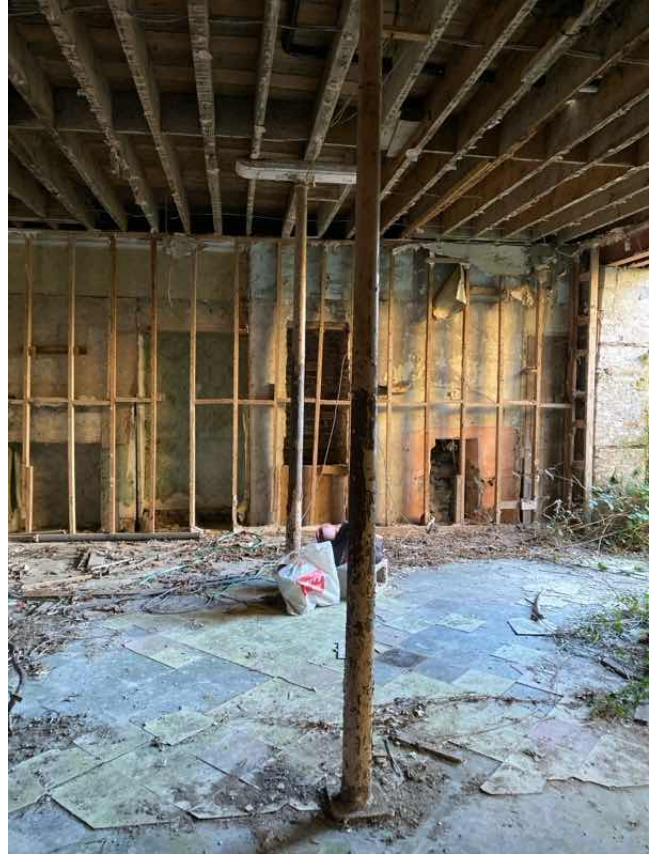
74

100mm diameter tapered cast iron columns (2 number) propping floor in middle of span.

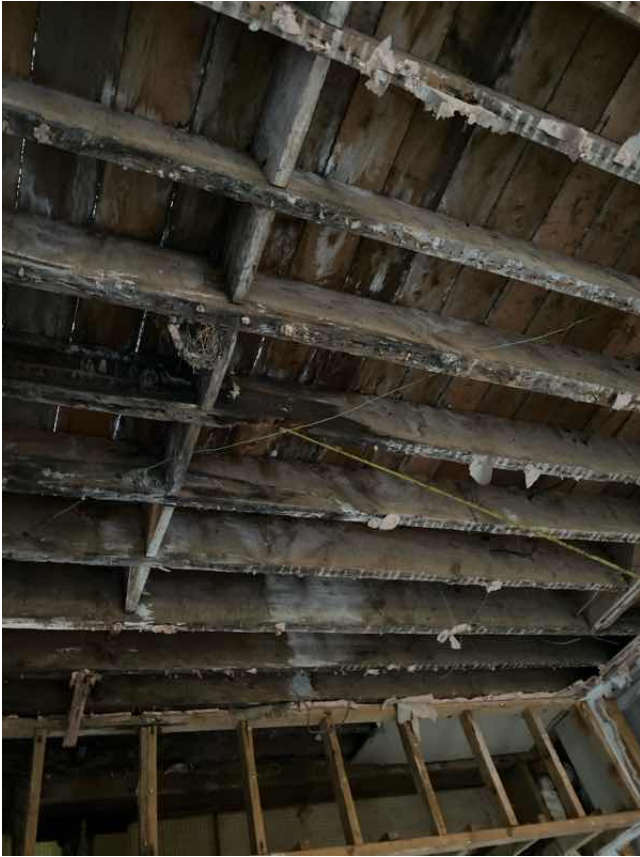
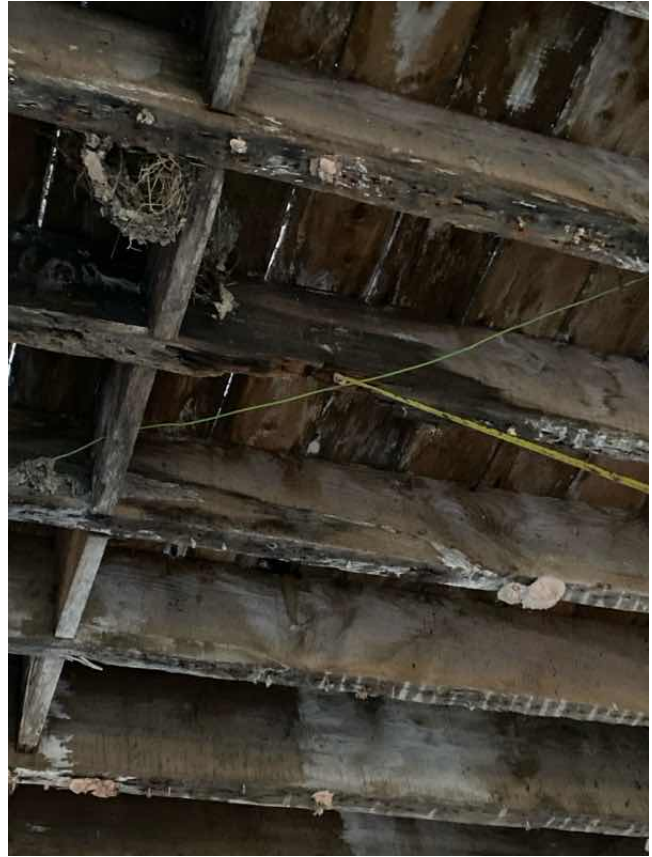
75

Floor joist badly deteriorated due to wet rot ( risk of collapse). Temporary propping recommended.

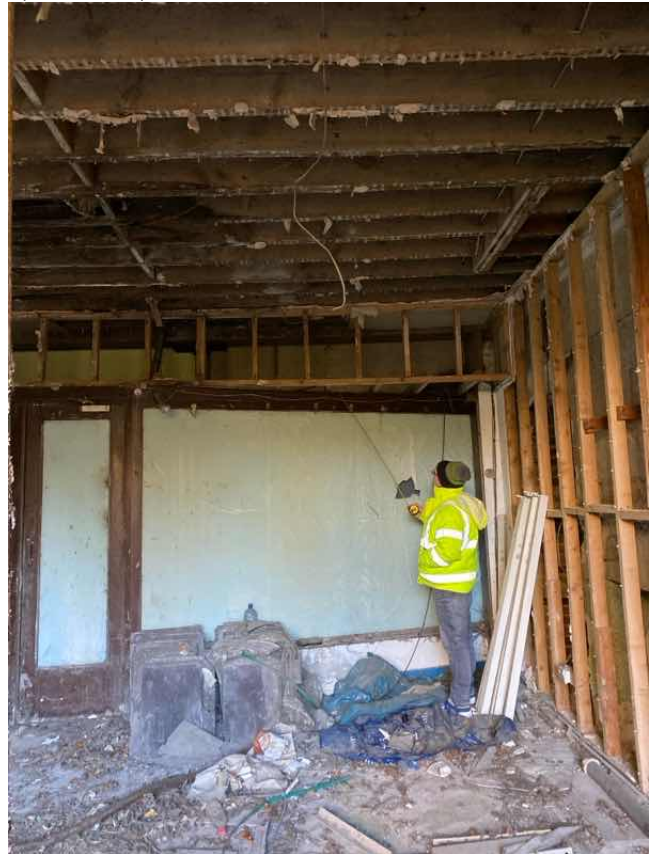
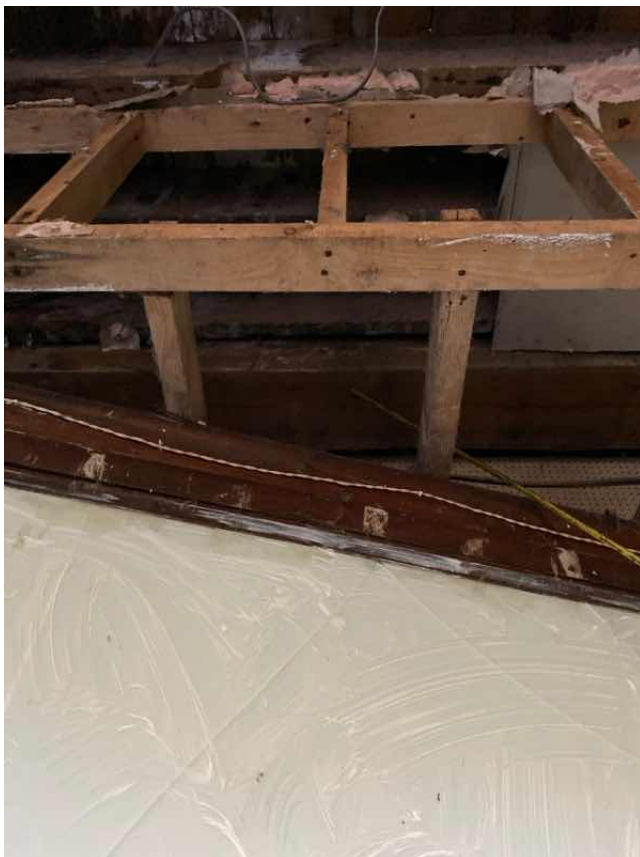
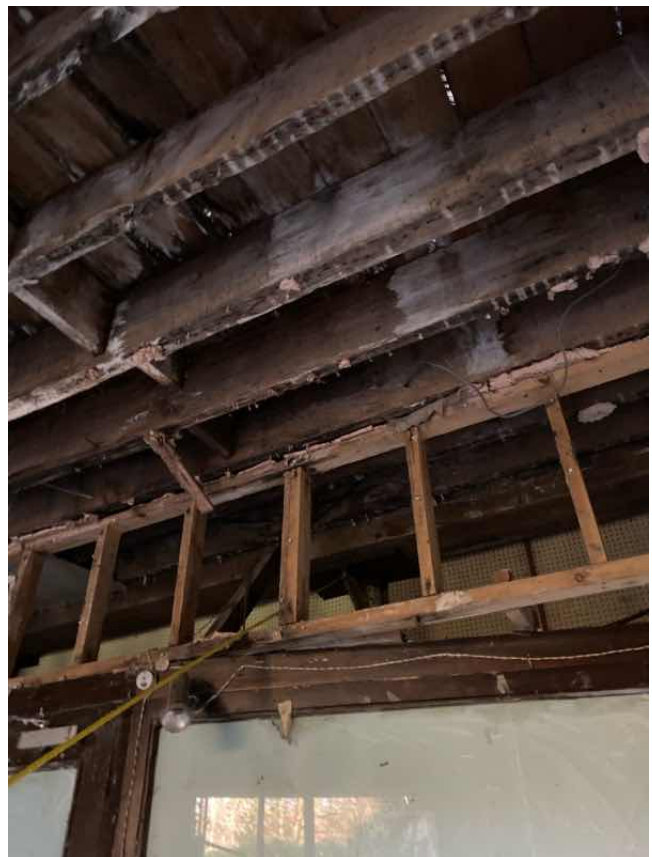
76

Timber beam used to form head of shop front. Bearing ends of beam to be checked for deterioration. Timber beams supported using two number cast iron columns at approximately one third points on span.

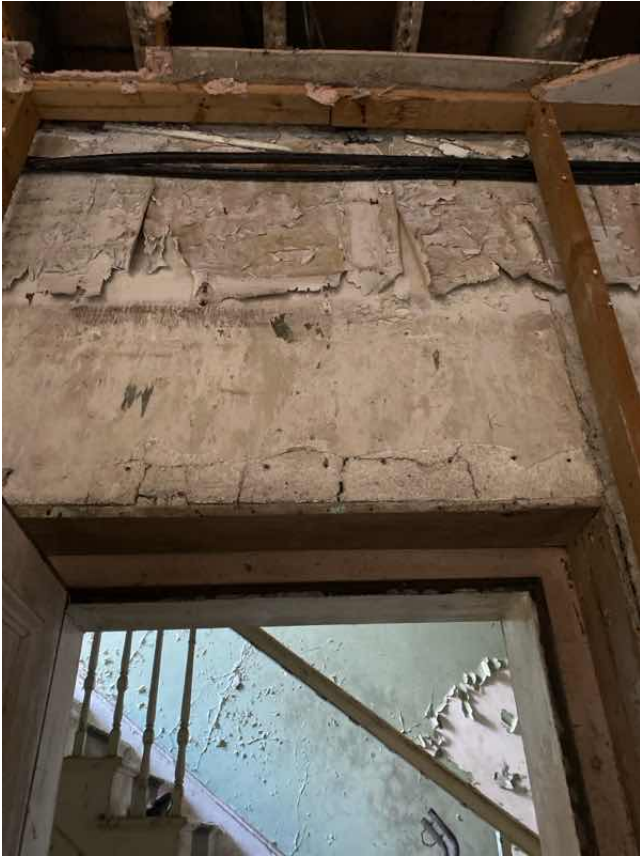
77

Appears to be no lintels above door opening into hallway.

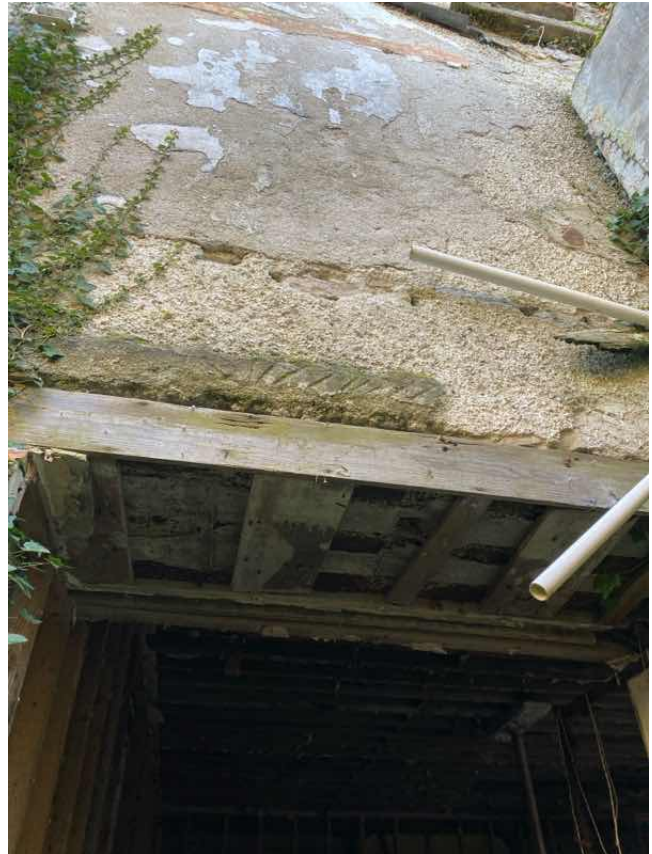
78

3 number steel beams are used to form the head of opening. Further opening required to confirm the condition of the lintel as significant amount of corrosion evident to underside of steel beams.

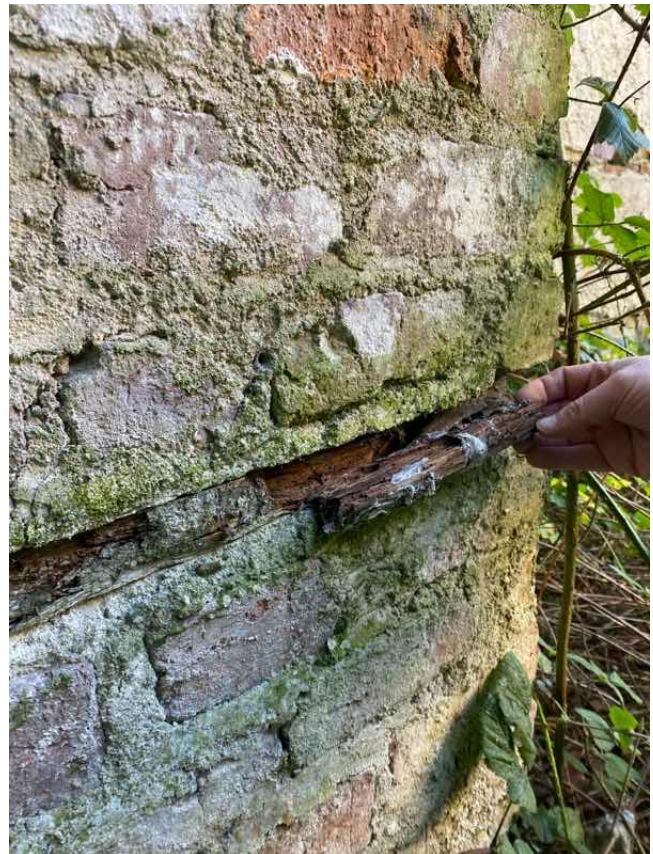
80

Rotten timber embedded into masonry pier.

We observed bonding timbers embedded in the external walls that are badly deteriorated, some of which can be removed and broken by hand. All defective bonding timbers will need to be removed and gaps (which weaken wall) should be filled in with new masonry.

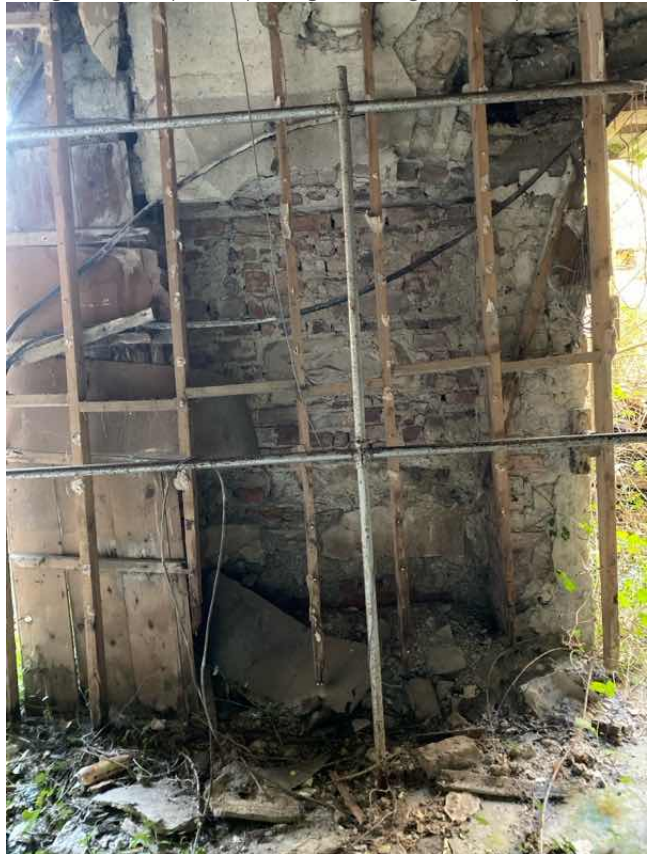
**81** Middle masonry pier on back wall has opening in middle of same (most likely an original window that has been bricked up). This weakens the load bearing pier, so we would be recommending to build up the opening to strengthen the pier.

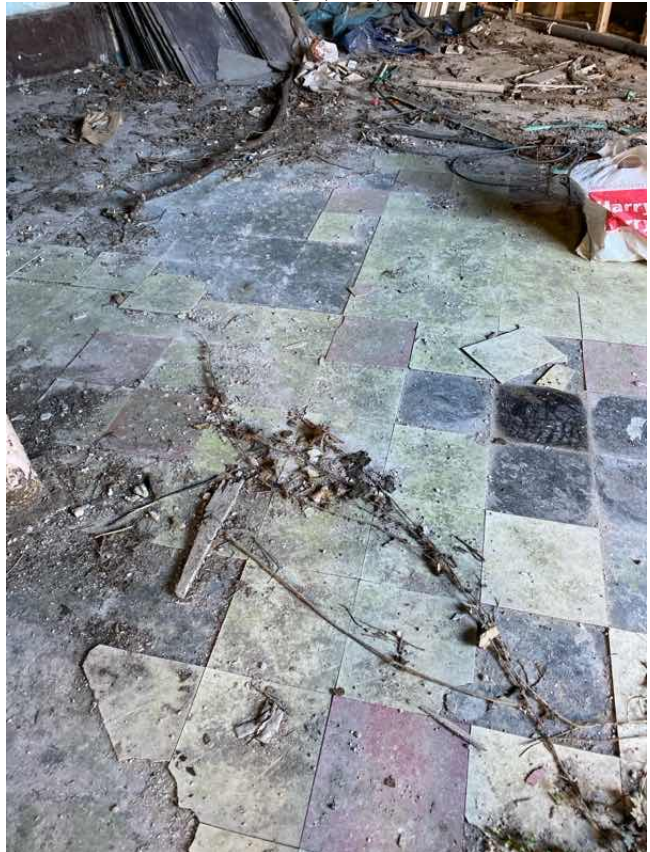
**82** Concrete floor slab in place. Unclear if DPM and insulation exist under the same. Opening up required to verify this.

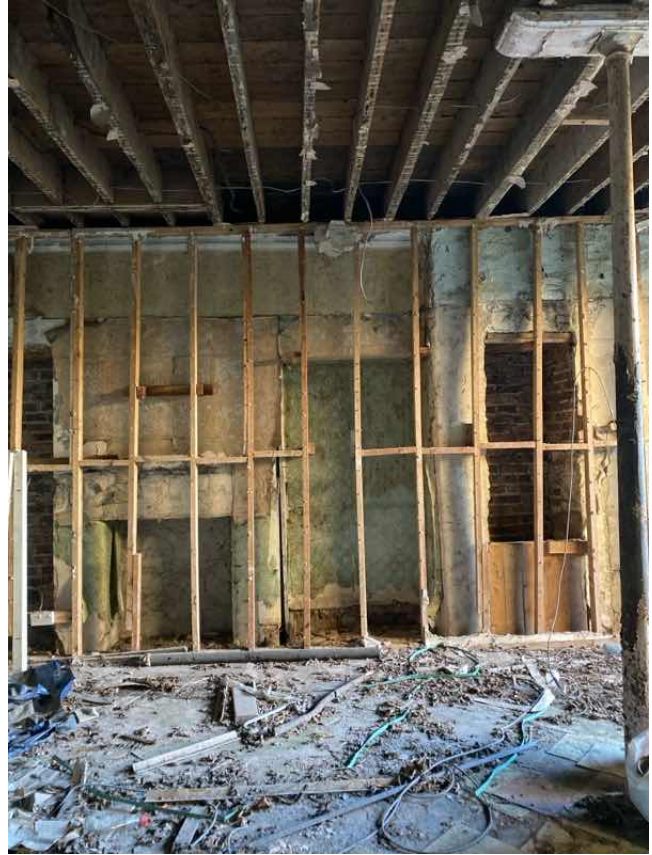
83

Disused fireplace with flue, a number of recesses in masonry with timber lintels over same. All timber lintels to be opened up to inspect the condition of same.

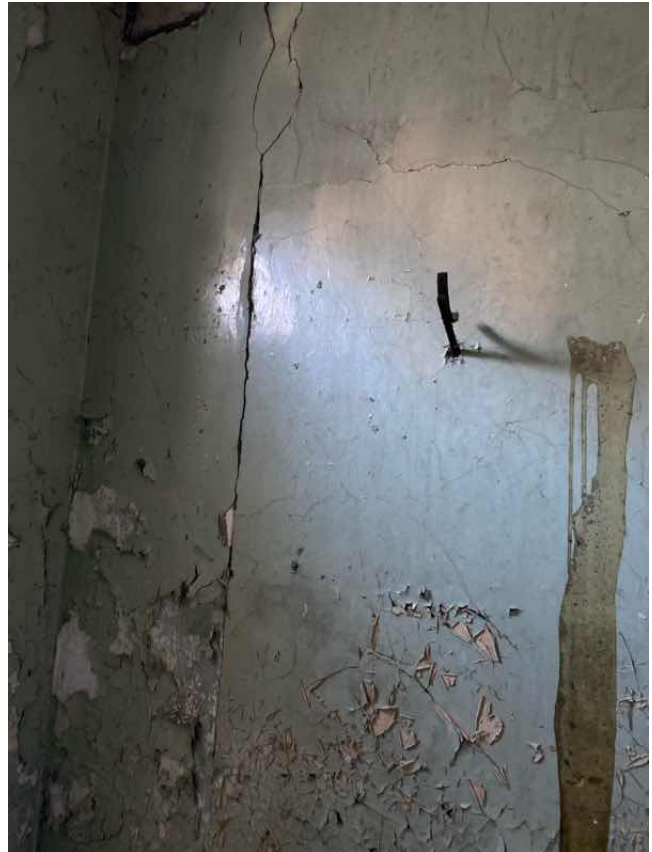
84

Vertical crack in wall coincides with location of blocked up door.

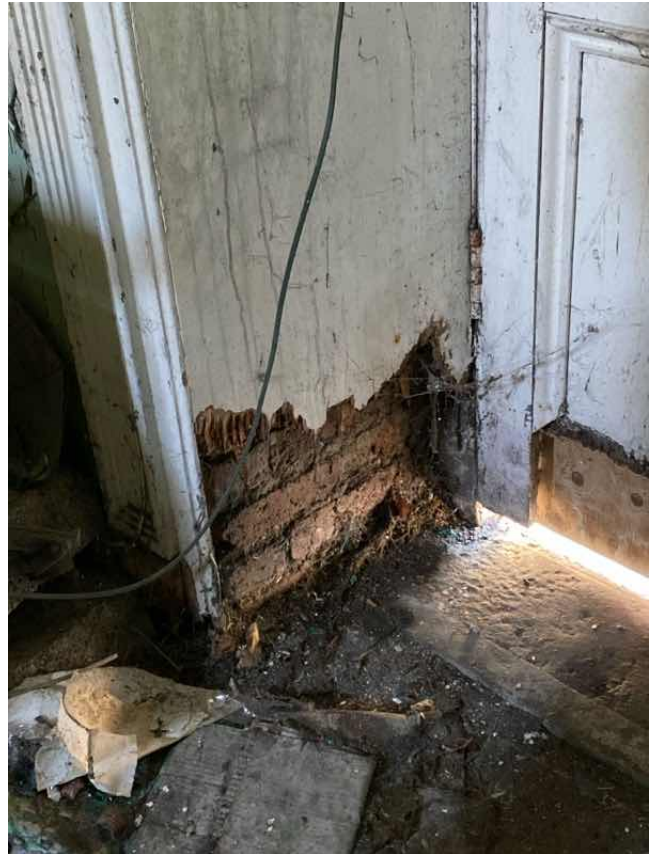
85

Evidence of rising dampness in masonry either side of front door. Plaster coming away and evidence of rotten timber liners to the opening.

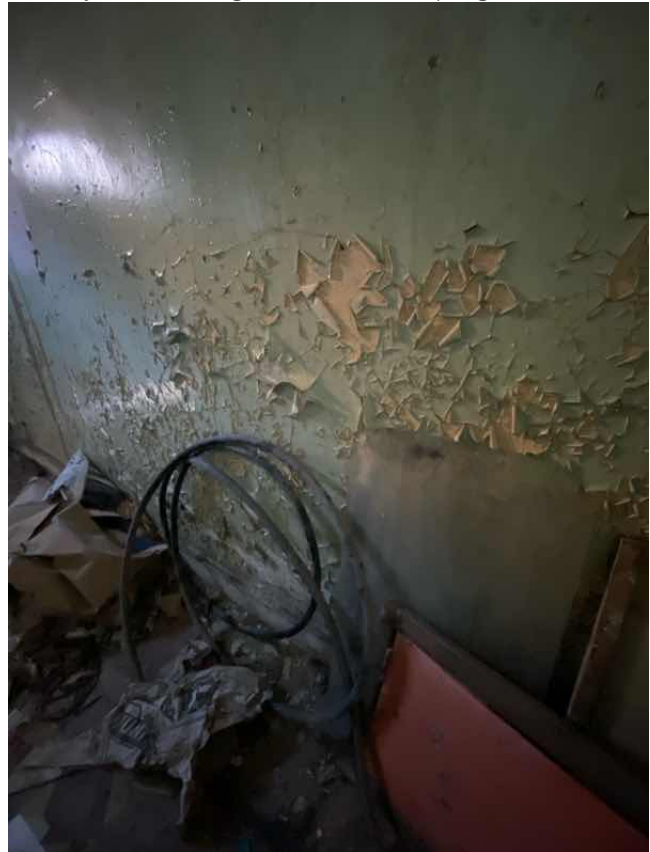
88

Generally throughout building paint is flaking off walls, more than likely due to old age rather than damp ingress.

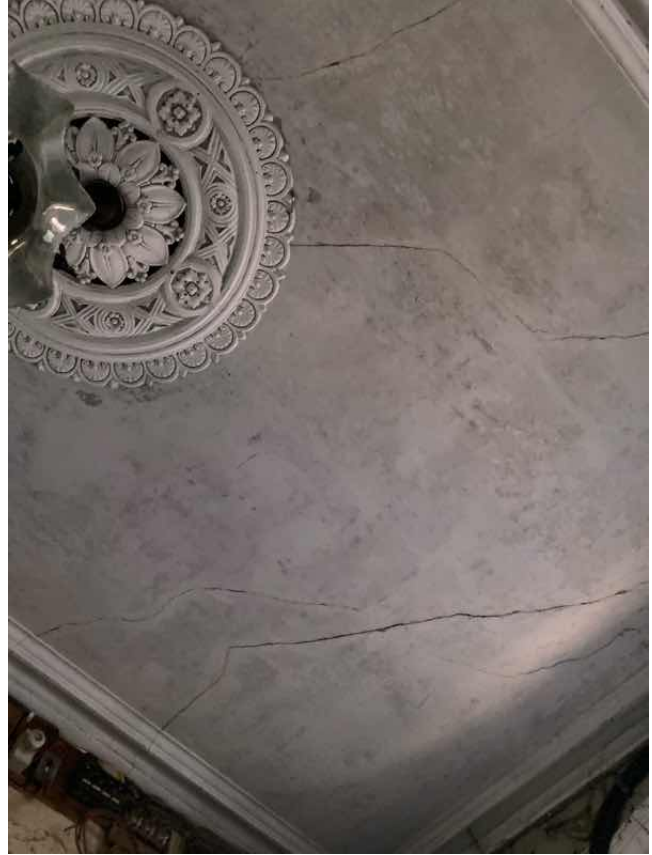
90

Number of cracks in existing ceiling and mould growth on ceiling surface due to the fact that building is opened to weather.

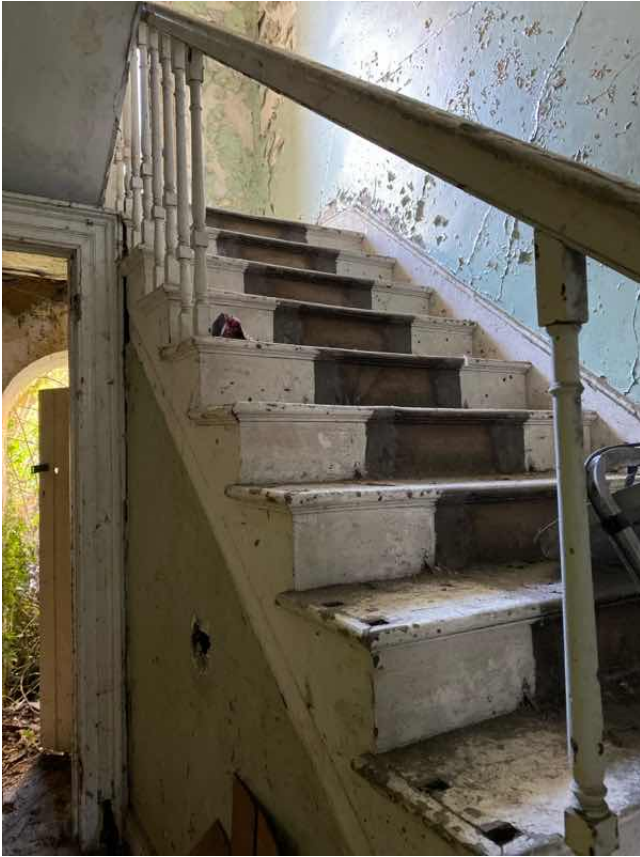
93

Number of spindles are missing from stairs balustrading.

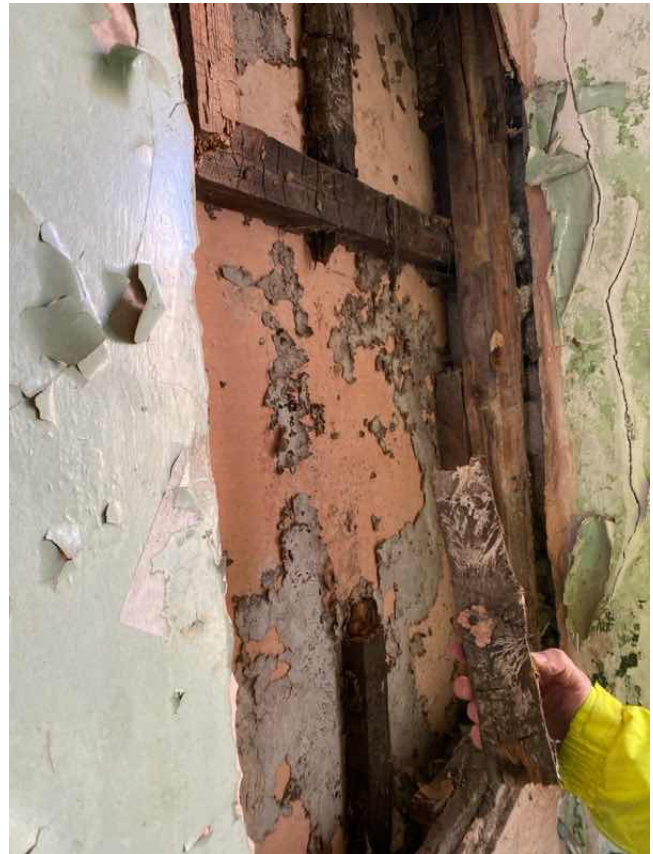
95

Evidence of dry rot of timber in stud wall at stair landing

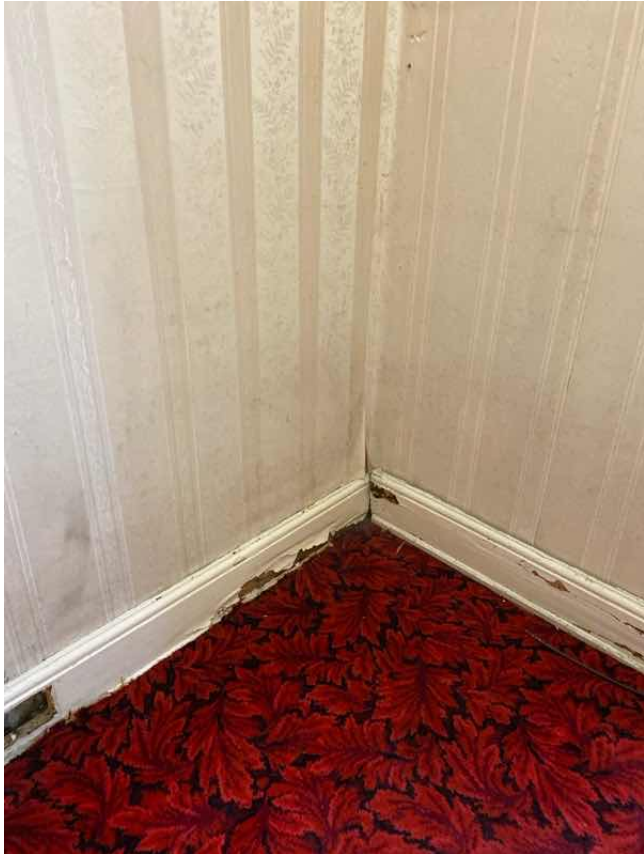
33

Deterioration of skirting board would indicate damp ingress through rear external wall

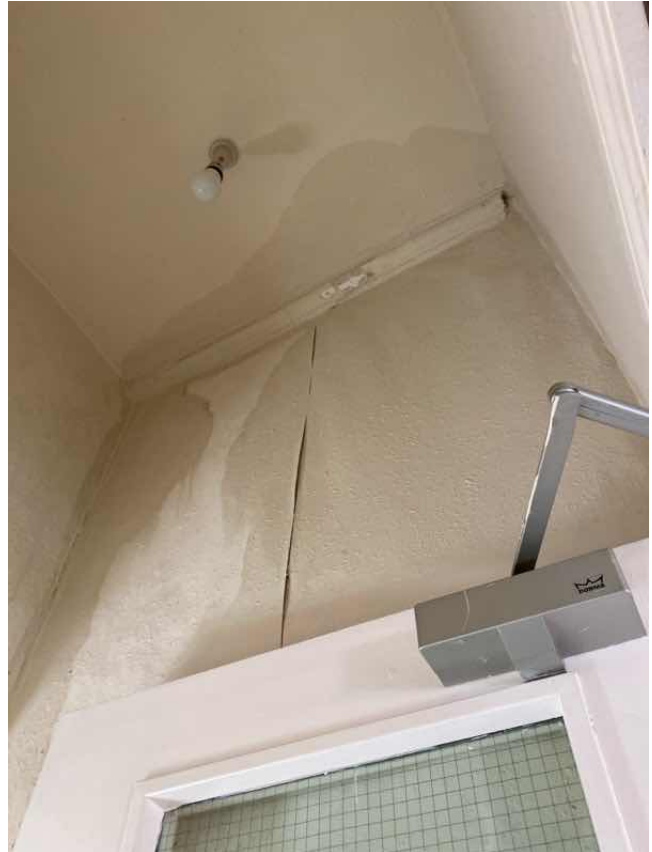
48

Significant ingress of water on rear external wall, wall damp to touch indicates an active leak

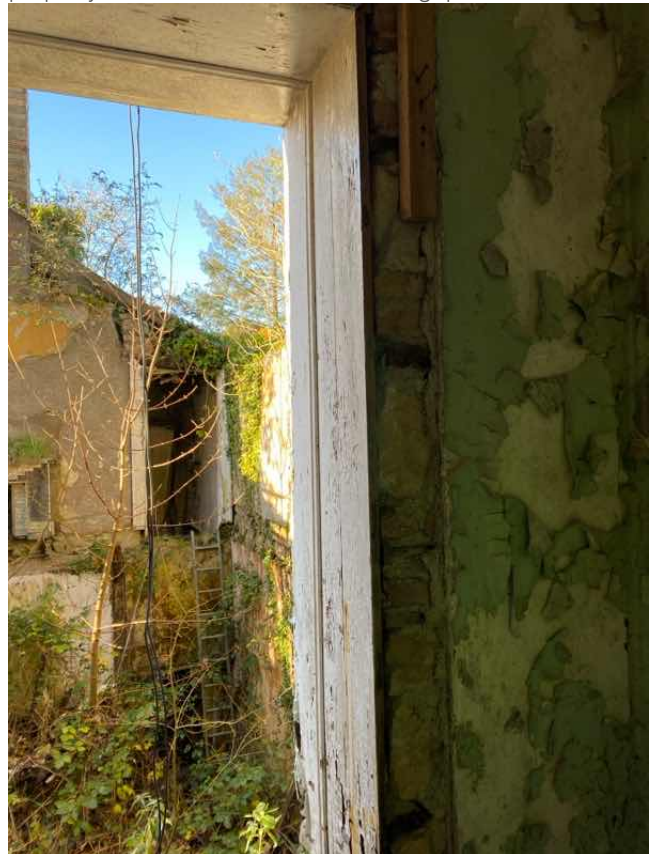
97

Defective embedded timbers in masonry walls throughout the property will need to be removed and gaps filled in with masonry.

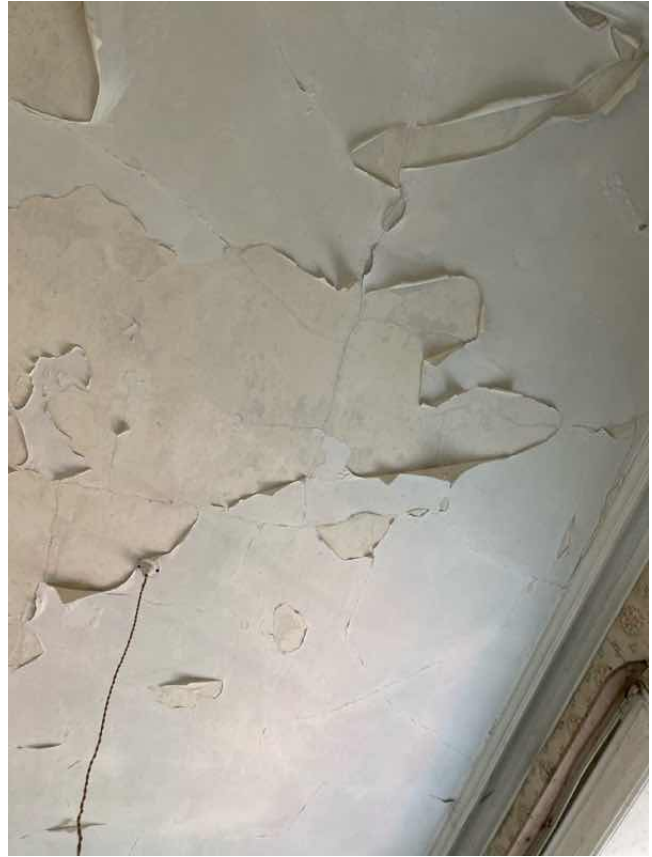
104

Cracking evident in Cieling and paint flaking

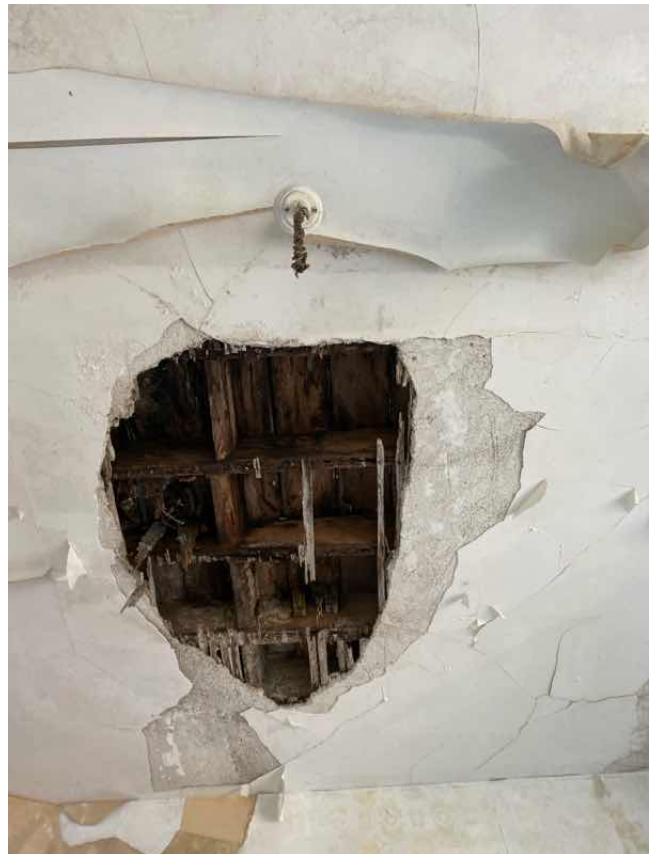
107

Lath and plaster of Ceiling has fallen away, revealing badly deteriorated floor joist spanning on to front exterior wall. This floor above is unsafe to walk on.

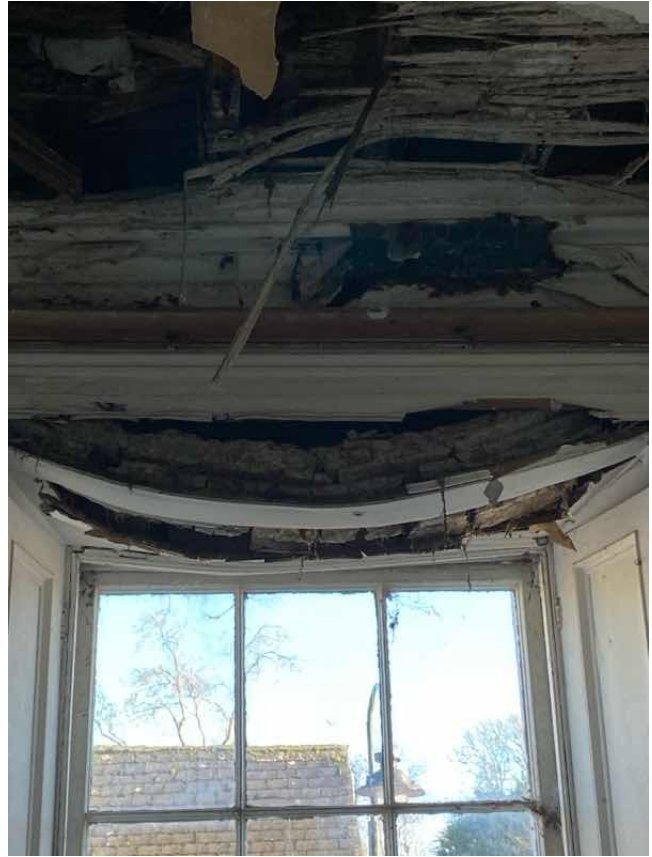
108

Timber lintel over window head has collapsed and it's unsafe.

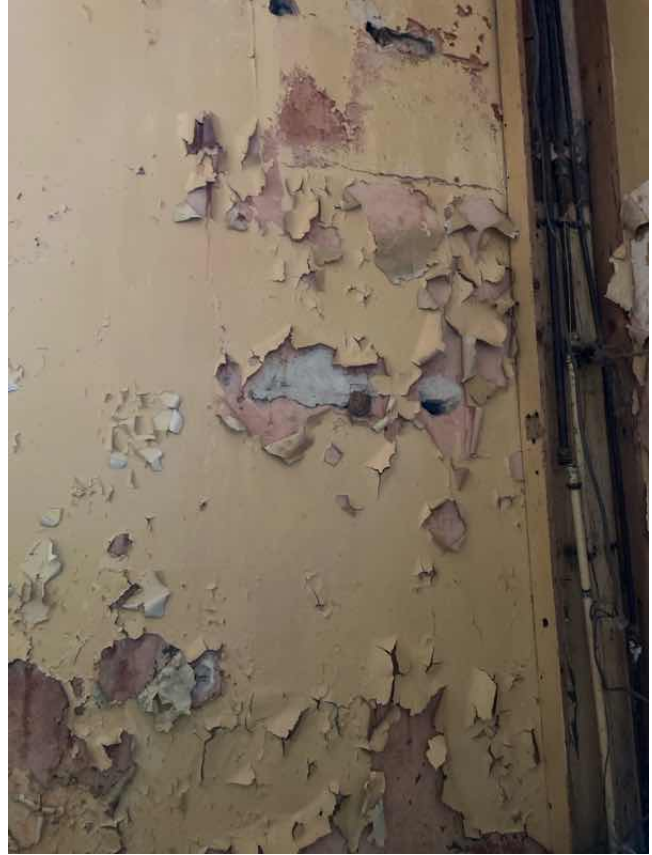
112

Cracks in rear wall possibly indicating blocked up opening.

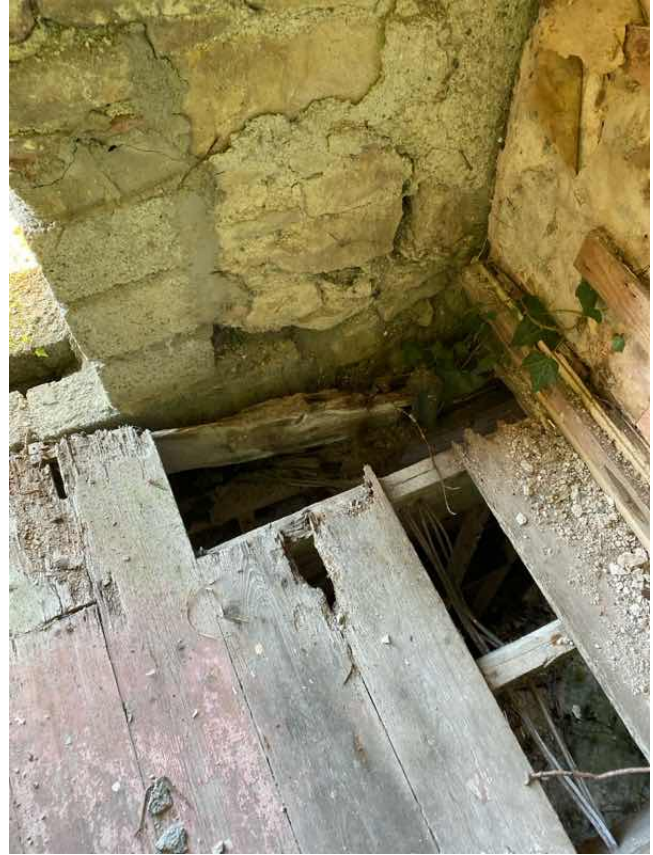
114

Floor joist badly deteriorated and collapsed adjacent to rear wall. Floor boards generally in poor condition with number of holes in same.

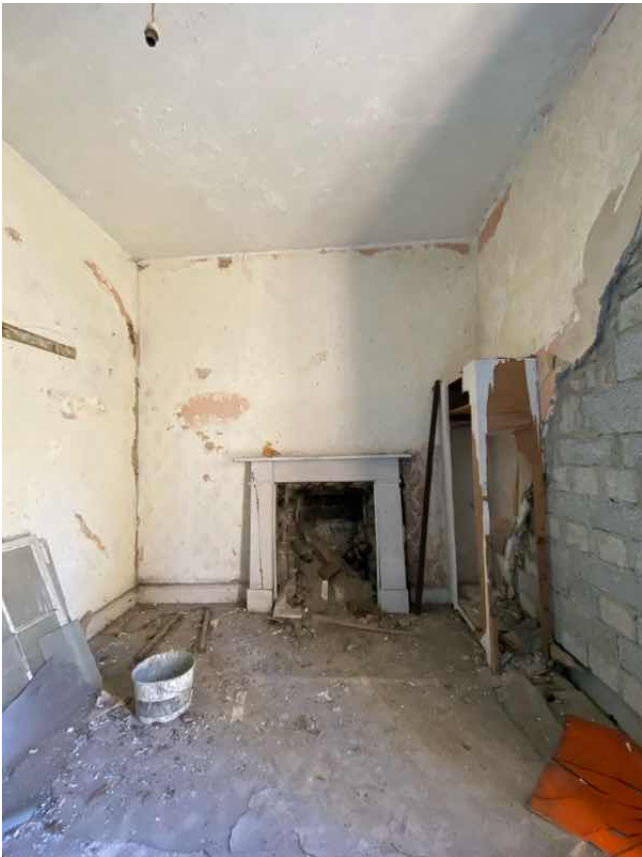
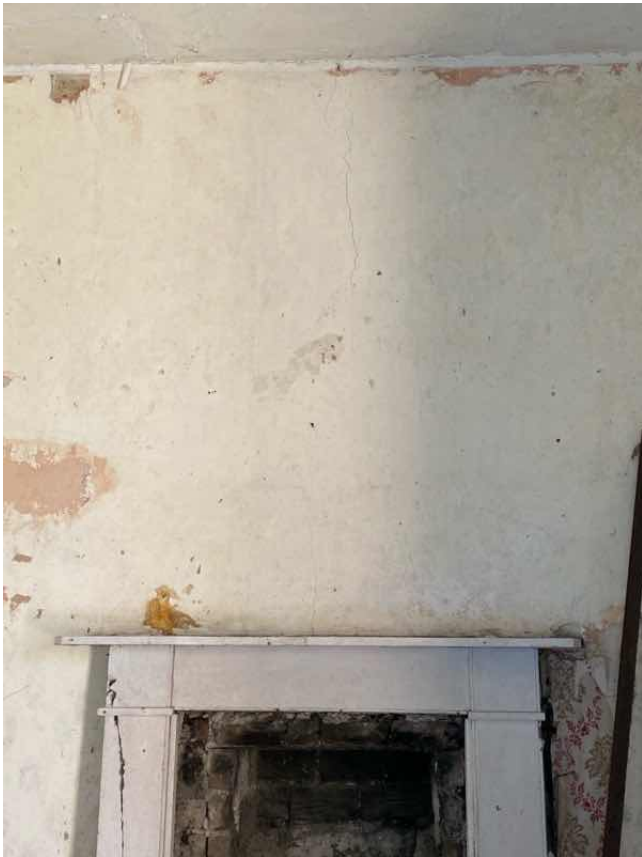
**118**

Evidence of cracking in wall above fire place. Masonry partially collapsed in fire place

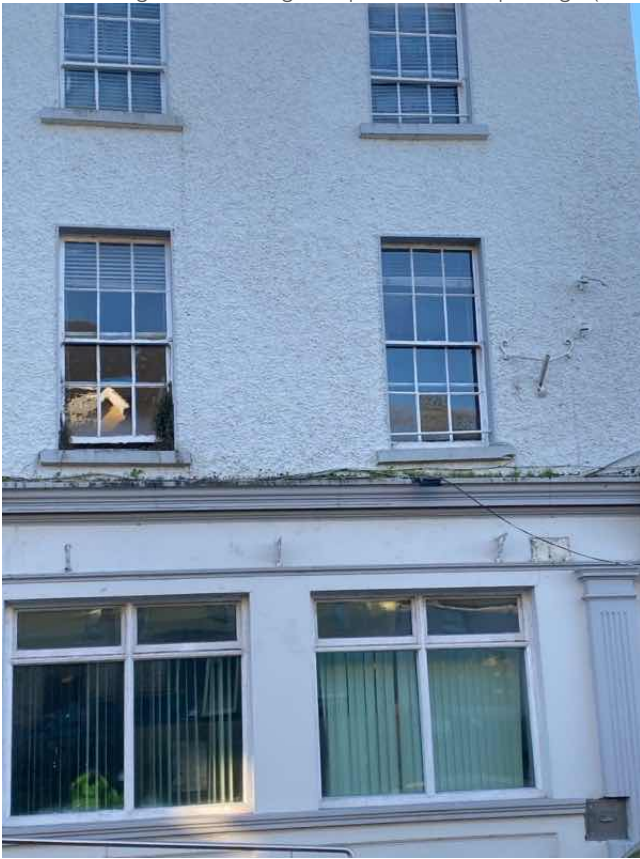
140

Vertical / diagonal cracking to top of window openings ( 2 no. end windows).
