## **Drumshanbo Town Centre Regeneration**

# **Structural Assessment Survey and Site Investigation Report**

**for former Bank of Ireland Building, Early's Building  
and Adjacent Derelict Building, Drumshanbo, Co  
Leitrim**

**December 2023**

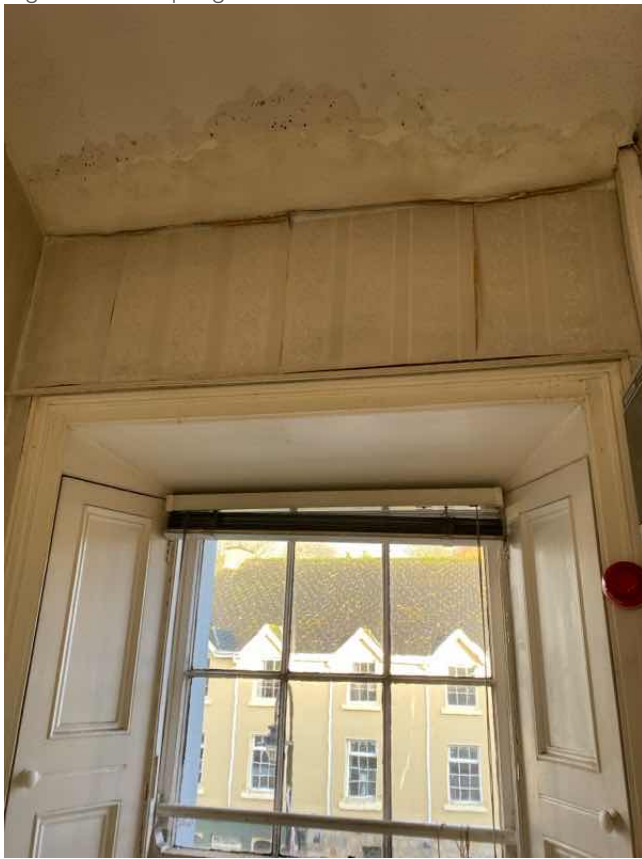
49

Significant damp ingress over window

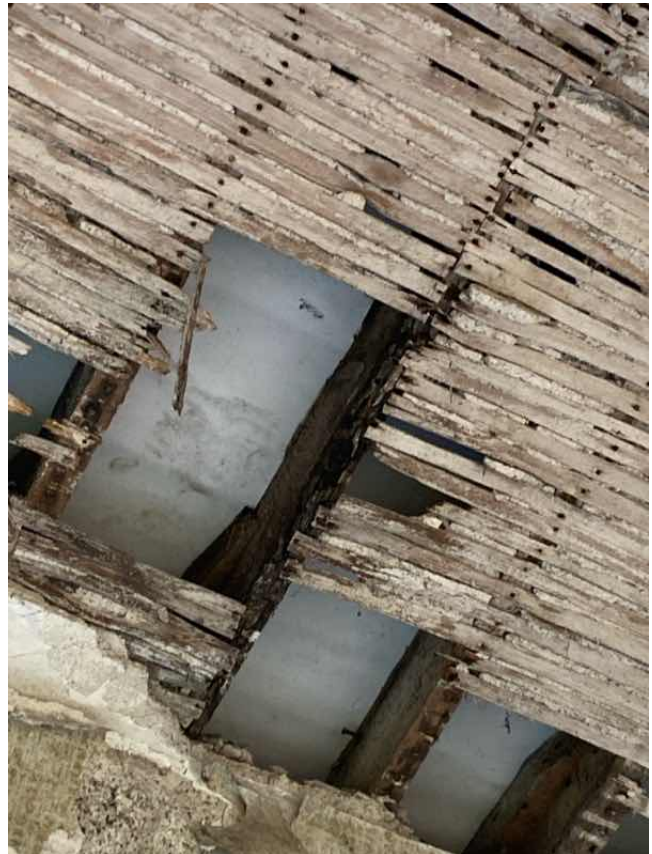
126

Plaster has come away, one rafter is exposed and has signs of deterioration.

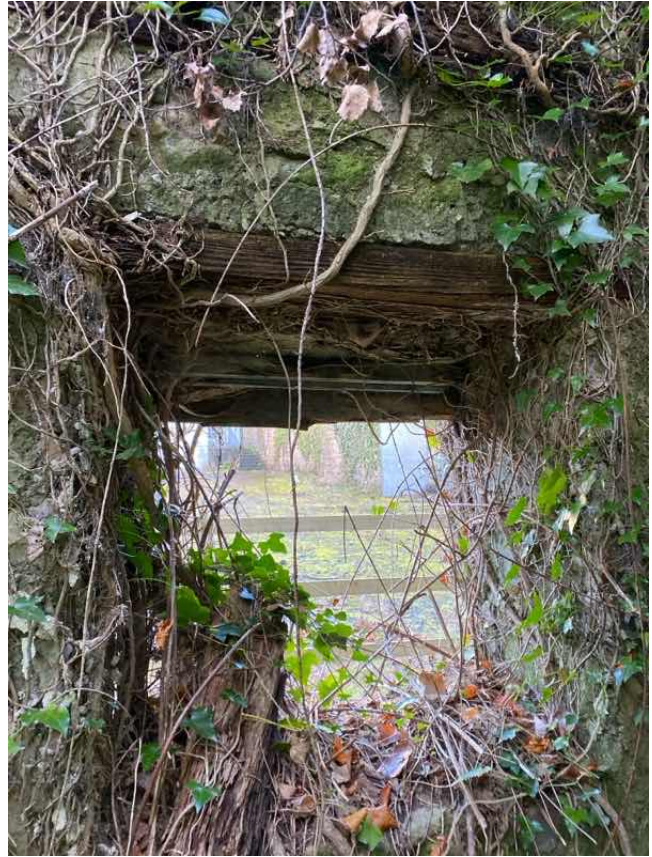
154

Stone lintel intact on outside but defective timber lintel on inside

For both buildings the door and window openings have generally been formed with stone lintels on the outside face and timber lintels on the inside. The stone lintels were generally found to be intact but as both buildings are fully open to the weather (no roofs) the internal timber lintels are either completely rotten or collapsed (which in turn has caused masonry to partially collapse). It is likely that all stone lintels can be retained and reused, and all timber lintels will need to be replaced.

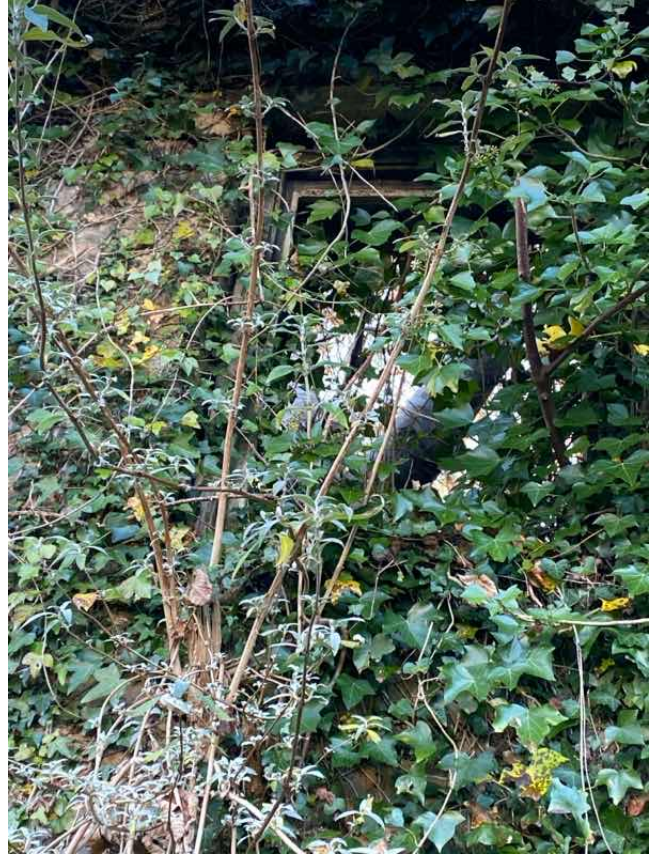
158

Timber lintel collapsed on inside . Stone lintel intact on outside

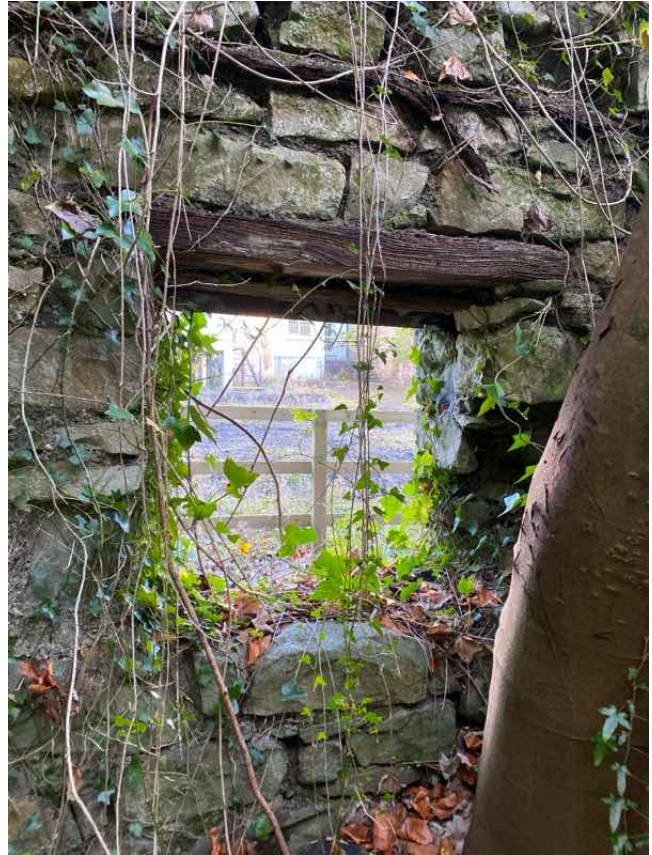
159

Stone lintel intact on outside but defective timber lintel on inside

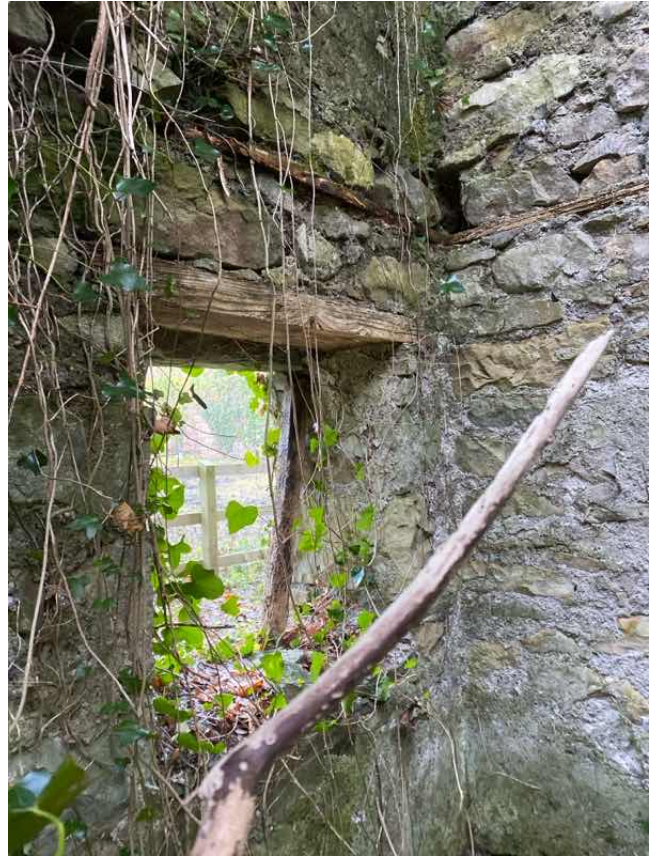
165

Stone lintel intact but defective timber lintel on inside

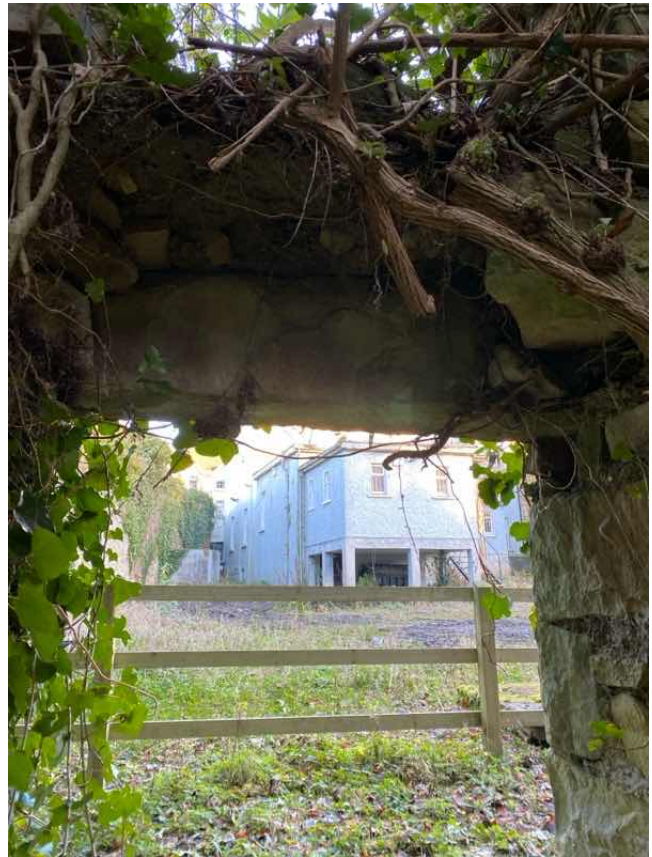
166

Stone lintel intact on outside but no lintel on inside

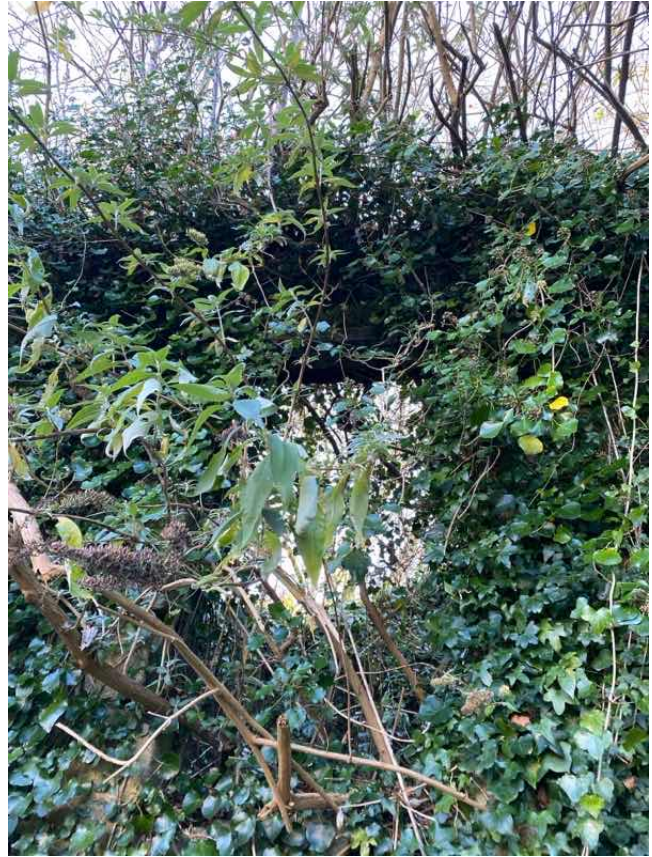
167

Lintel missing on inside face . Stone lintel in outside

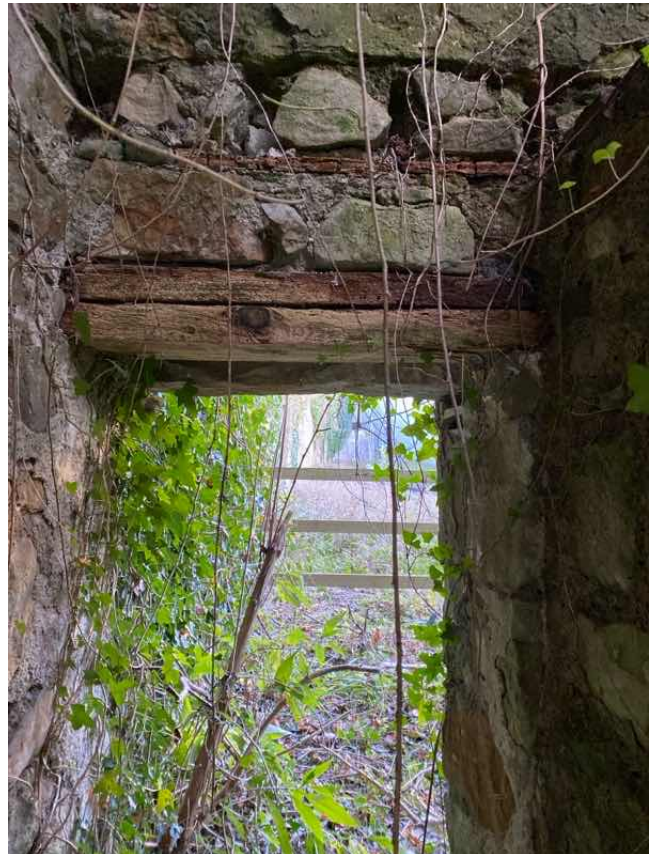
168

Stone lintel on outside. Defective timber lintel on inside
