Asbestos
Surveys Ireland Ltd

Asbestos Refurbishment/Demolition

Client:	Sweeney Architects
Site Address:	Dromahair Site
Contact:	Theresa Keegan
Date:	14/08/20
Surveyor:	Stephen Cullen
Survey No.:	A56140820
Report Issue:	Final

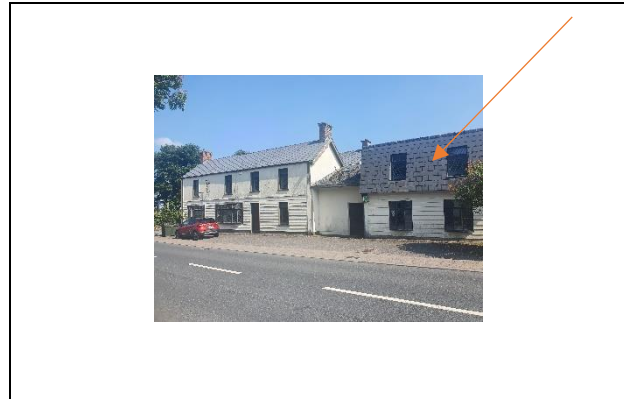
Survey No.	A56140820
Survey Type	Refurbishment/Demolition
Survey Date	14/08/20
Surveyor	Stephen Cullen
Client Name	Sweeney Architects
Site Address	Dromahair Site, Leitrim
Location	Slate-Front of Building
Sample Range	Sample 1

Product type	Asbestos Cement	Score	1
Extent of damage/deterioration	Low	Score	1
Surface treatment		Score	1
Asbestos type	Chrysotile	Score	1
		Total	4

An Asbestos Contractor should be appointed before any refurbishment or demolition
 Asbestos Cement slates typically contain around 10-15 % Chrysotile asbestos

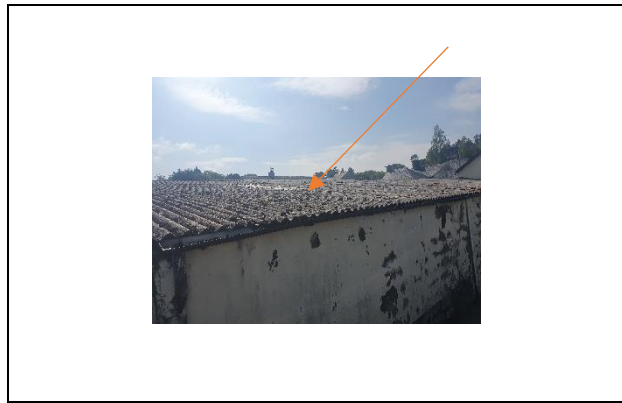
Survey No.	A56140820
Survey Type	Refurbishment/Demolition
Survey Date	14/08/20
Surveyor	Stephen Cullen
Client Name	Sweeney Architects
Site Address	Dromahair Site, Leirim
Location	Roof Sheet-Rear of Building (Dance-Hall)
Sample Range	Sample 2

Product type	Asbestos Cement	Score	
Extent of damage/deterioration	Low	Score	
Surface treatment		Score	
Asbestos type	Chrysotile	Score	
		Total

RECOMMENDATIONS
<p>An Asbestos contractor should be appointed before any refurbishment or demolition</p> <p>Asbestos Cement sheets typically contain around 10-15 % Chrysotile asbestos</p>

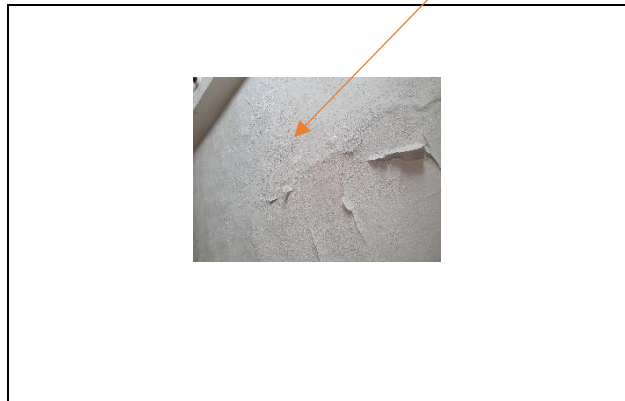
Survey No.	A56140820
Survey Type	Refurbishment/Demolition
Survey Date	14/08/20
Surveyor	Stephen Cullen
Client Name	Sweeney Architects
Site Address	Dromahair Site, Leitrim
Location	Ground Floor Ceiling- Texture Coated Paint
Sample Range	Sample 3

No Asbestos Detected in this sample

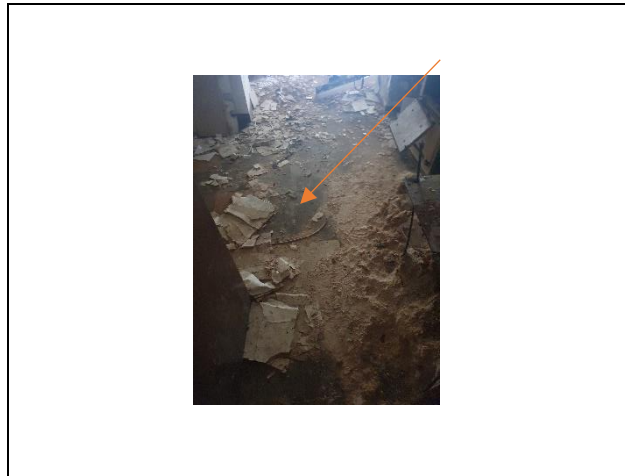
Survey No.	A56140820
Survey Type	Refurbishment/Demolition
Survey Date	14/08/20
Surveyor	Stephen Cullen
Client Name	Sweeney Architects
Site Address	Dromahair Site, Leirim
Location	Grey Floor Tile
Sample Range	Sample 4

RECOMMENDATIONS
No Asbestos Detected in this sample

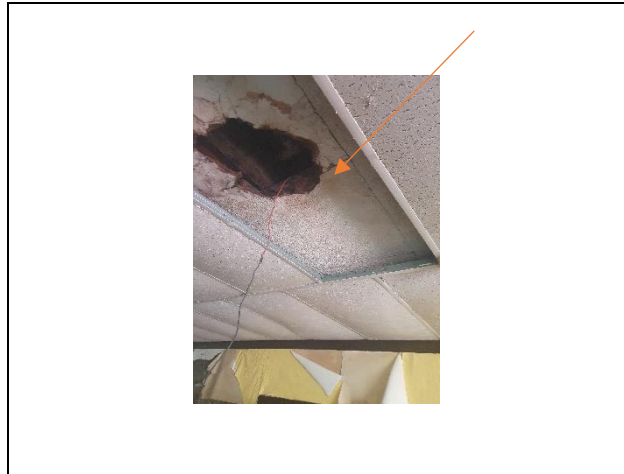
Survey No.	A56140820
Survey Type	Refurbishment/Demolition
Survey Date	14/08/20
Surveyor	Stephen Cullen
Client Name	Sweeney Architects
Site Address	Dromahair Site, Leirim
Location	Bar Area- Ceiling- Texture Coated Paint
Sample Range	Sample 5

No Asbestos Detected in this sample

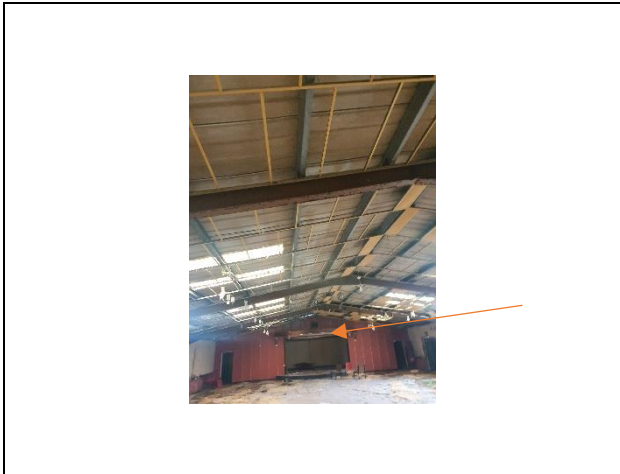
Survey No.	A56140820
Survey Type	Refurbishment/Demolition
Survey Date	14/08/20
Surveyor	Stephen Cullen
Client Name	Sweeney Architects
Site Address	Dromahair Site, Leirim
Location	Above Stage(Dance Hall) Texture Coated Paint
Sample Range	Sample 6

No Asbestos Detected in this sample

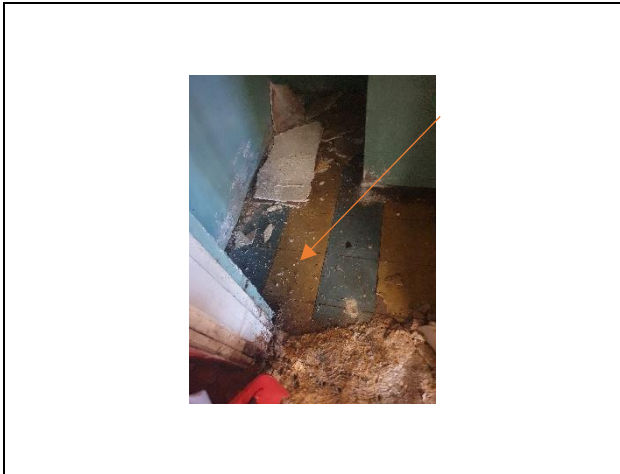
Survey No.	A56140820
Survey Type	Refurbishment/Demolition
Survey Date	14/08/20
Surveyor	Stephen Cullen
Client Name	Sweeney Architects
Site Address	Dromahair Site, Leirim
Location	Dance Hall Toilet-Beside Stage-Yellow Floor Tile
Sample Range	Sample 7

No Asbestos Detected in this sample

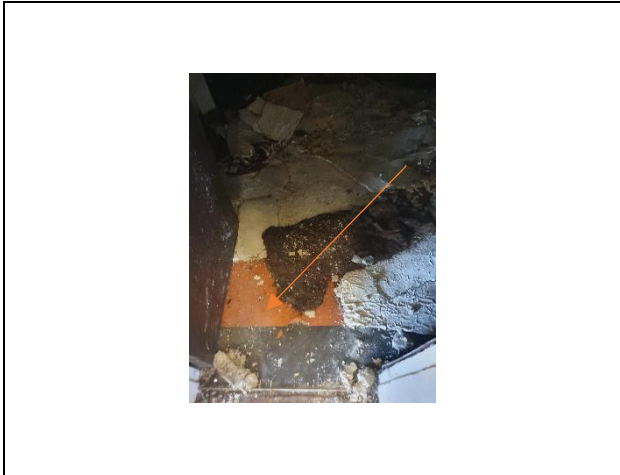
Survey No.	A56140820
Survey Type	Refurbishment/Demolition
Survey Date	14/08/20
Surveyor	Stephen Cullen
Client Name	Sweeney Architects
Site Address	Dromahair Site, Leirim
Location	Orange Floor Tile
Sample Range	Sample 8

Product type	Reinforced Composite	Score	
Extent of damage/deterioration		Score	
Surface treatment		Score	
Asbestos type	Chrysotile	Score	
		Total

An Asbestos contractor should be appointed before any refurbishment and demolition

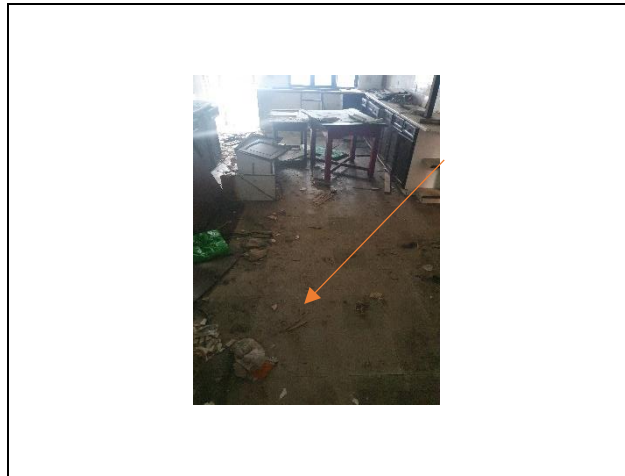
Survey No.	A56140820
Survey Type	Refurbishment/Demolition
Survey Date	14/08/20
Surveyor	Stephen Cullen
Client Name	Sweeney Architects
Site Address	Dromahair Site, Leirim
Location	Kitchen Floor Tile
Sample Range	Sample 9

RECOMMENDATIONS
No Asbestos Detected in this sample

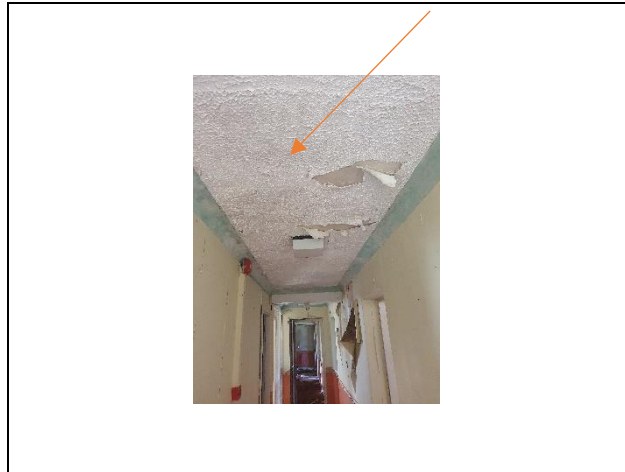
Survey No.	A56140820
Survey Type	Refurbishment/Demolition
Survey Date	14/08/20
Surveyor	Stephen Cullen
Client Name	Sweeney Architects
Site Address	Dromahair Site, Leirim
Location	Ceiling Up-Stairs (Hall)- Texture Coated Paint
Sample Range	Sample 10

Product type	Textured Coating	Score	1
Extent of damage/deterioration		Score	1
Surface treatment		Score	1
Asbestos type	Chrysotile	Score	1
		Total	4

RECOMMENDATIONS
An Asbestos contractor should be appointed before any refurbishment or demolition work takes place

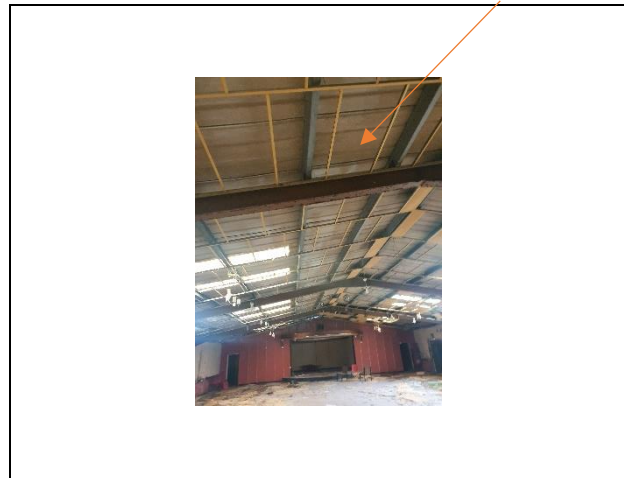
Survey No.	A56140820
Survey Type	Refurbishment/Demolition
Survey Date	14/08/20
Surveyor	Stephen Cullen
Client Name	Sweeney Architects
Site Address	Dromahair Site, Leirim
Location	Dance Hall. Asbestos Sheets in Ceiling
Sample Range

Product type	Asbestos Sheets	Score	
Extent of damage/deterioration		Score	
Surface treatment		Score	
Asbestos type	Strongly Presumed	Score	
		Total

RECOMMENDATIONS
<p>An Asbestos contractor should be appointed before any refurbishment or demolition work takes place,</p> <p>The Sheets in the ceiling are strongly presumed to contain asbestos</p>

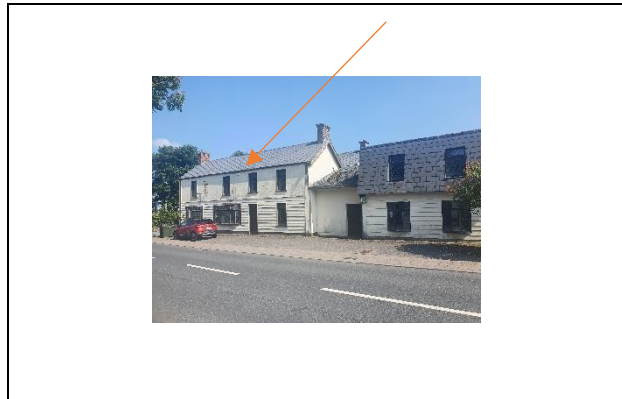
Survey No.	A56140820
Survey Type	Refurbishment/Demolition
Survey Date	14/08/20
Surveyor	Stephen Cullen
Client Name	Sweeney Architects
Site Address	Dromahair Site, Leitrim
Location	Front of the Building
Sample Range

Product type	Slates	Score	
Extent of damage/deterioration		Score	
Surface treatment		Score	
Asbestos type	Strongly Presumed	Score	
		Total

RECOMMENDATIONS
An Asbestos contractor should be appointed before any refurbishment or demolition work takes place
