ARCHITECTURAL HERITAGE IMPACT ASSESSMENT

BOUNDARY WALL OF ST. MARY'S, MAIN STREET, MOHILL, CO. LEITRIM

DERMOT NOLAN
CONSERVATION ARCHITECT

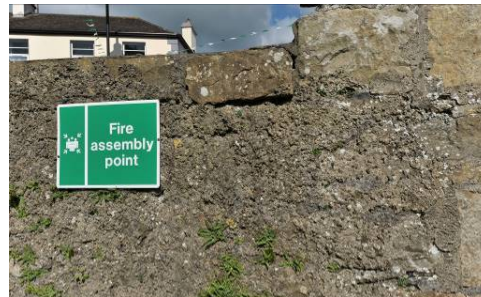
There are substantial remnants of a harling material, particularly to the inner face.

PIC. 4; ENTRANCE (FROM WITHIN); HARLING MATERIAL EVIDENT.

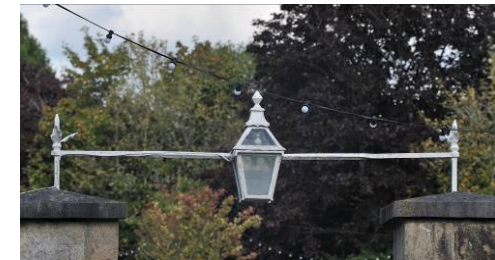
2.4 There is a glazed forged iron (with cast iron embellishments) lantern over the entrance, supported on the gate piers.

PIC. 5; WROUGHT/CAST IRON LANTERN OVER ENTRANCE.

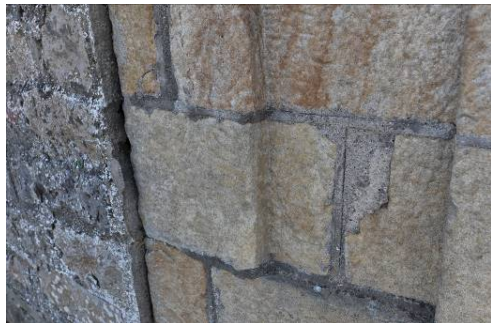
- 2.6 Condition of the wall is considered fair. It has moved outwards in places, mostly towards its western end, to varying degrees, where it is distinctly out of plumb.

The cause of this outward movement is thought principally to be lateral pressure caused by the higher level of earth on the church side.

This may be exacerbated by a degree of subsidence in the footing and, perhaps, by (when – c. 20 years ago?) the laying of the footpath, on the public side by the County Council.

- 2.7 Where there has been outward movement in the wall, cracking was evident between the rubble element and the piers.

FIG. 7; OPEN JOINT BETWEEN PIER AND ADJACENT WALL, INDICATING DIFFERENTIAL MOVEMENT.

4.5.1 The remainder of the wall will be restored, using appropriate expertise and conservation practice. These measures will include (a) removal of growth, (b) removal of cement-based material and repointing the wall and piers with lime-based mortar, (c) reinstatement of loose stonework & capping and (d) straightening and securing pier(s).

4.7.3 The railings could be stabilised by means of backstays; this could be utilised, along with straightening the east pier, to improve the stability of the wall and piers.

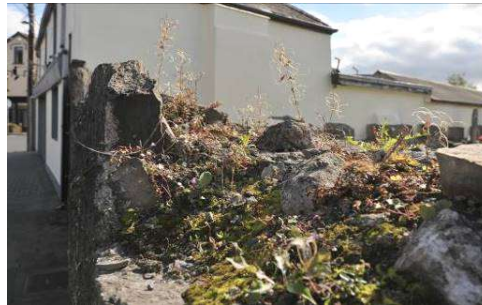
- 2.8 There are instances where stones have become dislodged, pointing mortar is missing, and growth is established in joints. The piers have also grown out-of-plumb, and have lost their bond with abutting walls, particularly the east one.

FIG. 8; GROWTH TO TOP OF WALL.

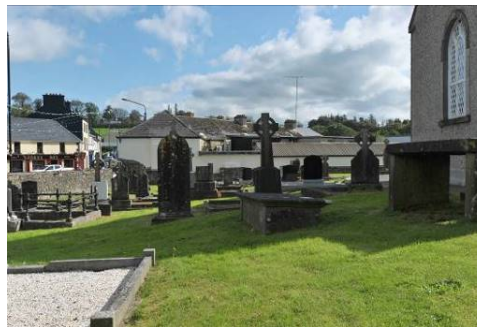
- 2.9 It is noted that the ground slopes, on all side, away from the church. This is particularly true on the north side (i.e. towards the subject wall).

Level of graves is stepped accordingly.

FIG. 9; EARTH SLOPES FRPM CHURCH TOWARDS WALL (TO THE NORTH).

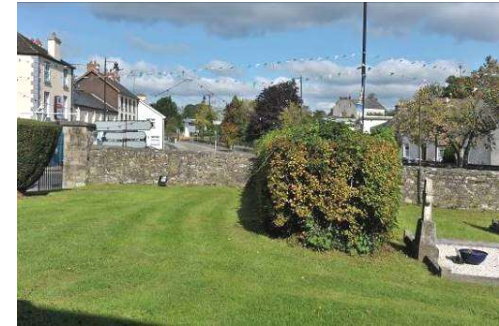
FIG. 10; AREA INSIDE ENTRANCE WHICH IS FREE OF GRAVES.

- 2.10 A significant feature of the grounds is that, while graves are widespread throughout the area, there is a small area immediately to the east of the gate which is free of graves.

This corresponds to the position where it is proposed to replace the rubble wall with railings.

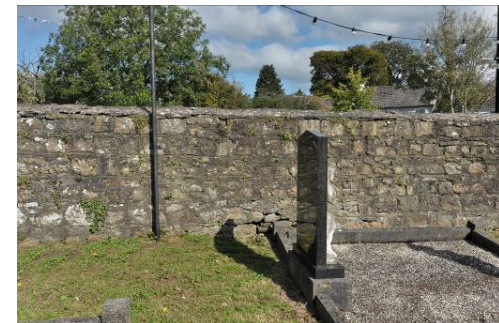
- 2.11 Also significant is how close certain graves to the boundary wall, some almost touching it.

FIG. 11; CLOSENESS OF SOME GRAVES TO WALL.
