Leitrim Sweathouse Project

Project Report 2022

On behalf of Leitrim County Council, supported by the Heritage Council

30th October 2022

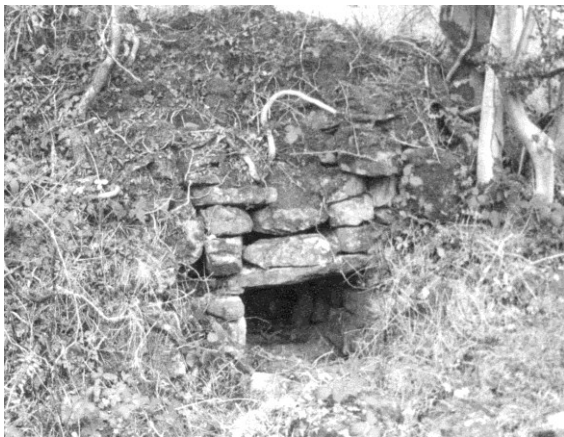
Plate 6: Largandill LE018-075 in 1992 from SW (courtesy of G Burns)

Other surveys undertaken in the past are therefore of utmost importance. Mr Gabriel (Gaby) Burns carried out a survey of Sweathouses in 1992 covering Co. Fermanagh and parts of counties Leitrim, Cavan and Roscommon (Burns 1992). He generously gave his time to forward data that he collected back in the early 1990's, including locations measurements and photographs. Unfortunately, his discoveries were not reported to the Archaeological Survey of Ireland at that time – while they were still surveying in Co. Leitrim up until 2003 – meaning that that his survey work remained largely undocumented for 30 years. For example, the Sweathouse at Largandill (LE018-075----) was recorded as in 1991 as *'Not visible at ground level'* (Moore 2003, 225) yet G. Burns photographed the site in 1992 (Plate 6). In 2008, the Archaeological survey updated the online record to *'it might still survive'*, possibly owing to it being surveyed once again by Bolton in 2005. Finally, it was surveyed for a third time in 2022 and while in a deteriorating condition is still largely extant (Plate 7).

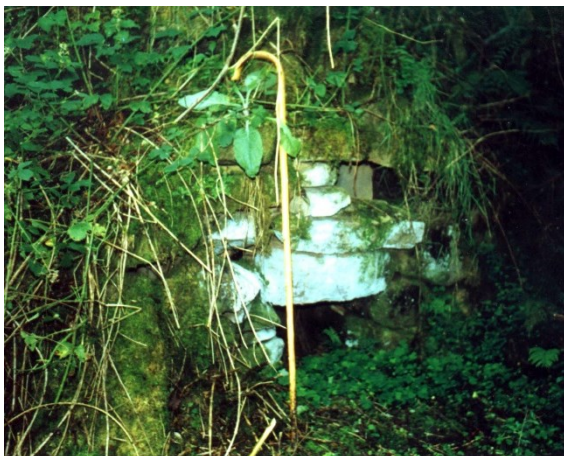
Plate 8: Tullynahaia LE019-005 in 1992 from SW (courtesy of G Burns)

Another instance is the Sweathouse at Tullynahaia (LE019-005----) which was recorded in by the Archaeological Survey in 1991 as *'Not visible at ground level'* (Moore 2003, 227), and yet Burns,

together with archaeologist Simon Large, again had photographed and measured the structure in 1992 (Plate 8). This year in the course of the Leitrim sweathouse project, the same site was surveyed but only a trace remained (Plate 9). Had this Sweathouse been recorded officially as an intact example would this have helped protect or preserve it? It is difficult to say with certainty, but it highlights the need for accurate surveying particularly when assessing vulnerable Sweathouse sites.

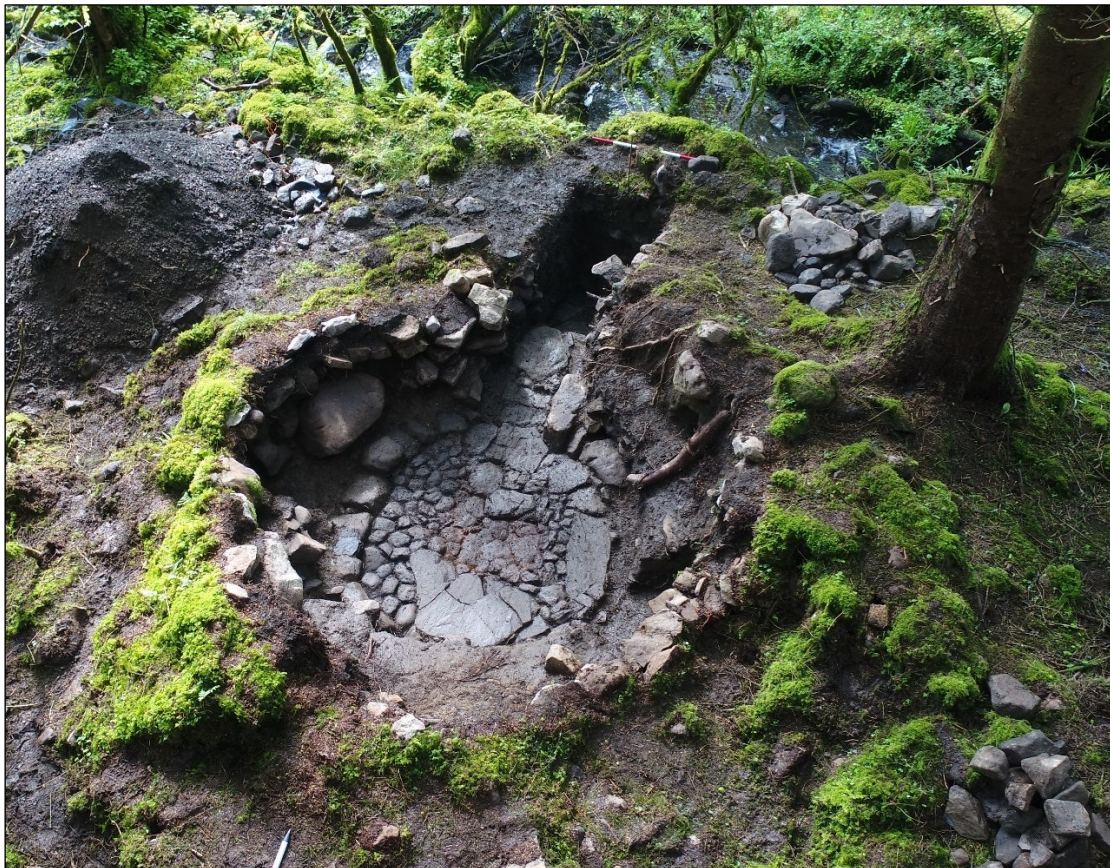
Plate 12: View of Alteenacres Glebe at the end of excavation

Alteenacres Glebe was excavated under licence 22E0288. The site is recorded as a '*Vapour Bath*' on the 1835 edition O.S. map, and subsequently as '*Sweat House*', and now survives as a collapsed mound in forestry plantation. It had not yet collapsed by the late 1970s (Weir 1979) and remained to a height of 1.8m into the 1990s (Burns 1992). In 2021, the internal diameter was recorded as 2.8m and no internal measurements were recorded prior to this. The excavated trench included the circular internal area of the Sweathouse chamber with an extension 2.4m to the southeast, 1m in width.

in width and at least 0.6m in length and opened to the southeast. From the entrance, a series of large stones stepped down in the direction of the river (2.5m to south). The path/steps became covered by burnt rake-out, mound slippage and weathered debris throughout the sites period of use. Within the chamber, only thin remnants of burning episodes remained.

Almost all the sampled burnt material consisted of turf embers. Charcoal was recovered from the steps outside the entrance (alder) and within the collapsed mound material (oak), and the former has been forwarded for radiocarbon dating. The site was backfilled and secured to allow the backfilled material to settle.

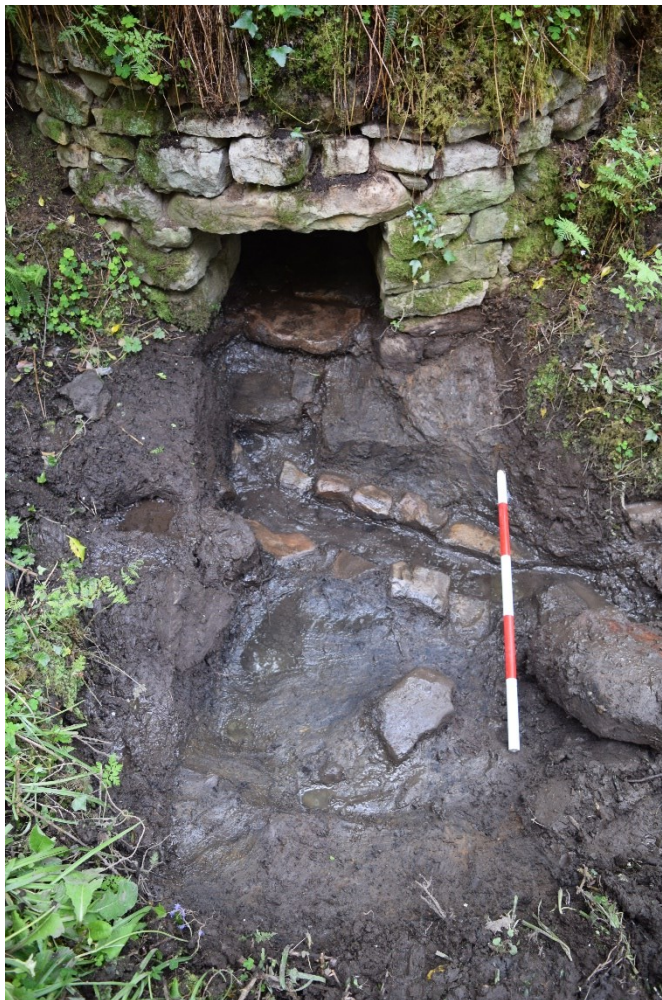
Plate 13: Killadiskert, stone lined drain and entrance from west

The western half of the interior was excavated, through the entrance, where a 1m wide trench extended out 1.8m. Only deposits above the floor were excavated internally. This found a level flagstone floor, with very thin overlying deposits and only trace indications of burning activity. The flagstones continued through the 0.46m wide entrance. Having both the floor and top lintels of the entrance, a minimum height of 0.53m was measured. Outside, to west, a wide gully ran alongside the field boundary, but only a couple of metres either side of the Sweathouse. A series of large stones formed stepping-stones

leading up to the entrance. Around the base of these stones, a thin burnt deposit was the remnant of burnt material removed from the chamber. Beneath the stepping-stone nearest the entrance, a stone-line drain crossed the trench from north to south. This appears to have been used to keep the Sweathouse dry but may also have provided water to a pool further downslope.

A single find of a partial leather shoe was recovered from the upper fill of the drain and is likely post-medieval in date (*pers. comm.* M Hurley May 2022). All samples were sieved and showed an abundance of turf embers. Charred reeds were also noted from immediately outside the entrance. Charcoal (alder and blackthorn/cherry) recovered from both outside and inside the chamber have been sent for radiocarbon dating. The site was backfilled and cordoned off to allow the backfilled materials to settle.

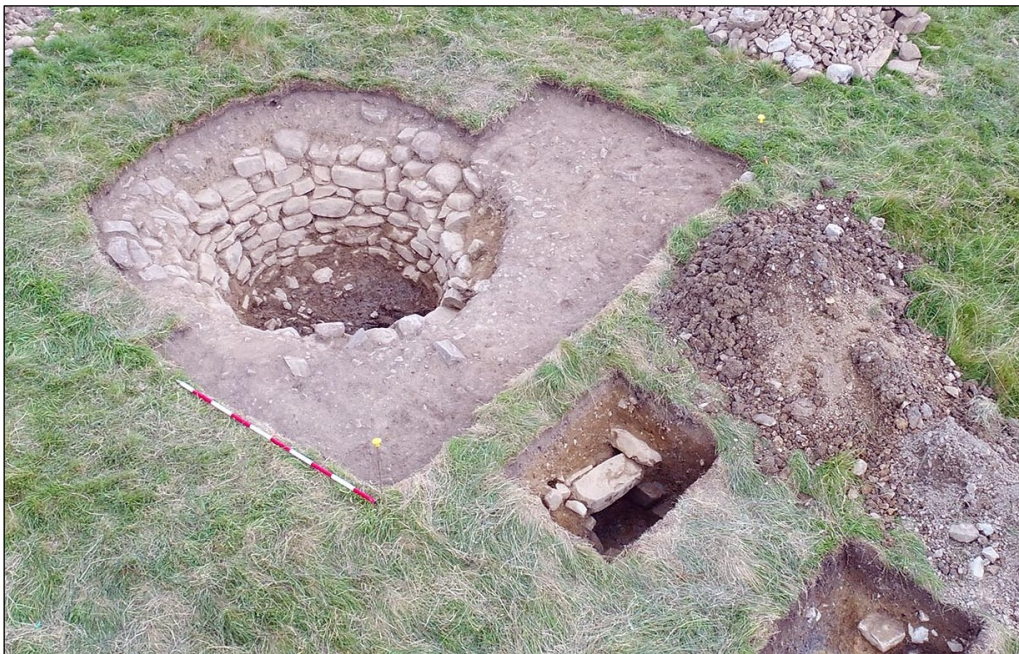
Plate 14: Cattan end of excavation

The structure excavated was a drying kiln, most likely for cereal-drying. This comprised of a funnel shaped bowl, with stone lining, 2.9m in diameter at the top and narrowing to a base c. 1.45m in diameter. It had a depth of 1.28m with a stone-lined flue opening at the base to the west (H: 0.48m; W: 0.62m). A second trench was opened 0.4m to the west. The flue was again located but the capping lintels did not remain after a combined length of 2.6m but the side-walls did continue beyond this trench. A third trench at 1.2m further west, found no evidence of the flue or burning activity. Therefore, the flue length was originally >3m but <4.3m. a small amount of burnt material was found at the base of the flue in Trench 2. Only sparse evidence of burnt material was found within the bowl area, however, several wooden branches were preserved here. These were arranged in such a way as to suggest that they may have been used as a drying rack. Broken fragments of this wood (alder and willow) were sampled for radiocarbon dating. About a third of this material was excavated. The timber at the base was covered with breathable membrane and the site was backfilled, with finer sediments at the base. The sod was replaced at the surface.

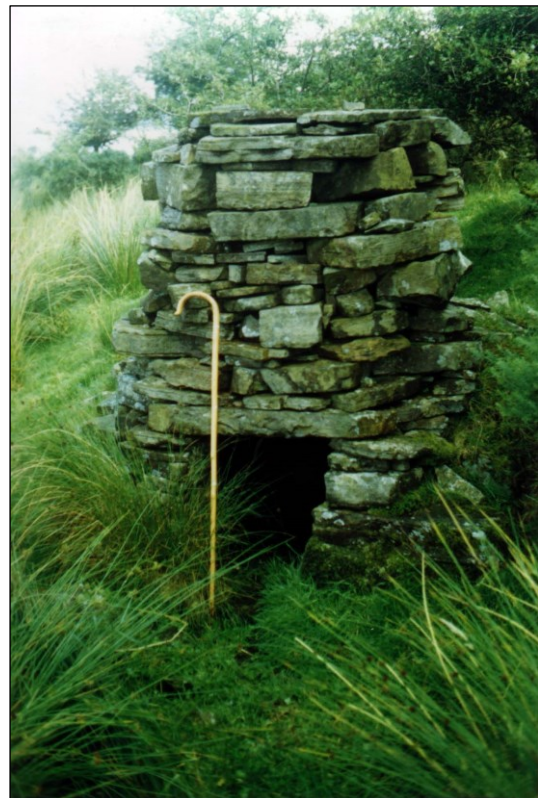
Plate 19: Rebuilt Sweathouse at Briscloonagh LE012-043 (photo by G Burns)

It must be noted that currently two of the Sweathouses recorded in this project have been 'rebuilt' to some degree (Plate 16). This can be problematic as we often do not know from what basis they were rebuilt. The advice from the National Inventory of Architectural Heritage is that *'the primary aim of conservation is to prolong the life of something of value, and to do so in a way that protects what is valuable about it'* (Quinlan Hanna & Kelly, 2010, 22). If the size or orientation or setting of a Sweathouse is altered during rebuilding, then much of that value is lost.

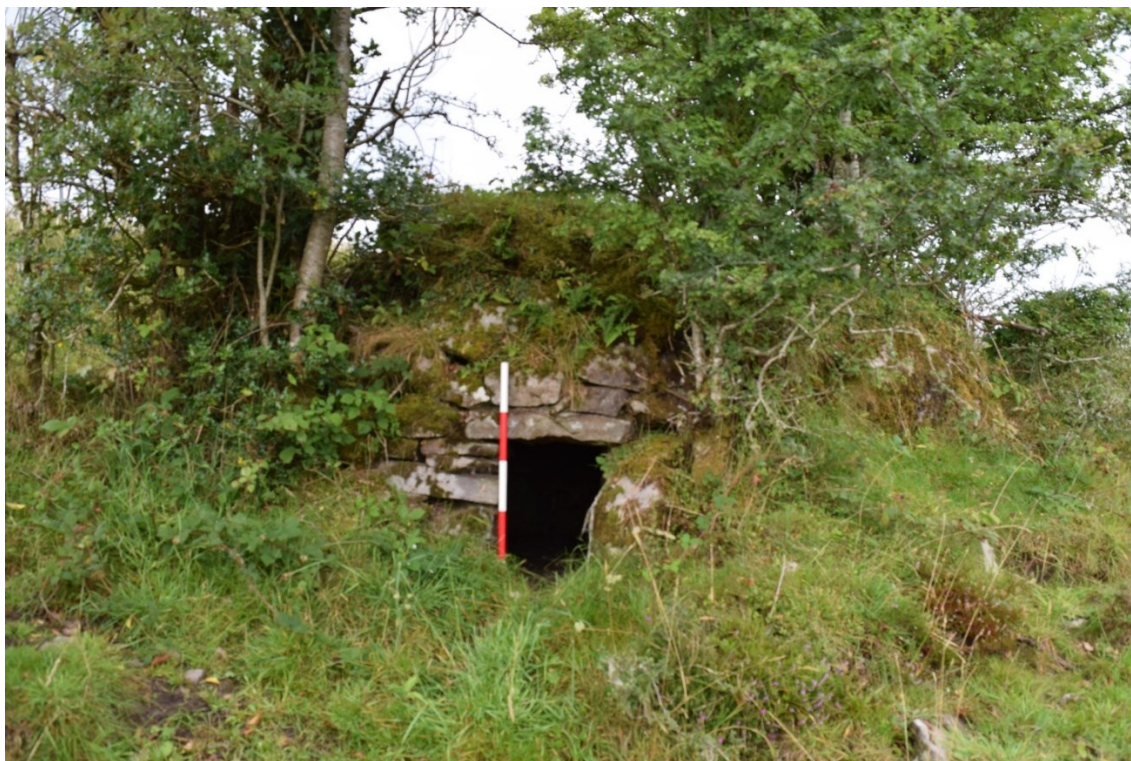
View of Sweathouse from SE, 25th Aug 2022

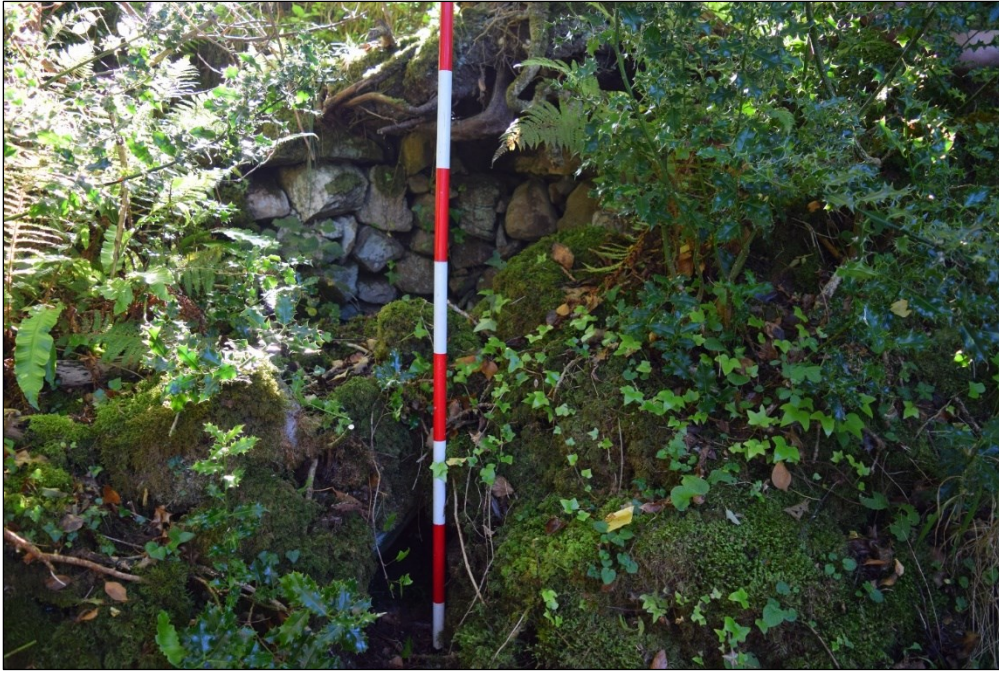
View of Sweathouse from N, 13th Sept 2022 (A. Harte)

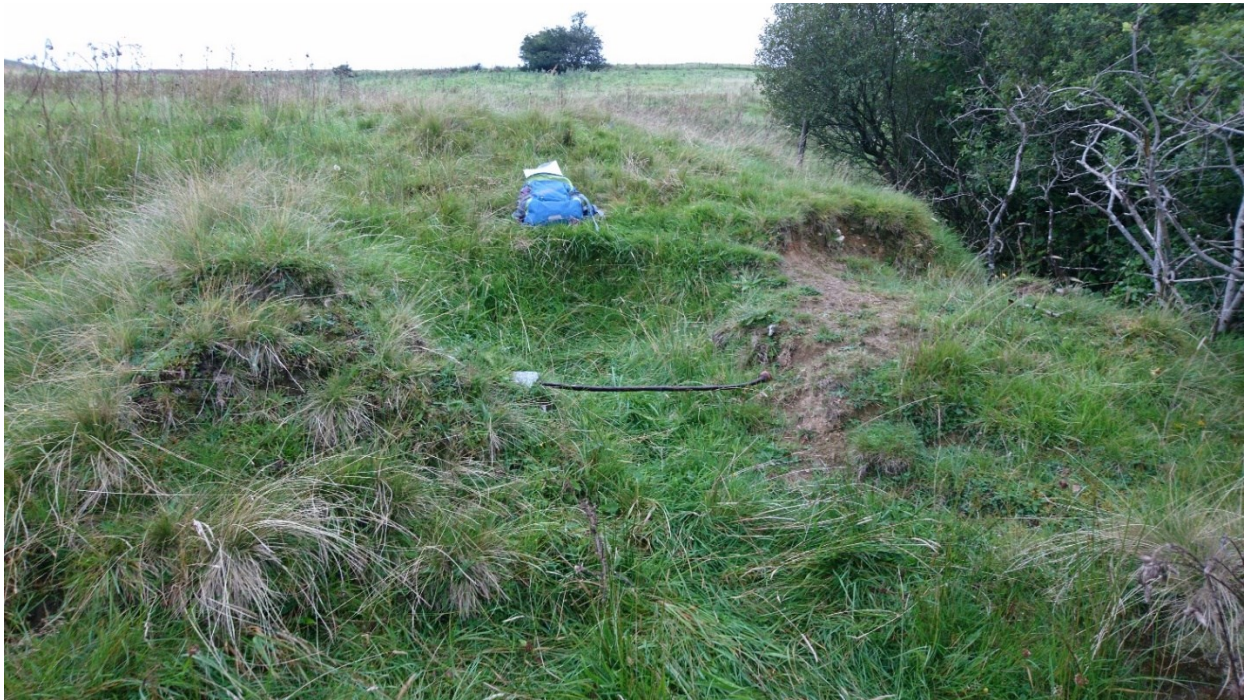
View of Sweathouse from SE, 11th Sept 2022 (F. Kelly)

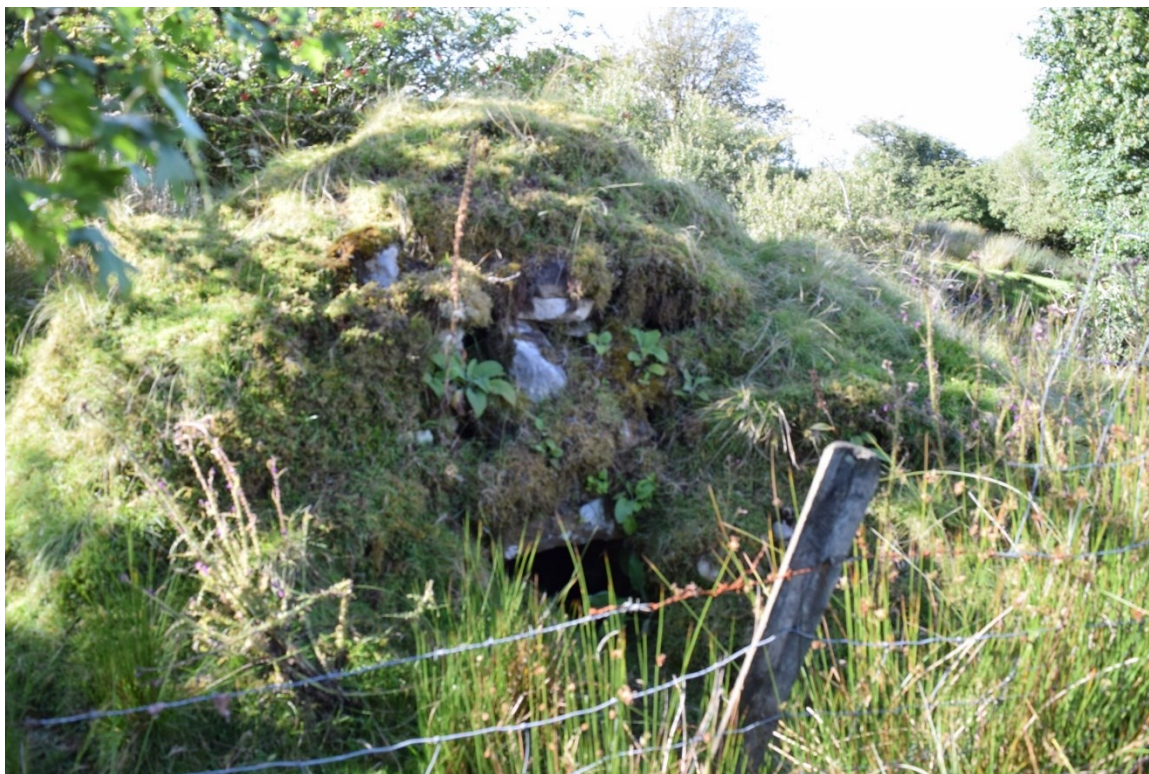
View of Sweathouse from S, 25th Aug 2022

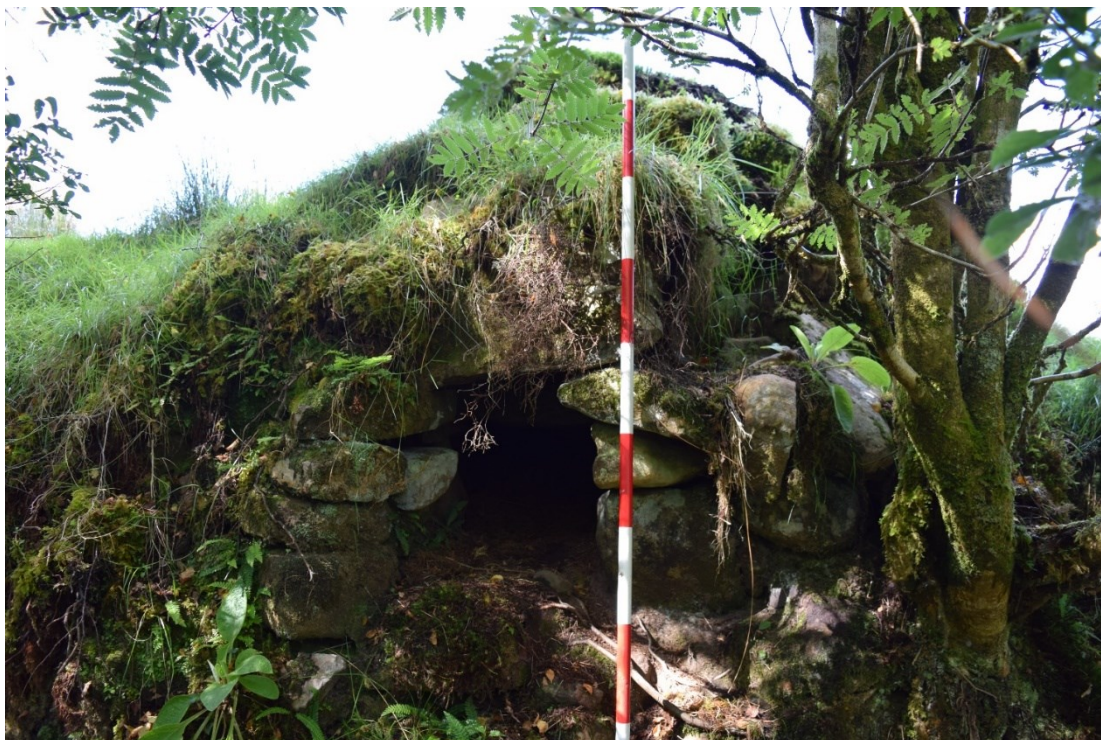
View of Sweathouse from SE, 25th Aug 2022
