## Hartley Bridge Structural Investigation & Assessment

### Stage 2 Assessment Report

DRAFT ISSUE 1 | AUGUST 2017

**Document No:**..... 16.181.10 – DL-LP2784-001

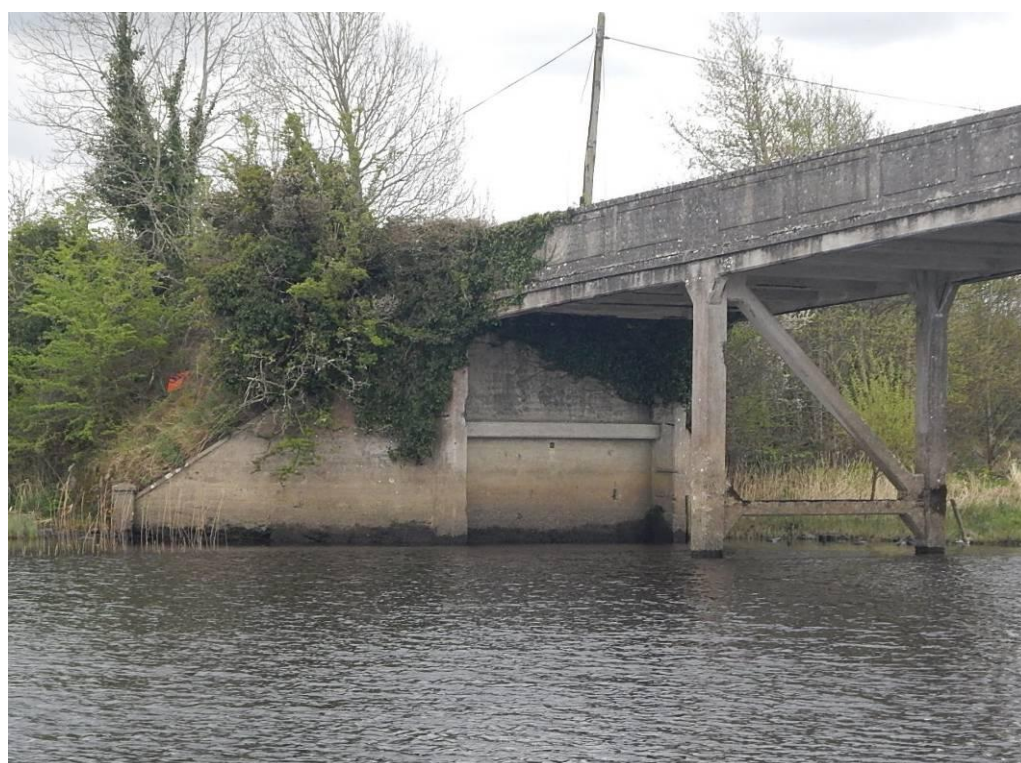
**Photograph 4: East Abutment**

The reinforced concrete piers and abutments are in relatively good condition but also exhibit spalling with exposed reinforcement in numerous locations. As per the bridge deck/beams, there is no evidence to suggest that the observed defects are indicative of structural distress due to overload. However, the defects noted do pose a durability issue and will require concrete repairs as part of any proposed remedial works.

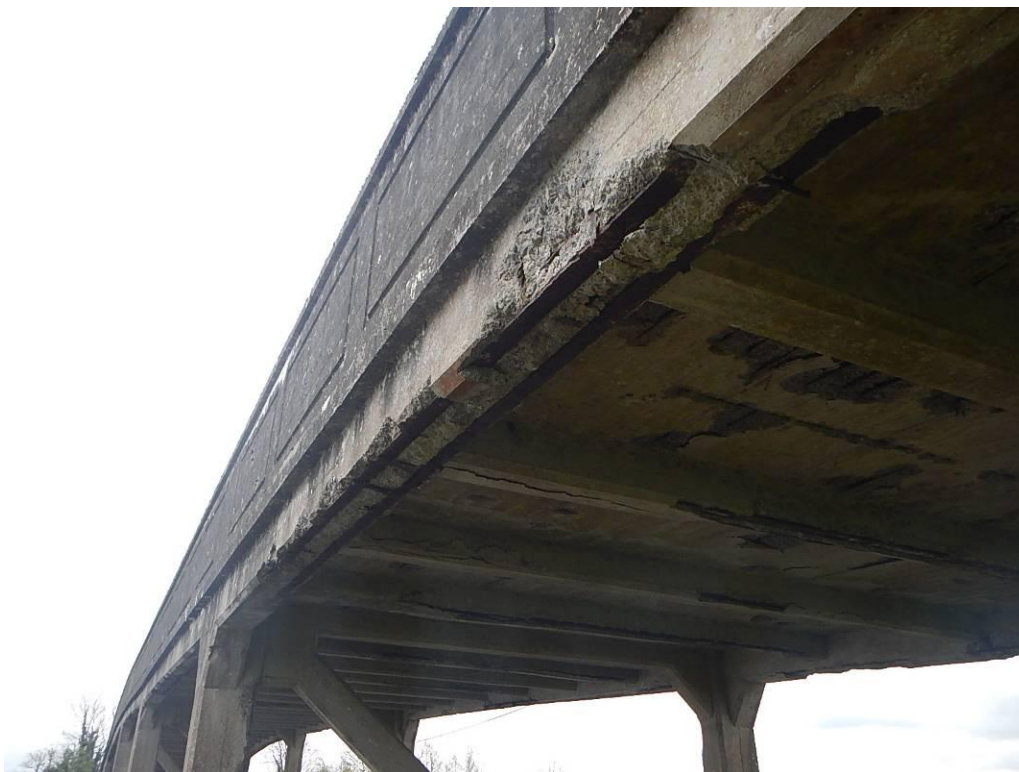
**Photograph 7: Bridge Beam –Span 6**

The bridge reinforced concrete deck soffit and beams were inspected from the underbridge unit and riverbanks and were found to be in poor condition. As noted during previous inspections, there is widespread spalling with exposed reinforcement evident throughout the soffit of the bridge deck, longitudinal beams and transverse beams. Significant spalling was also noted to the sides of the beams below deck level. The exposed reinforcement exhibits corrosion with loss of section and lamination of steel flanges noted in some locations. Based on the record information made available, the spalling appears to have progressed over a relatively long period of time. However, no direct comparison was possible to determine the rate of deterioration.

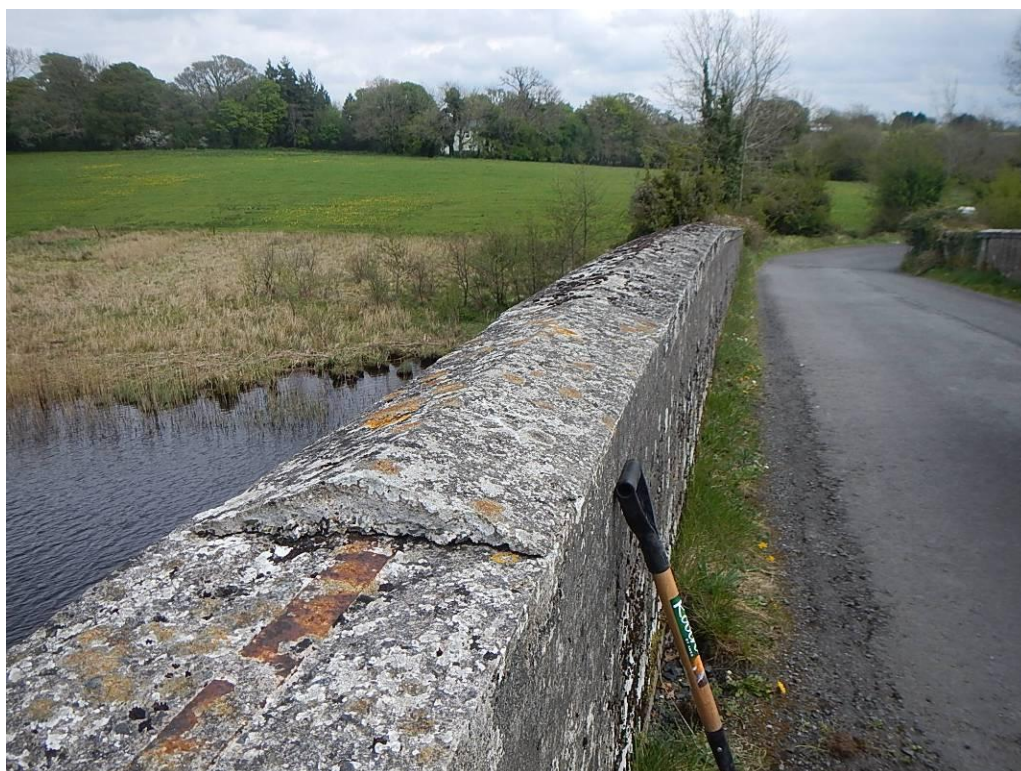
**Photograph 14: Bridge Parapet / Main Longitudinal Beam (North)**

The reinforced concrete parapets are also the main longitudinal beams and therefore are discussed in more detail in that capacity in the paragraphs below. With regard to their vehicle containment function, the parapets appear to be adequate for the observed road speeds. However, this is based on visual observations only as no assessment calculations were carried out to determine their vehicle containment capacity. Numerous locations of exposed reinforcement (shear link steel straps) were noted to the inside and outside faces of the parapets and in a small number of instances, significant corrosion with section loss was evident on the straps. This appears to be due to insufficient concrete cover. In general, the extent of corrosion

appears minimal and the exposed area is relatively small, and therefore this defect is not considered to be structurally significant at this time. However, concrete repairs are recommended to prevent further deterioration. There are no safety barriers provided on the western approach and the safety barriers on the eastern approach are in very poor condition and do not comply with current standards. The installation of a compliant safety barrier system should be considered as part of any proposed remedial works. There are no footways across the structure and no raised concrete verges (rubbing strips) are provided. Grassed verges have formed on the road surfacing along the face of both parapets.

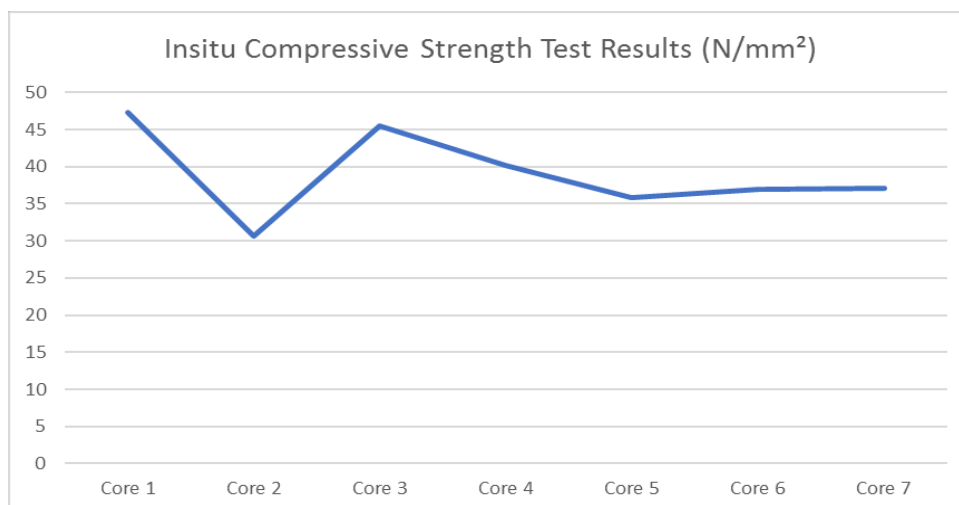
Cores 4 - 7 were horizontal cores that came from either the bridge wing wall (Core 4) or the RC piers at two locations (Core 4 – 7). The pier cores seem to indicate a reasonably high voids of 5% with the visual description of the cores identifying “poor compaction”. The horizontal concrete cores had a mean concrete core strength result of 37.5N/mm<sup>2</sup> with and a mean density of 2400kg/m<sup>3</sup>.

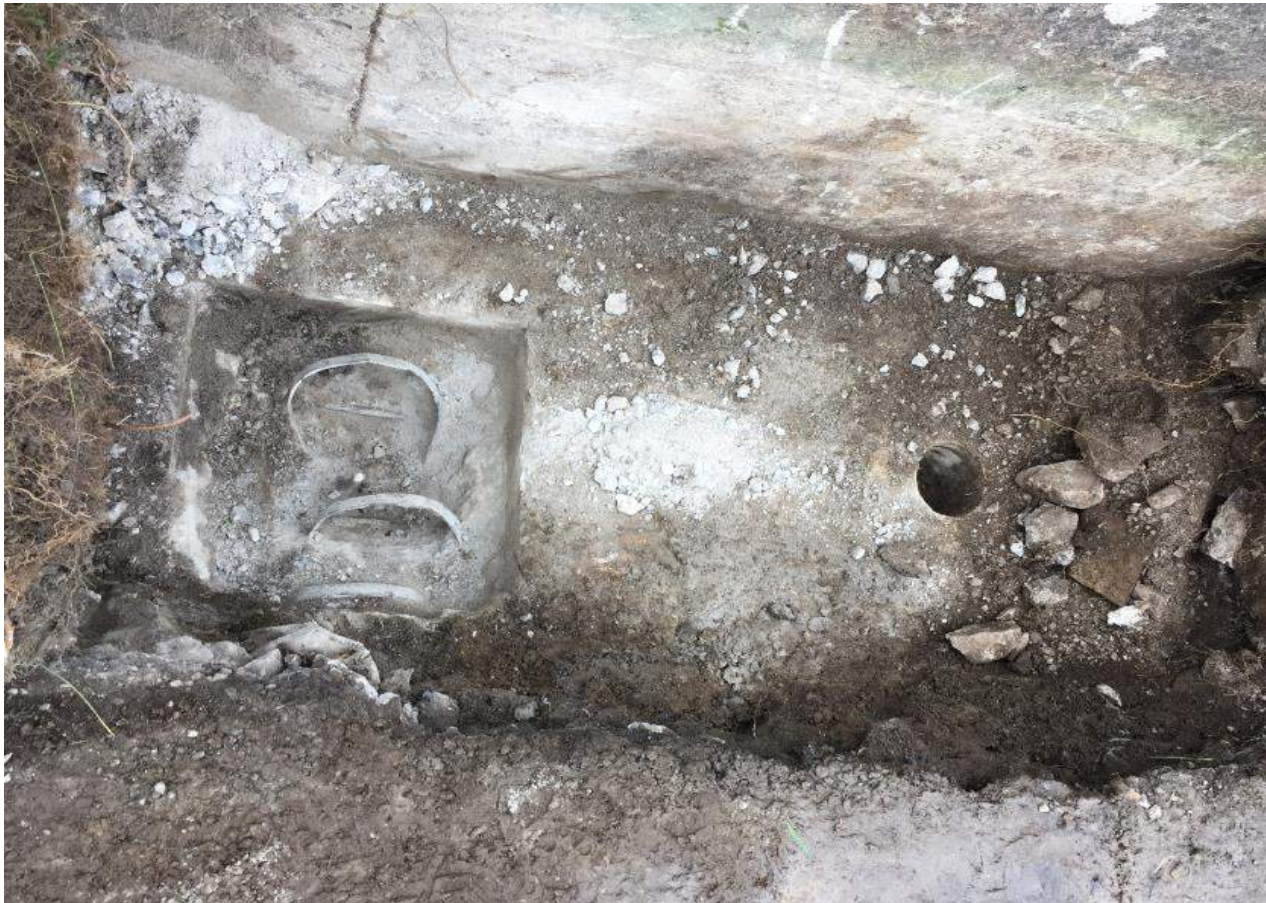
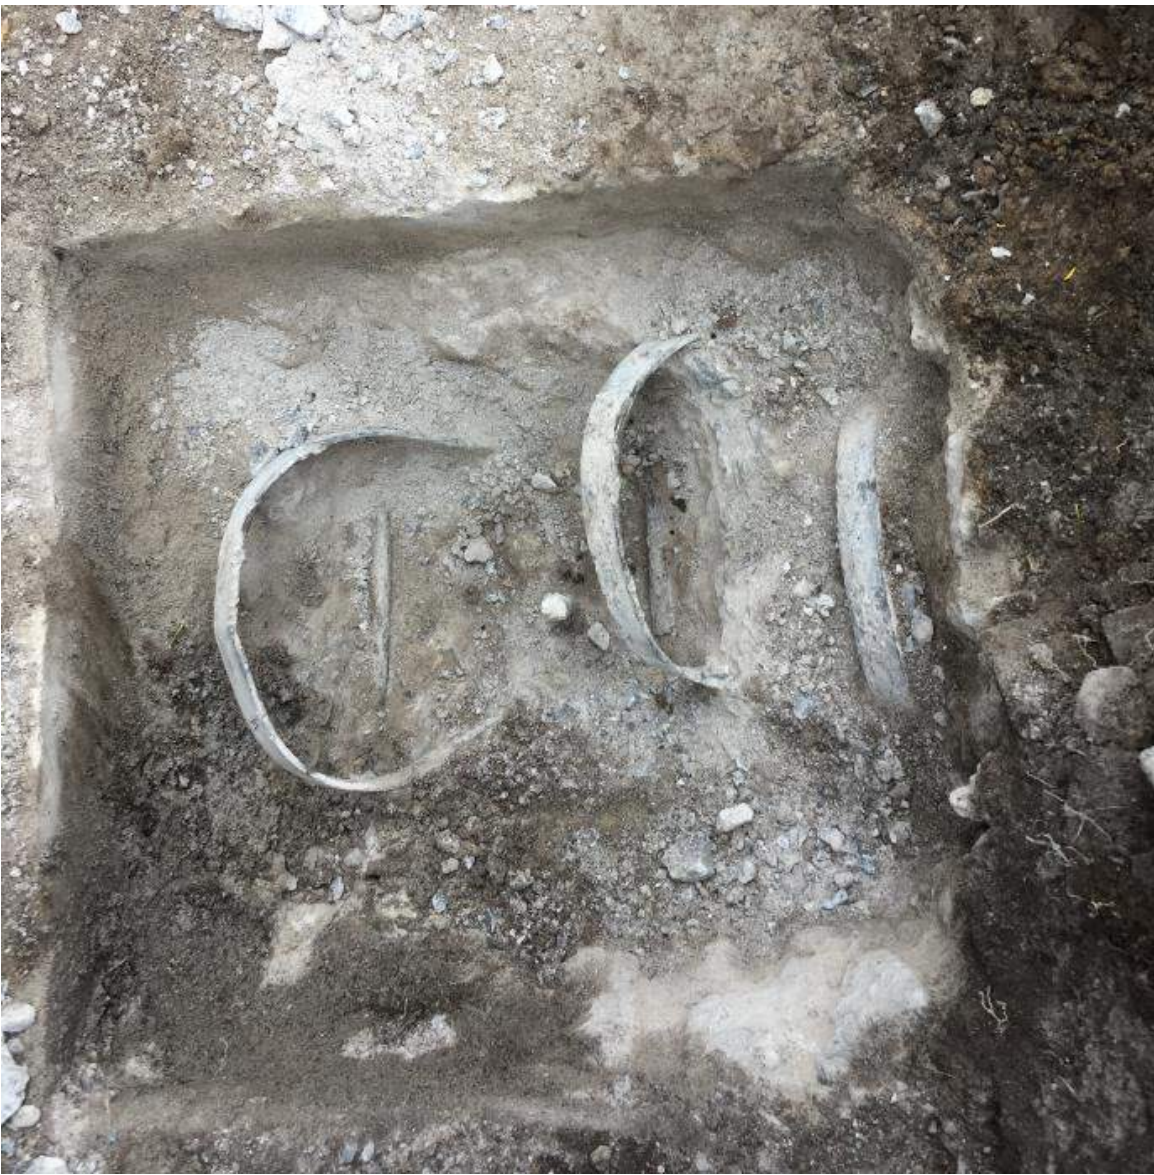
BHP scanned deck slab 1 at all available exposed space. There was no steel reinforcement detected. BHP then scanned deck slab 2. There were irregular reinforcement readings. In order to further investigate, BHP completed a trial pit into the concrete to expose the reinforcement present and to calibrate the scanning tool.

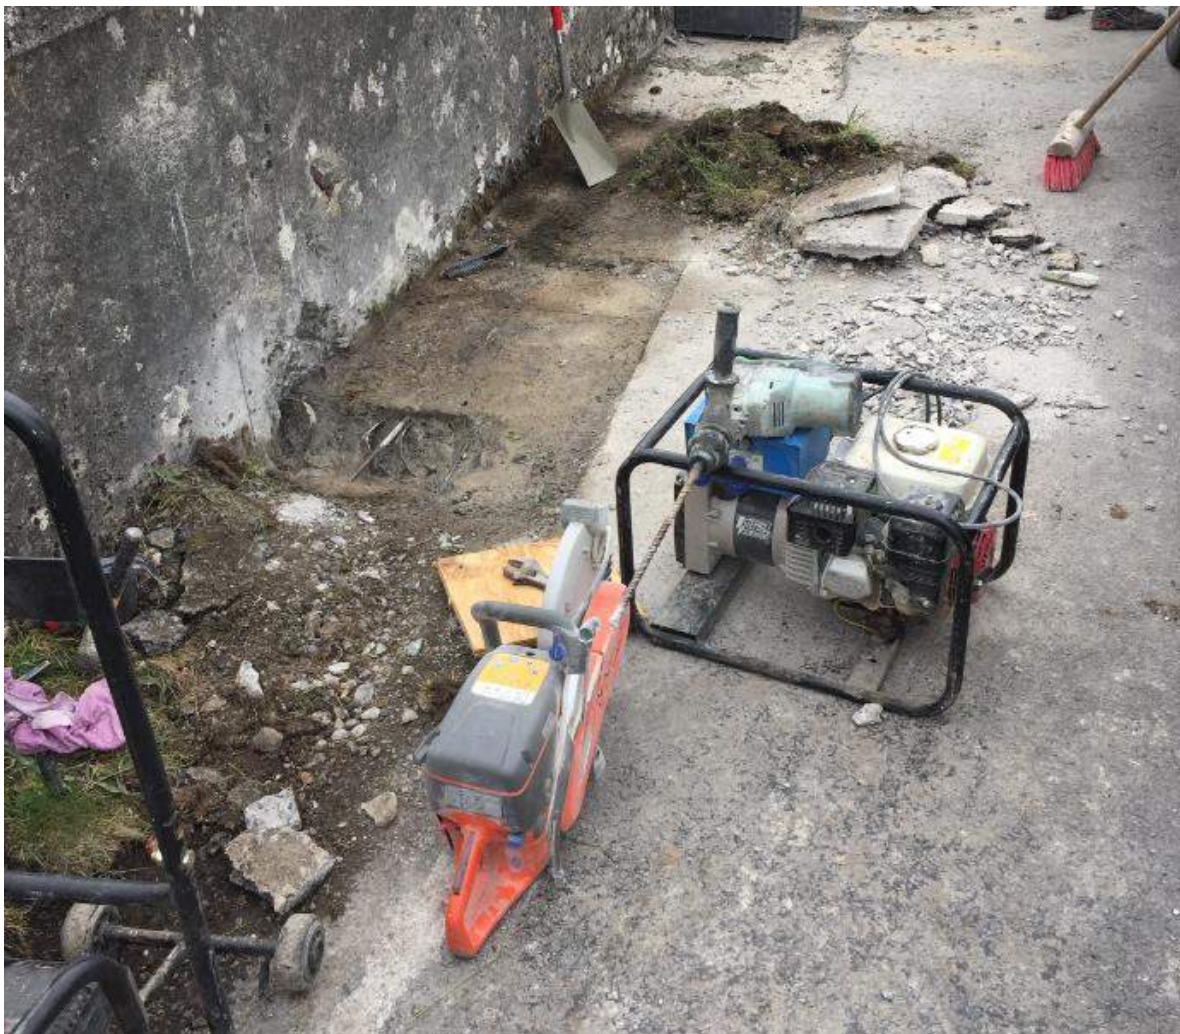
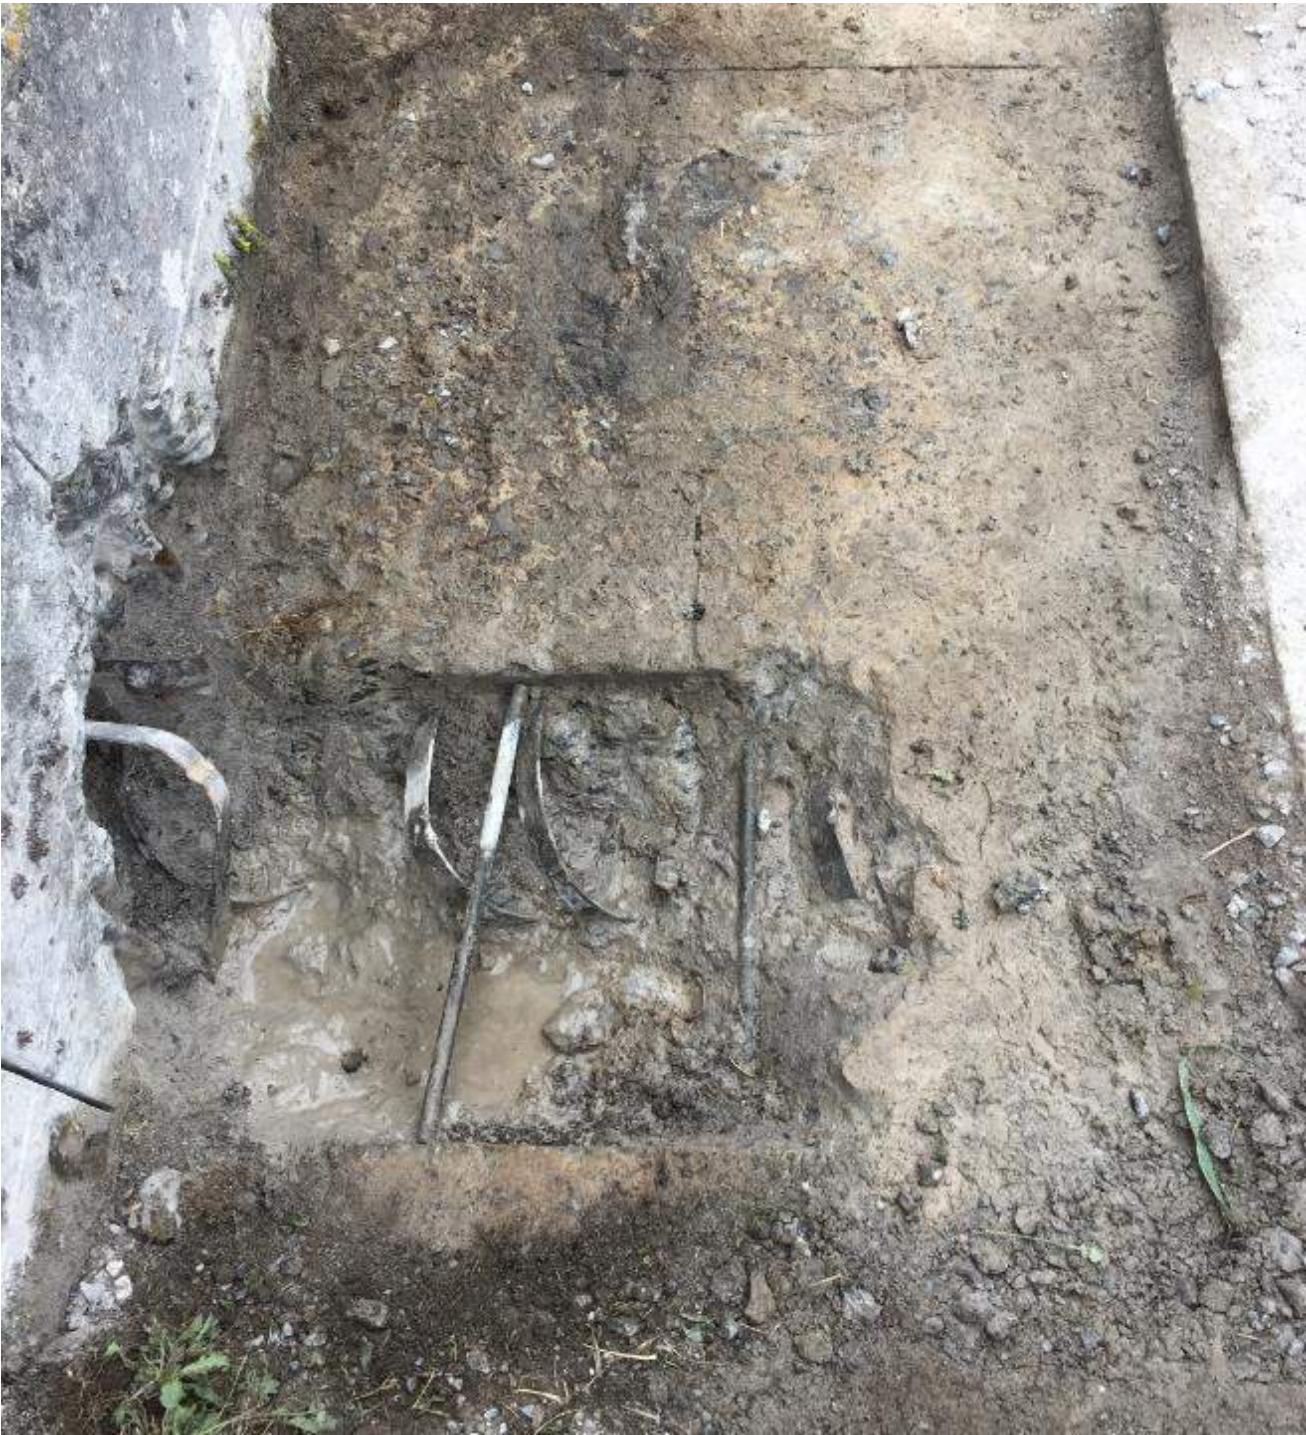
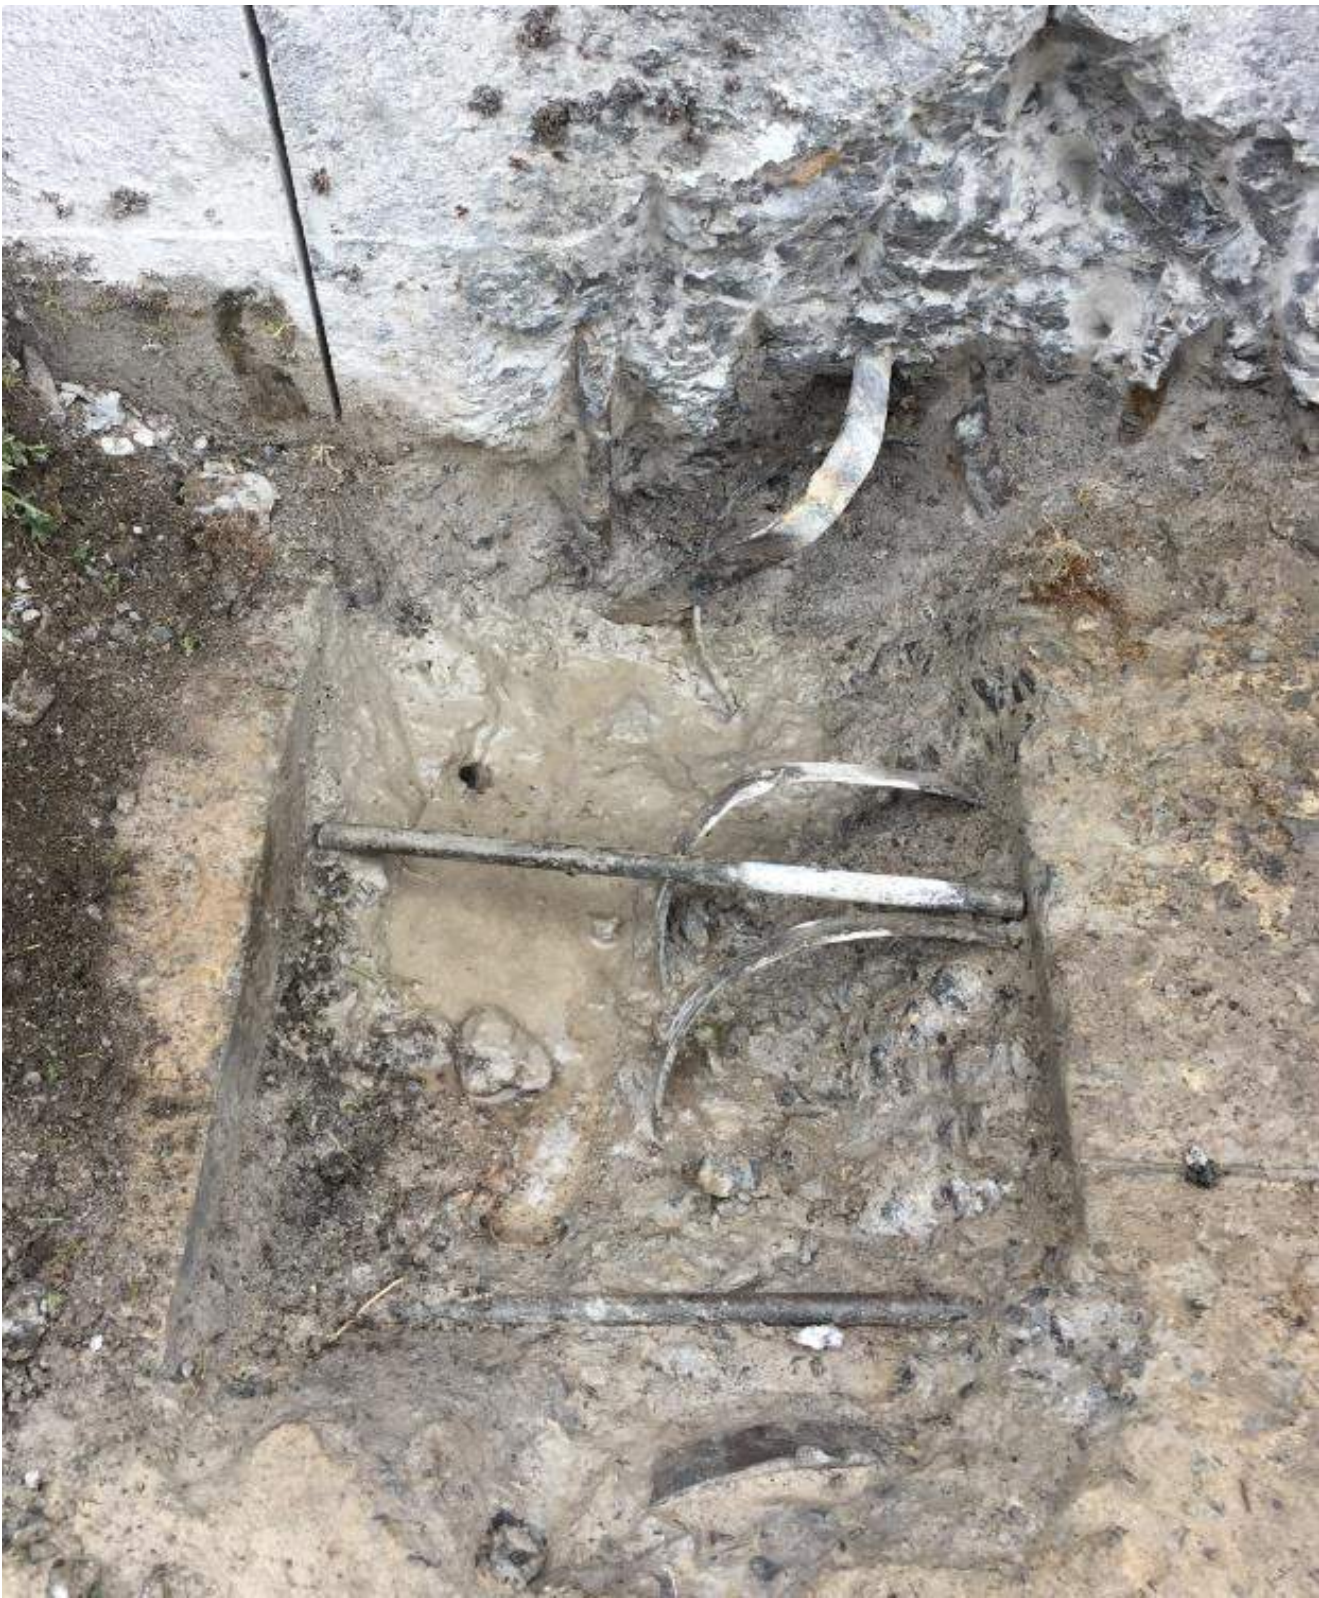
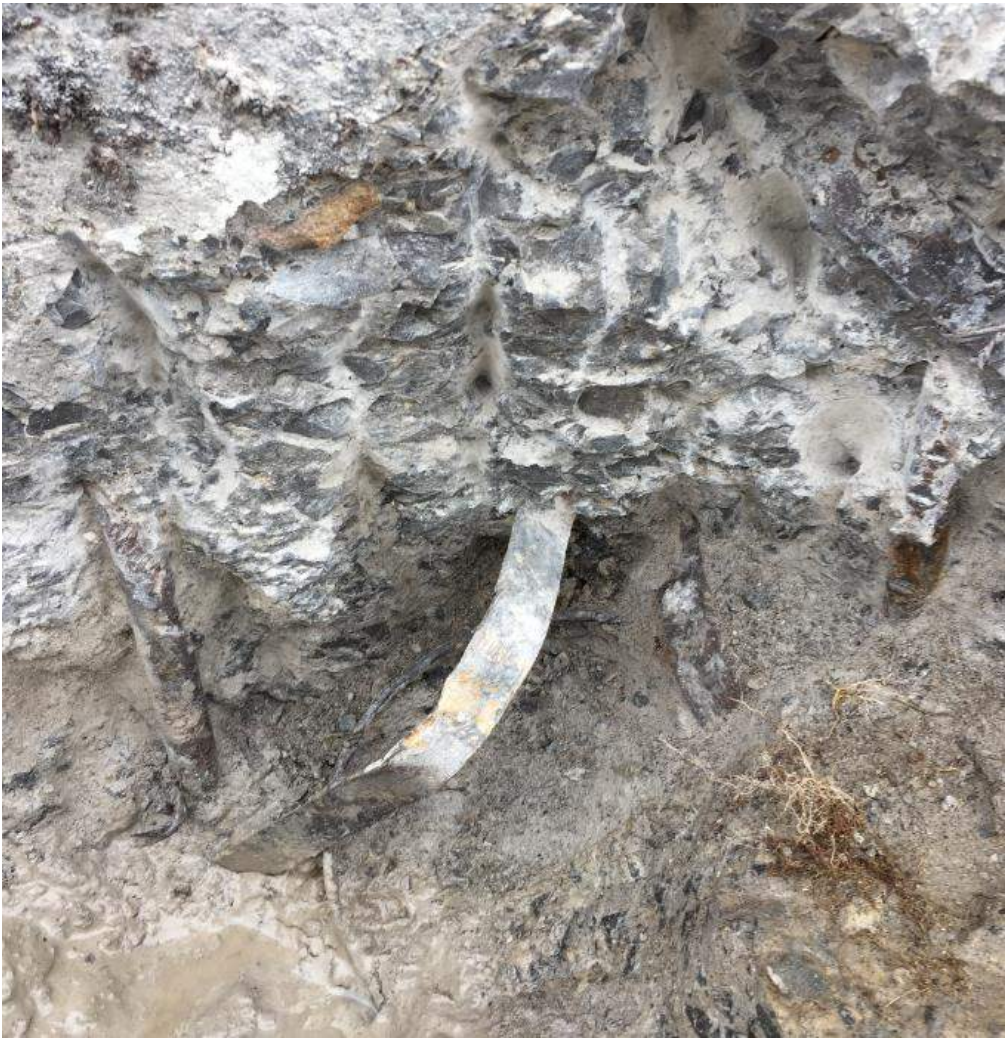
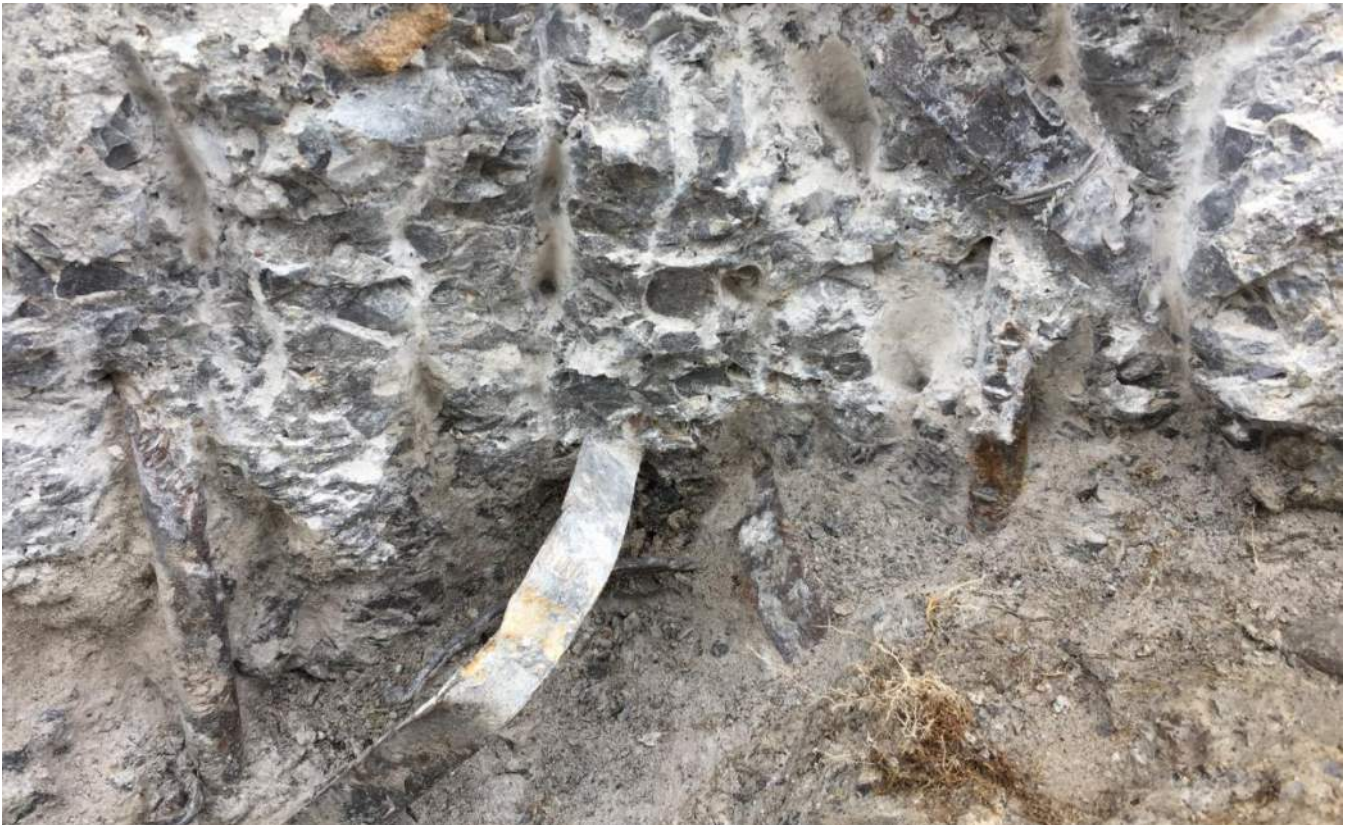
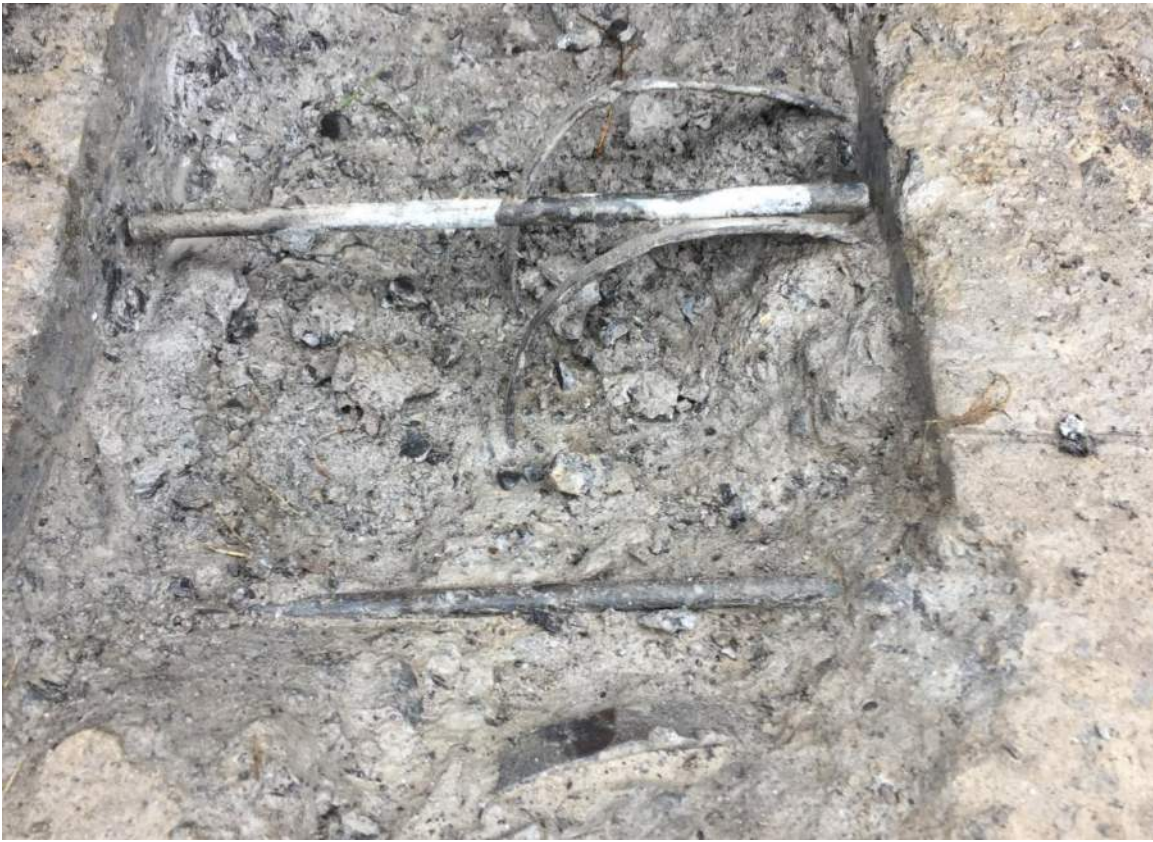
**Breakout findings for CS4 & CB4 (side wall)**

As part of the survey work required at locations CS4 and CB4, BHP completed a trial pit on the top of the bridge surface (location confirmed below, photographs included). This trial pit was 700mm wide and 3000mm in length. In order to access the deck slab, the verge material (soil and grass) and road surface was removed. There is a layer of bitmac (road surfacing) of approx. 50mm at this point of the bridge. This is laid directly down on the bridge deck slab. There is no evidence of waterproofing on the bridge.

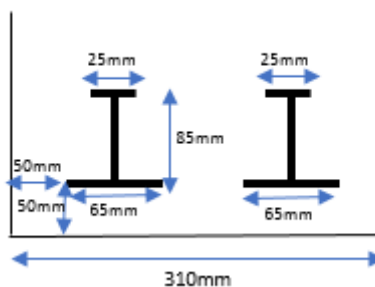
Each of the edge beams and transverse beams (at piers/columns) had diagonal support struts. These triangle shaped concrete supports were approximately 500-600mm in length on the exposed edge. The supports for the edge beams has 2 equally spaced 12mm Ø smooth reinforcement bars that continued from within the edge beam, through the strut and then turned 45° into the column. The breakout at CS3 CB3 found a 12mm Ø smooth bar within the column and stop before the concrete face. BHP assume this was a similar bar to these diagonal reinforcement bars except from the other side. The sketches below illustrate this assumption.

Sketch of make-up of edge beam (south side of bridge)

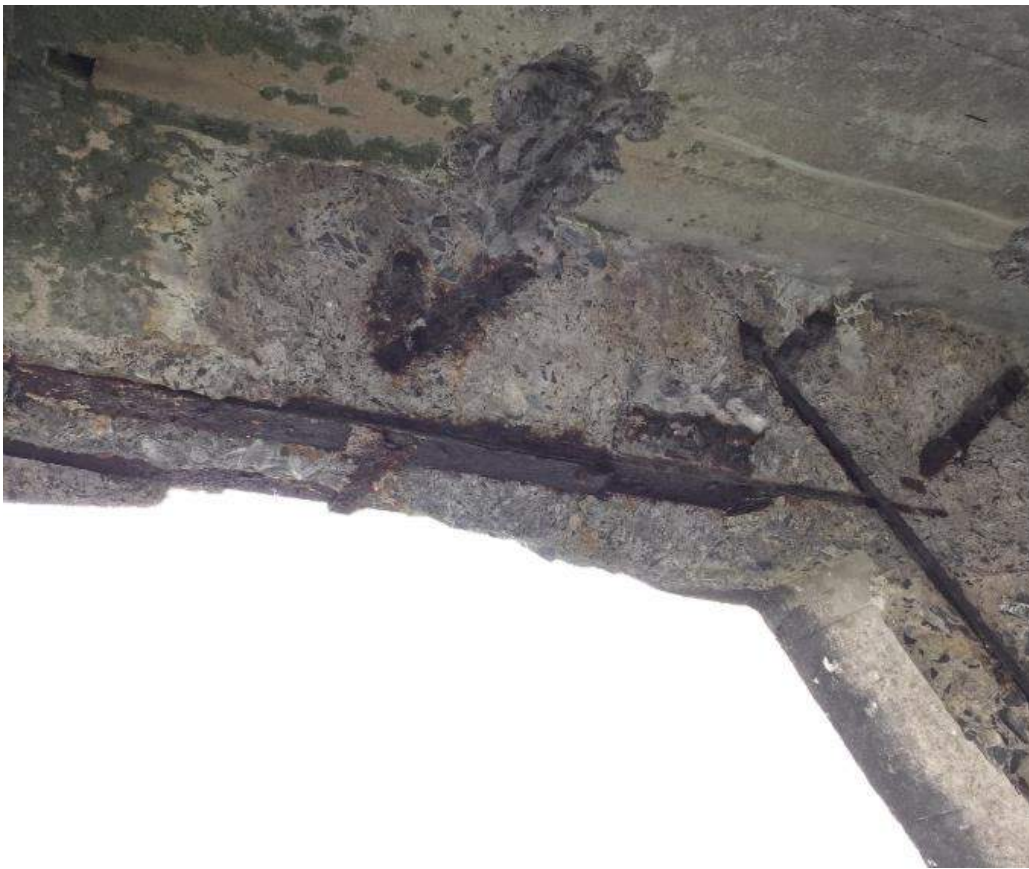
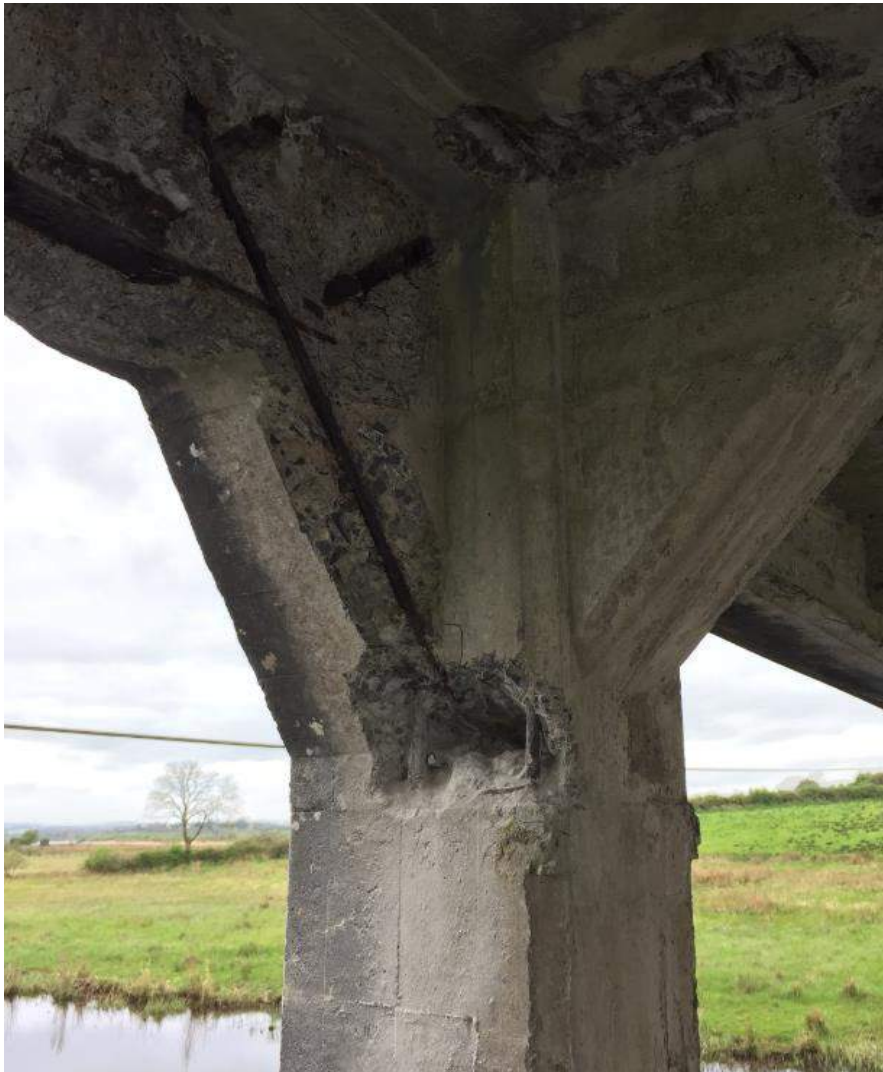
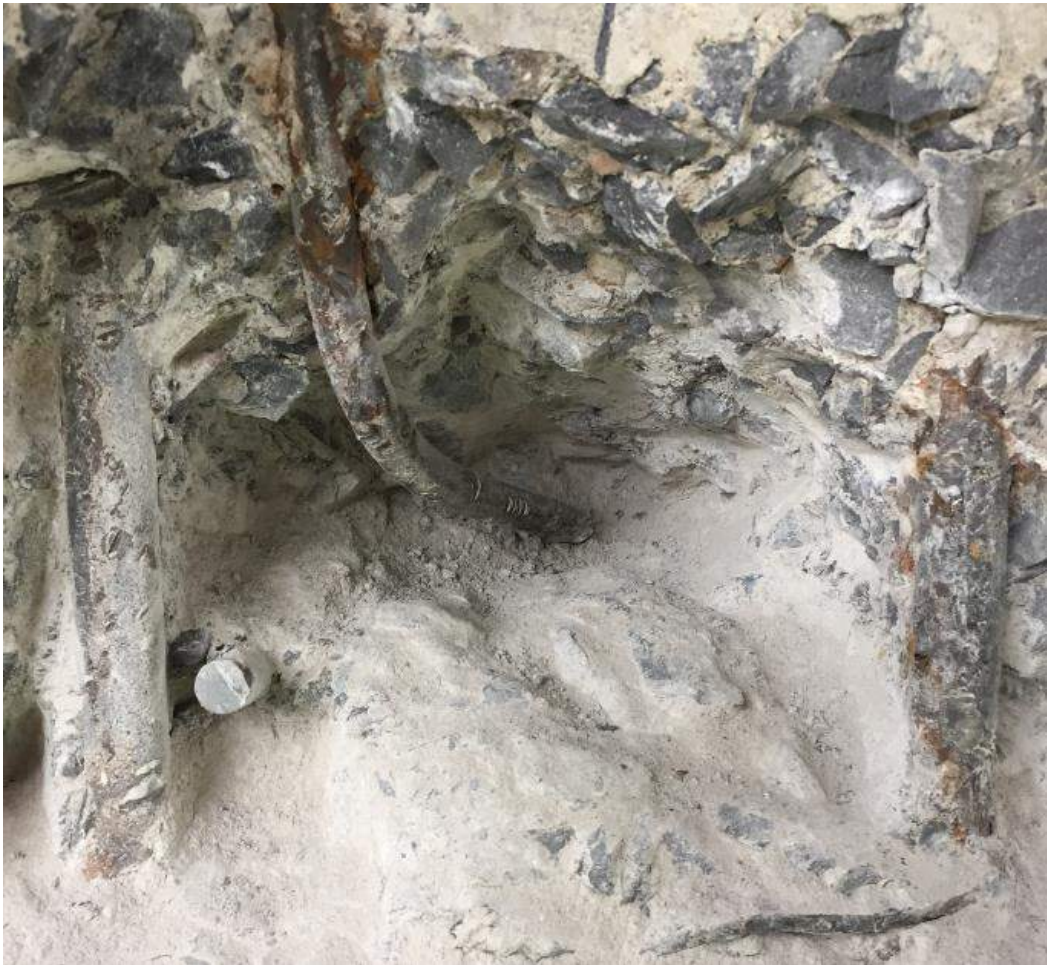
The beams are supported by steel straps. These straps are approximately 25mm wide and 4-5mm thick. There are two distinct types of straps on the edge beams – vertical and diagonal. There appears to be three diagonal straps either side of the bridge piers/columns. These are/were welded or attached to the centre point of the longitudinal steel beams. These appear to be the primary cause of the corrosion / concrete spalling. The cover appears to have been much lower to these than other steel elements within the concrete beams. In almost all locations, the concrete has spalled and the straps are in many cases full corroded and not providing any obvious support to the structure. The diagonal straps are spaced at approximately 250-350mm. The vertical straps are providing support to the longitudinal steel beams (in that they are still present in many cases and not widely corroded. There appears to be three of these straps running directly under the beams and continuing up into the top of the edge beam / deck slab – a breakout was carried out to chase these straps but it did not find an end point. It should be noted that the breakout of the bridge wall exposed steel straps at similar angles at CB4 and CS4. Perhaps these straps rung from top to bottom (at an angle) of the beams. The corroded sections of steel beams or straps was either on the soffit of the beams or inside side. There was no evidence of this on the exposed edges.

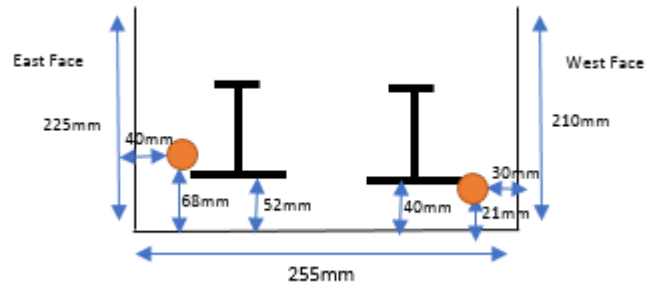
The make-up of the transverse beam at the pier/column locations is detailed below. There is a pattern of steel beams similar to those found in the edge beams (described in section 1.4.2). In addition to these, there are 2No. 20mm  $\varnothing$  smooth reinforcement bars running throughout the beam. These bars are set at alternate positions at the breakout location at CS3 and CB3. The sketch below confirms this positioning with the associated cover. It must be noted that the concrete at this location was extremely hollow with spalling likely to occur very soon. Great care was required to saw cut the dimensions of the breakout first as the kango vibration could have led to significant collapse of the transverse beam soffit/side concrete.

Sketch of make-up of transverse beam running from one side of the pier to another.
