## Hartley Bridge Structural Investigation & Assessment

### Stage 2 Assessment Report

DRAFT ISSUE 1 | AUGUST 2017

**Document No:**..... 16.181.10 – DL-LP2784-001

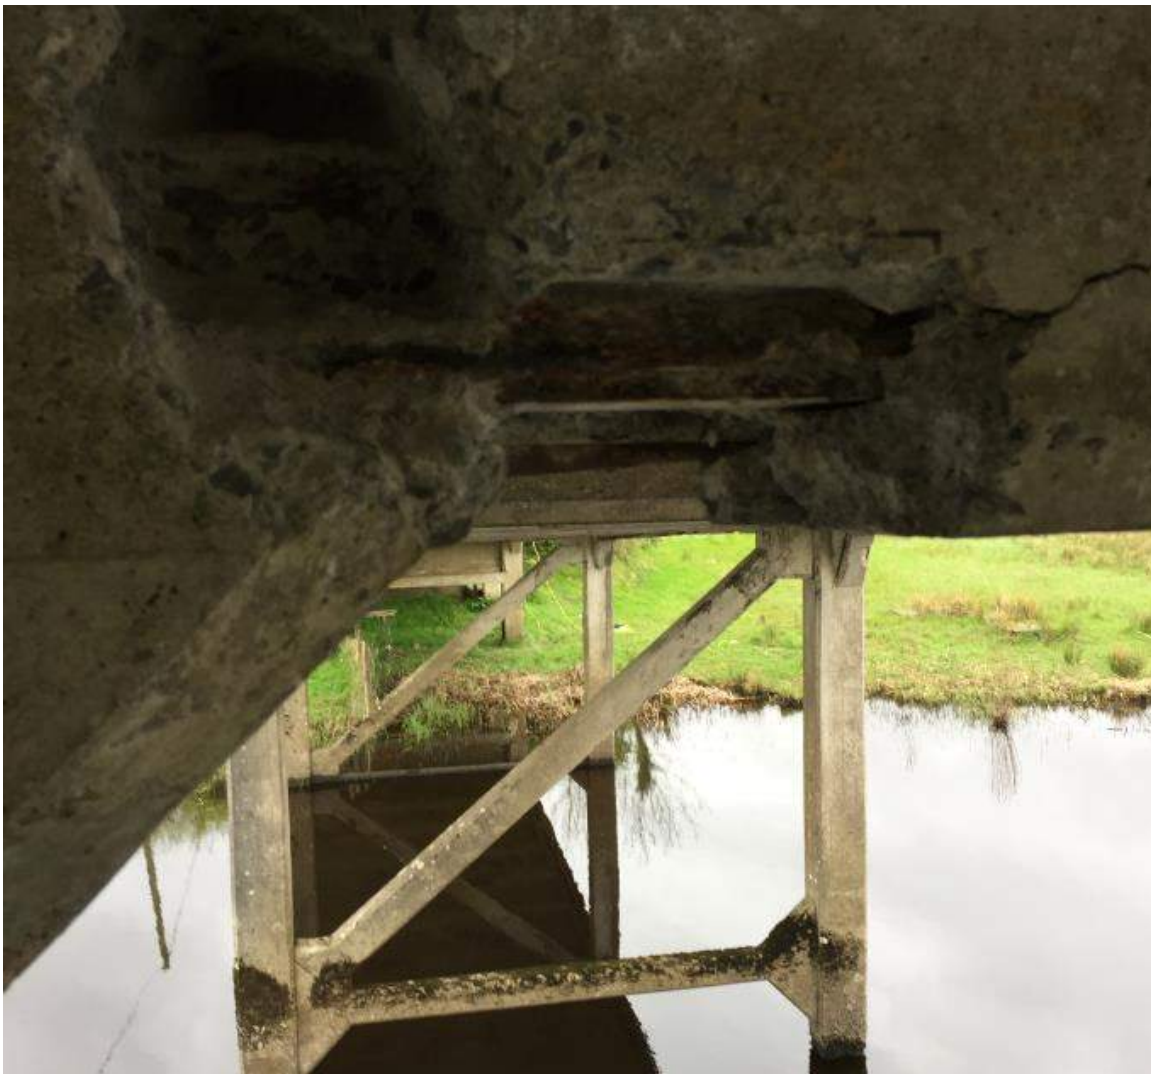
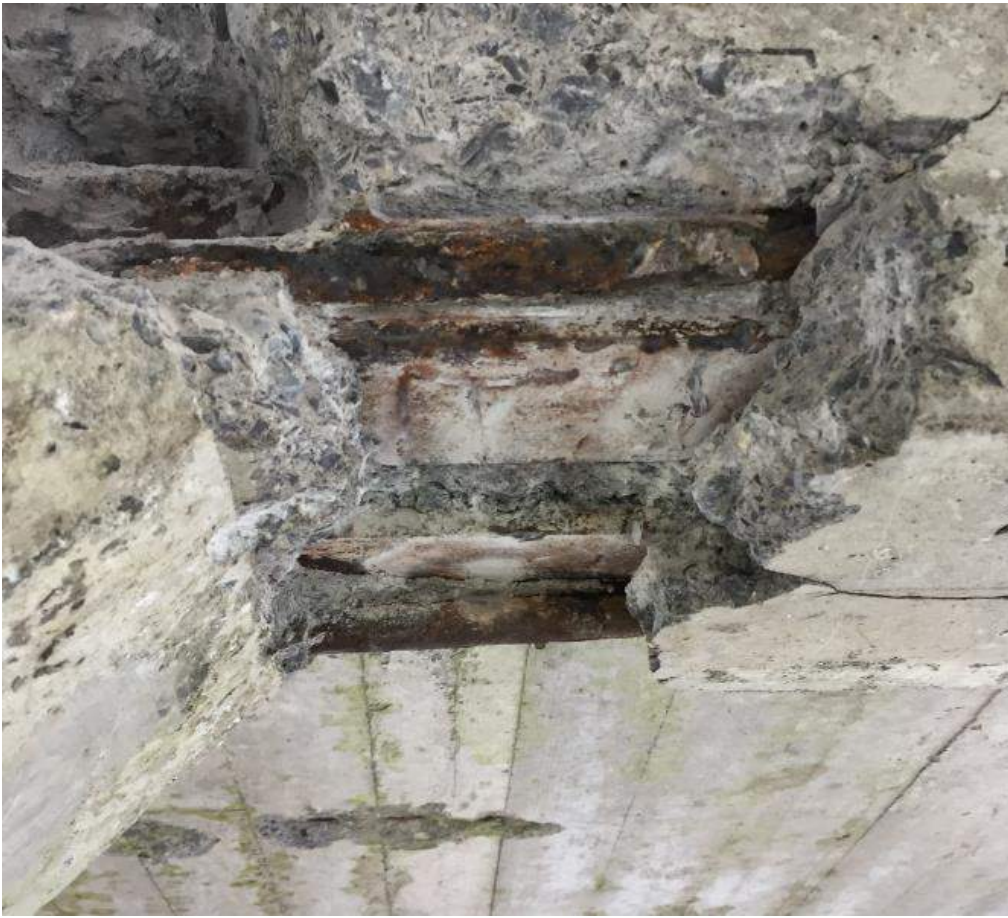
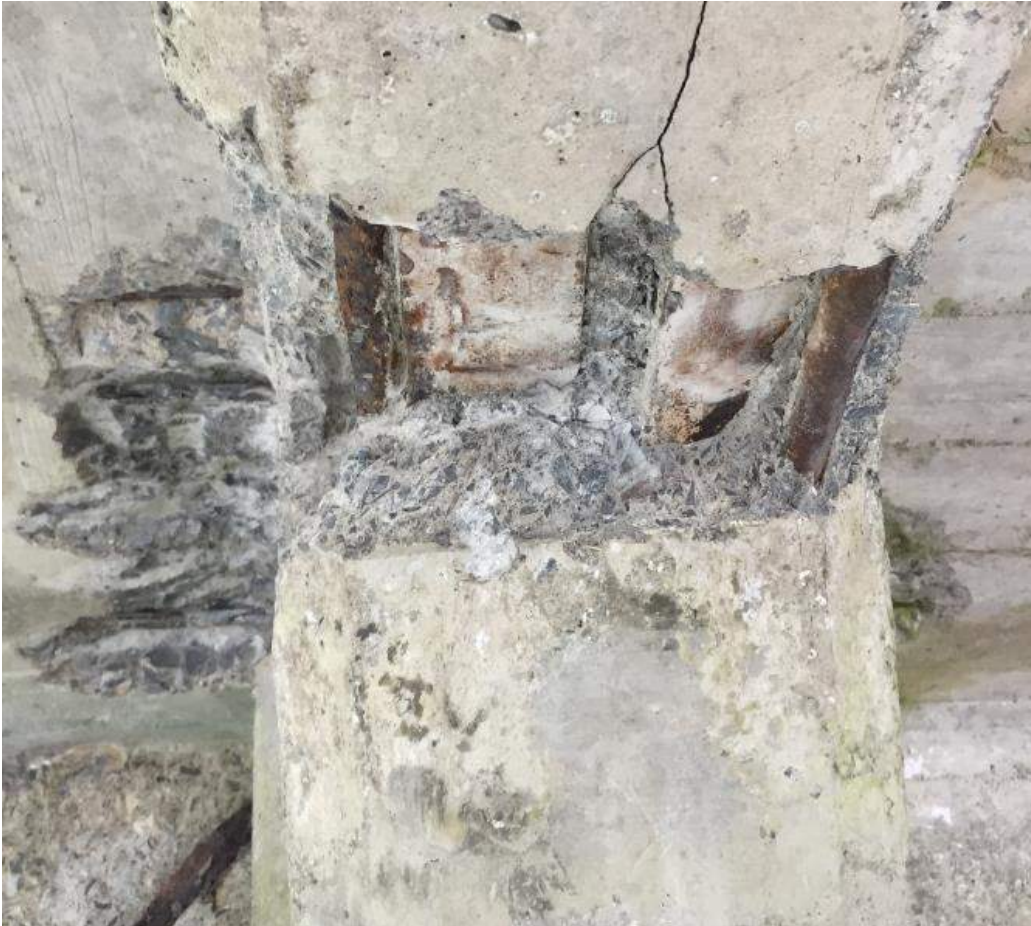
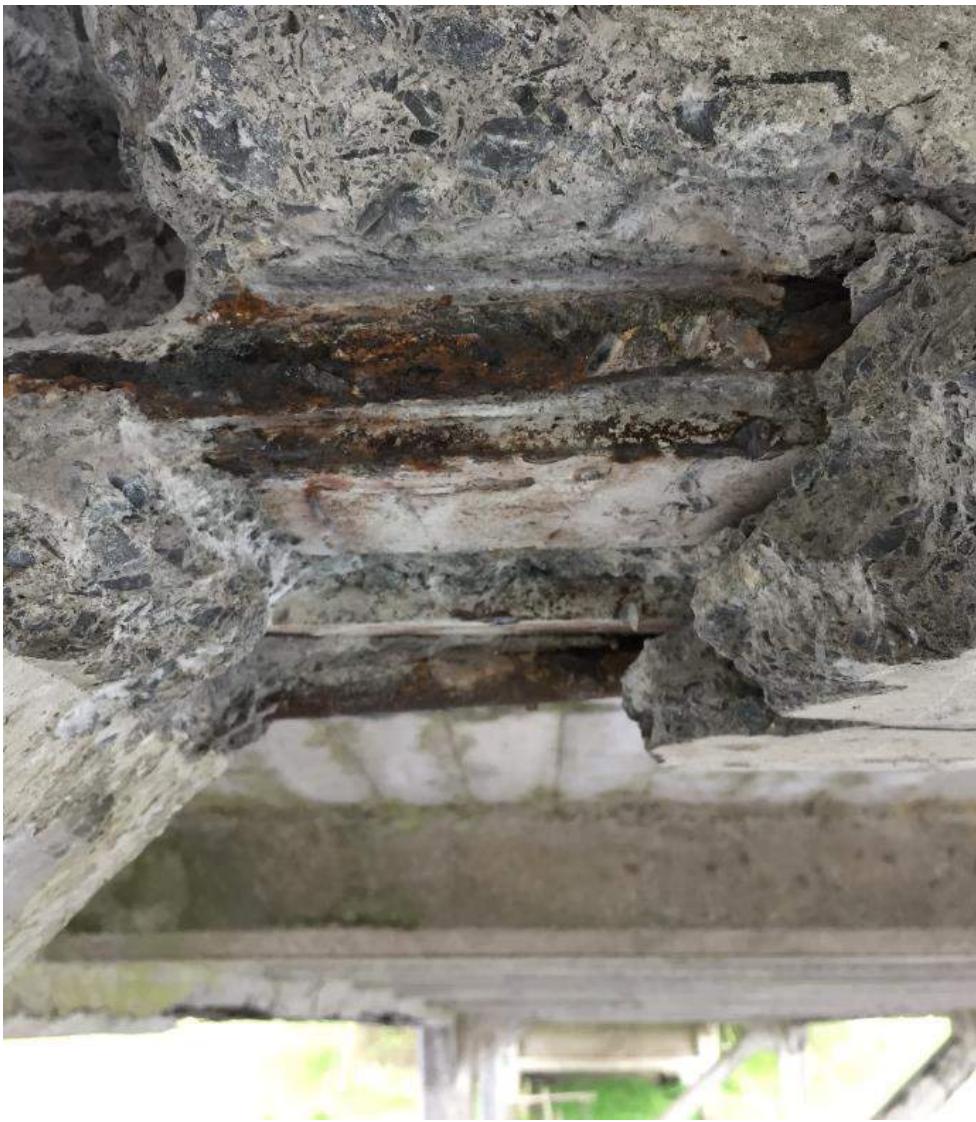
The make-up of the transverse beam at the pier/column locations is detailed below. There is a pattern of steel beams similar to those found in the edge beams (described in section 1.4.2). In addition to these, there are 2No. 20mm  $\varnothing$  smooth reinforcement bars running throughout the beam. These bars are set at alternate positions at the breakout location at CS3 and CB3. The sketch below confirms this positioning with the associated cover. It must be noted that the concrete at this location was extremely hollow with spalling likely to occur very soon. Great care was required to saw cut the dimensions of the breakout first as the kango vibration could have led to significant collapse of the transverse beam soffit/side concrete.

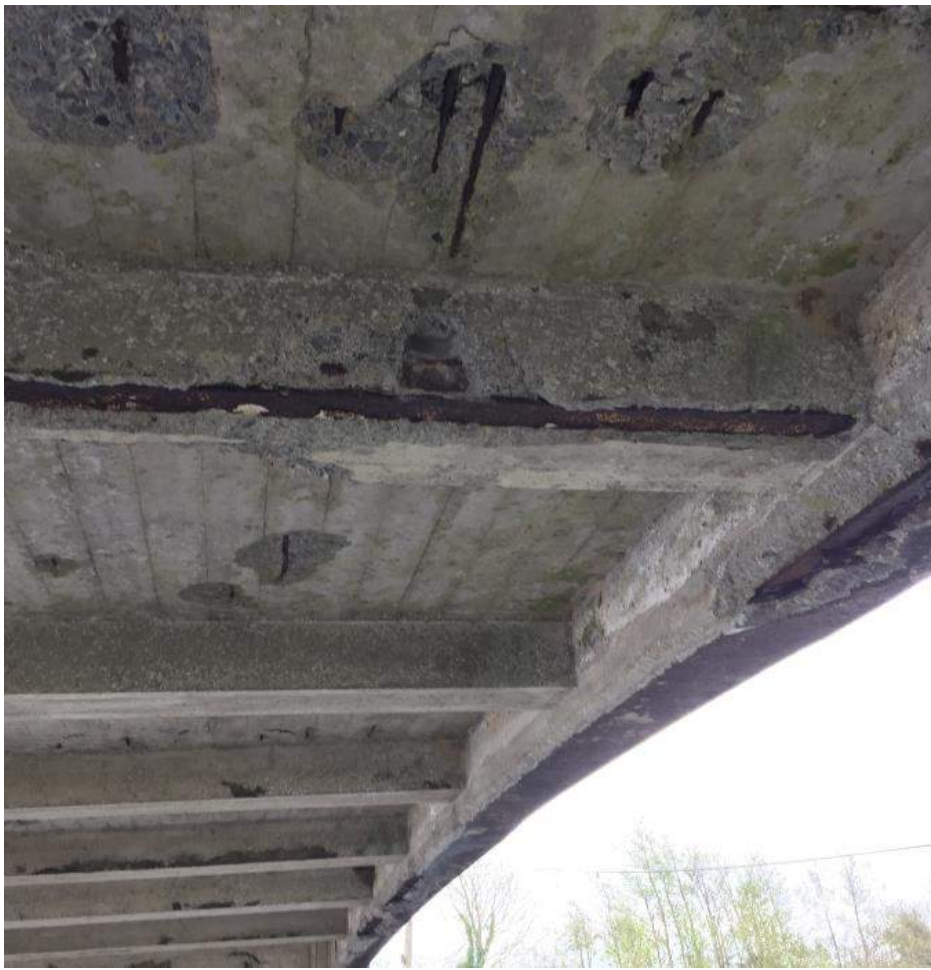
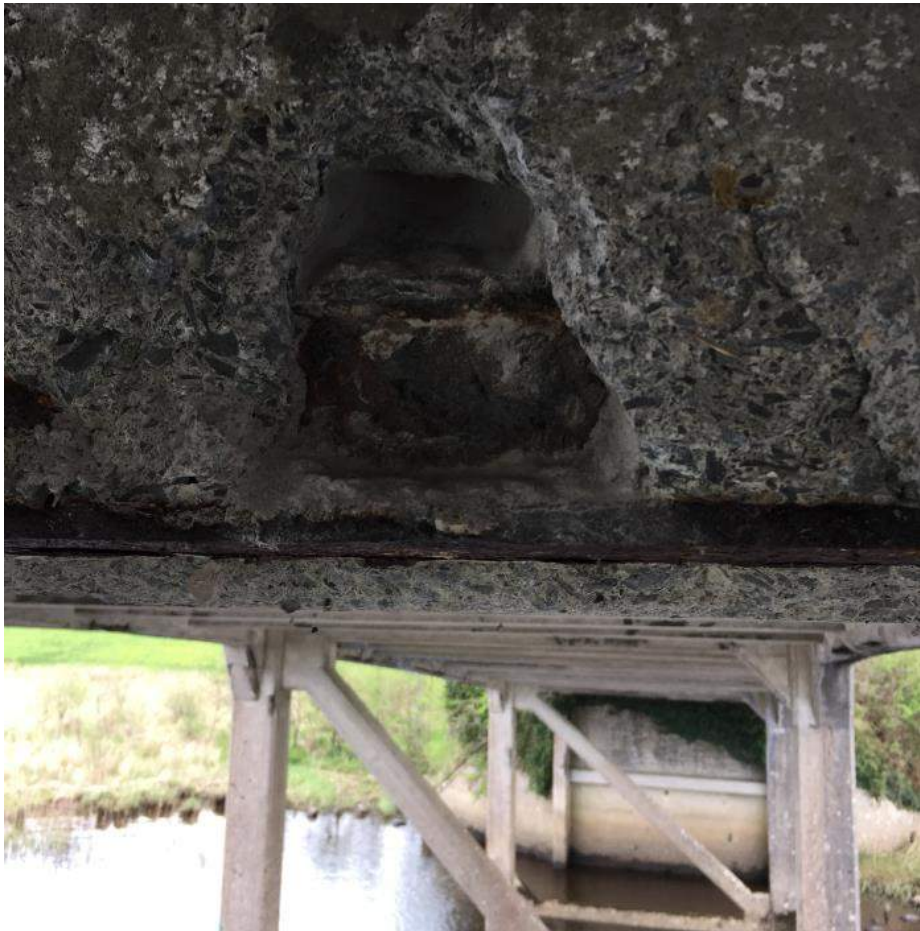
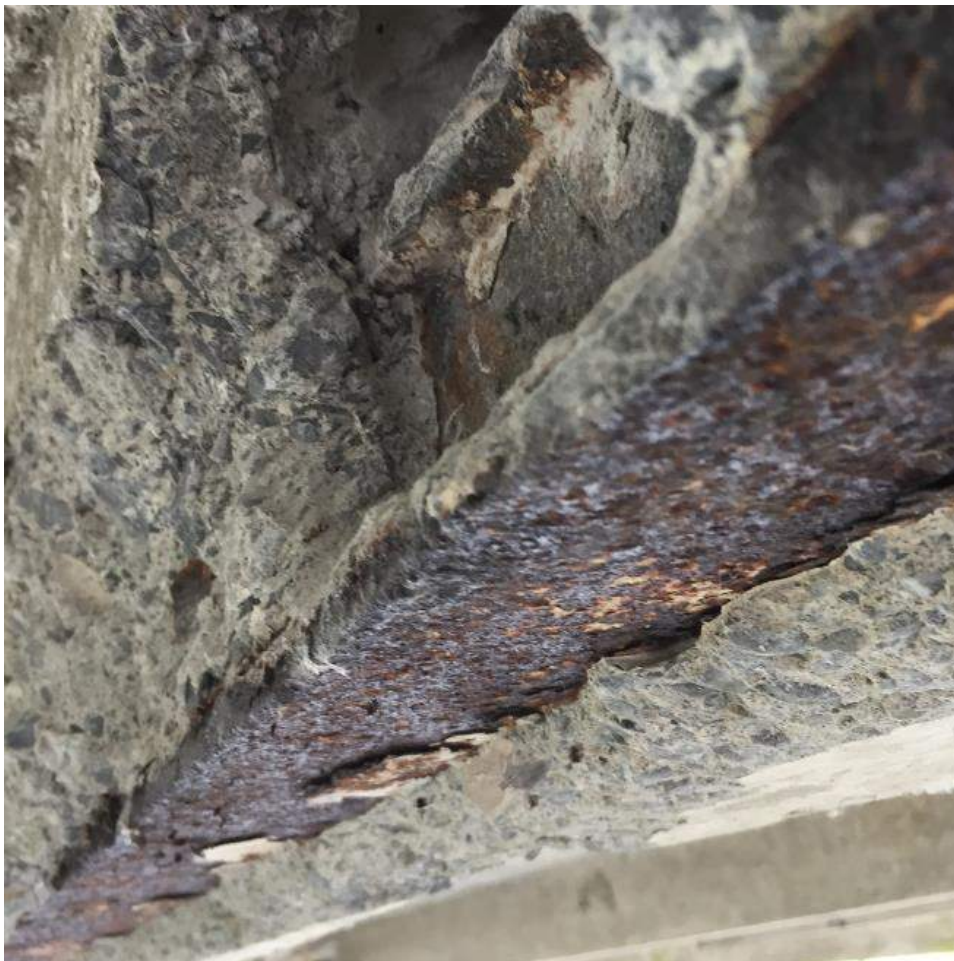
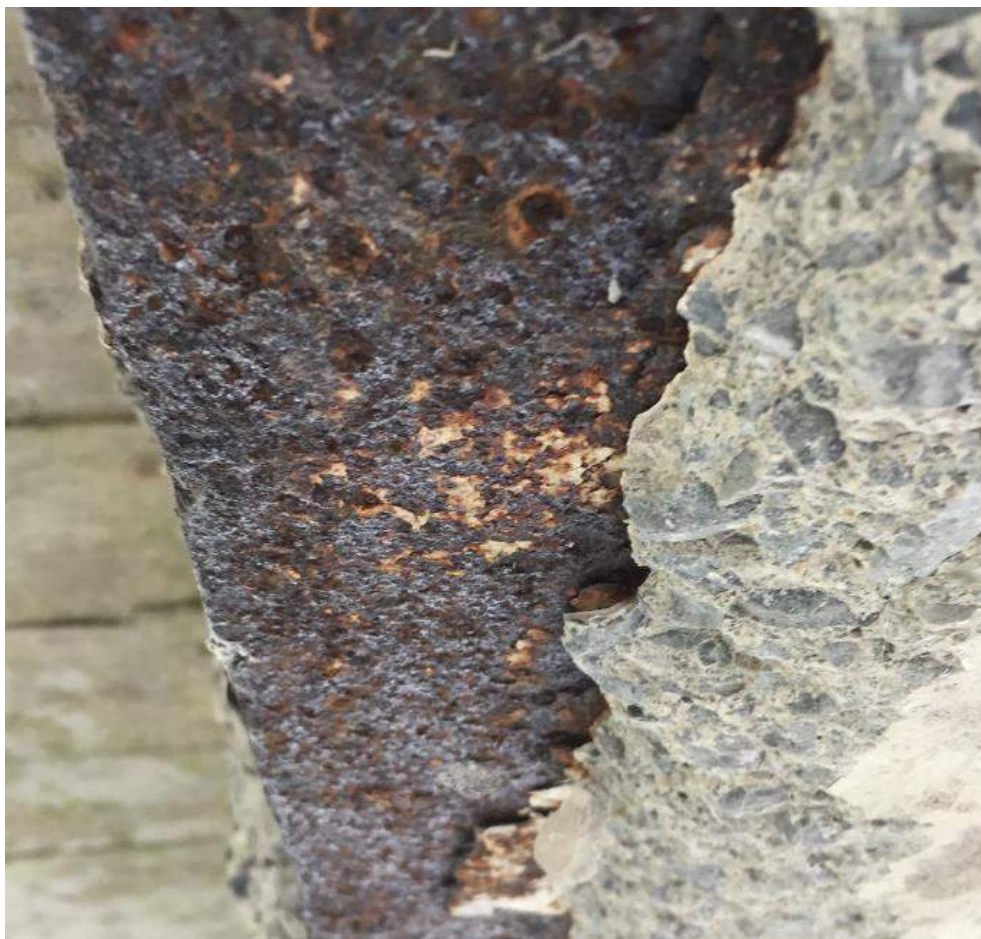
The transverse beams mid-span were similar to the ones at pier locations with the exception of no 20mm Ø steel reinforcement bars. The sketch below confirms the make-up of the first mid-span beam that is east of the pier at CS3 & CB3.

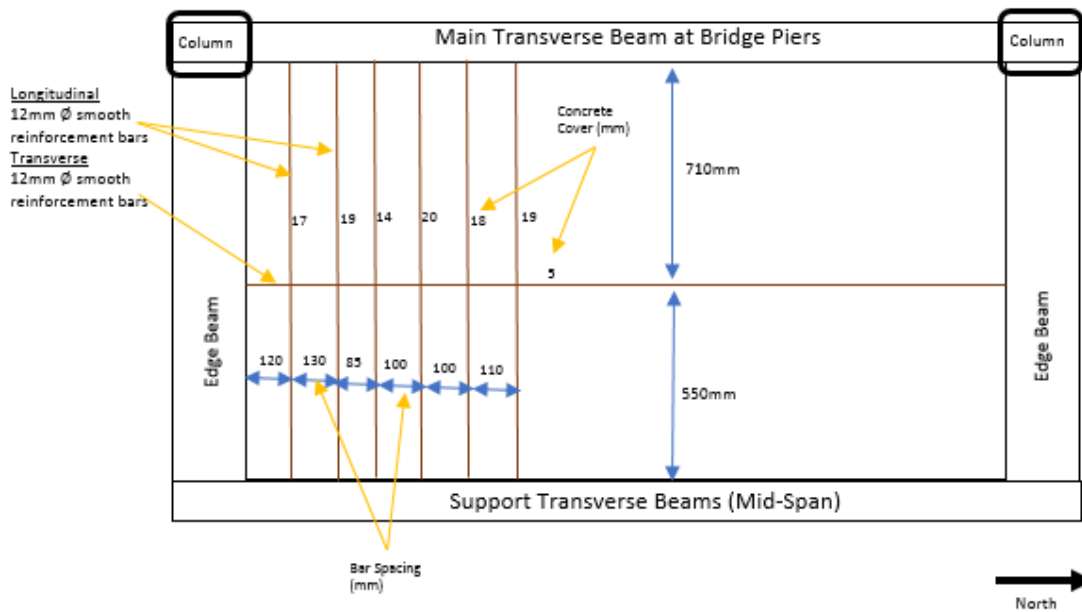
As part of the survey work required at location CS3 and CB3, BHP surveyed the bridge deck soffit. The survey took place on the section of deck slab that was east of the pier location at CS3 and CB3. In short, there are a series of 12mm Ø smooth reinforcement bars running longitudinal to the road. These bars are spaced at approximately 85-150mm and have concrete cover of approximately 20mm. There are many locations where the reinforcement bars are demonstrating corrosion that leads to concrete spalling and stained surfaces. In each span there is also one 12mm Ø smooth reinforcement bar running transverse to the road. This bar is placed below the longitudinal bars. Its location varies from span to span but tends to be roughly in the middle. Due to it being placed below the other directional bars, the cover is extremely low. At this survey location, where concrete covered the bar, it was approximately 5-6mm in depth. As a result and throughout the bridge, these bars are exposed due to concrete spalling and appear to be highly corroded.

Sketch of make-up of deck slab soffit

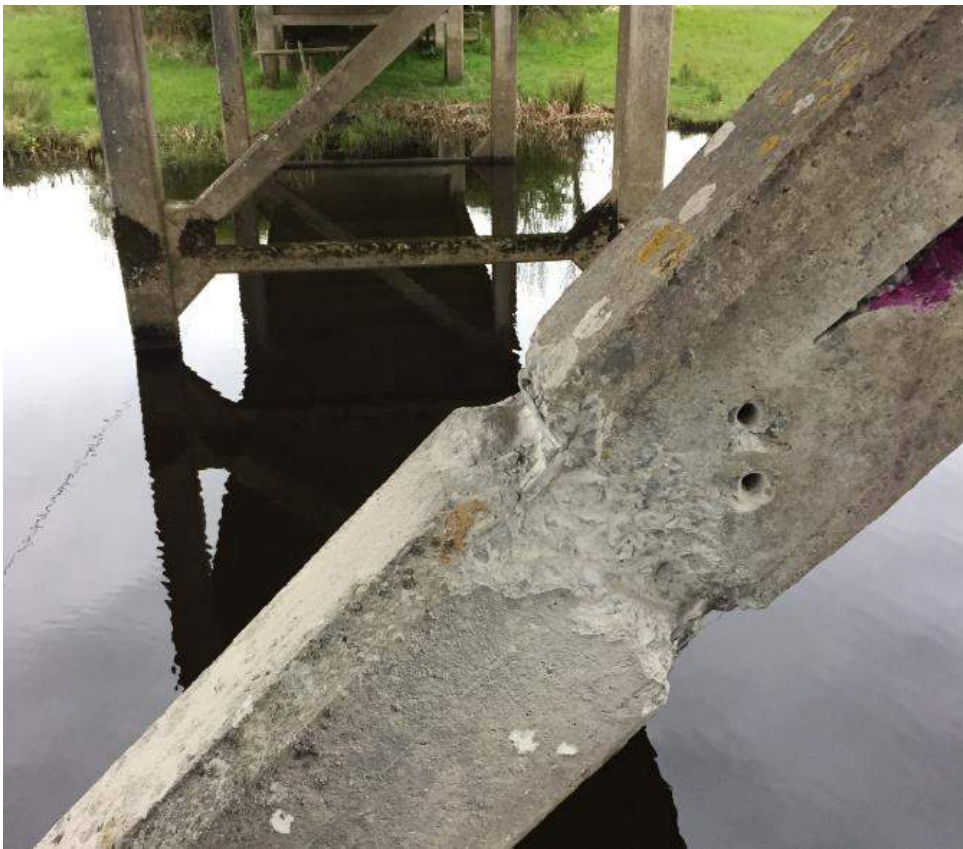
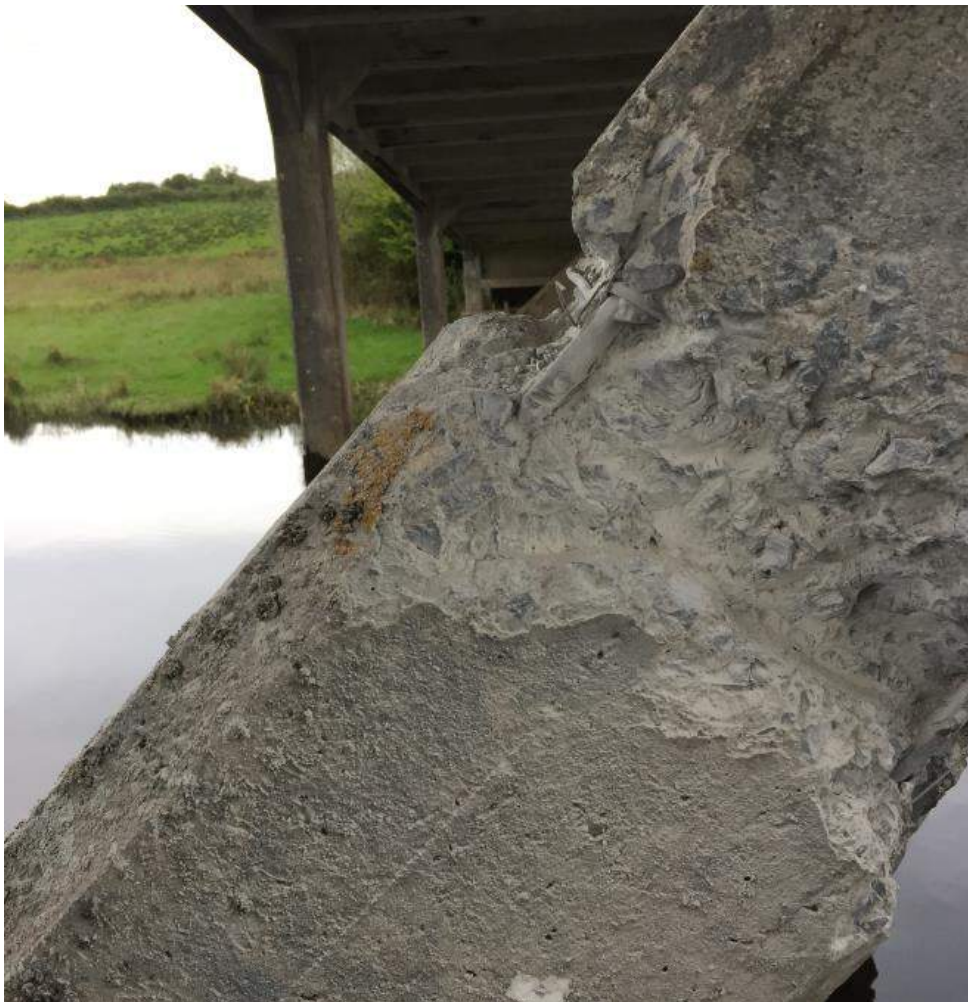
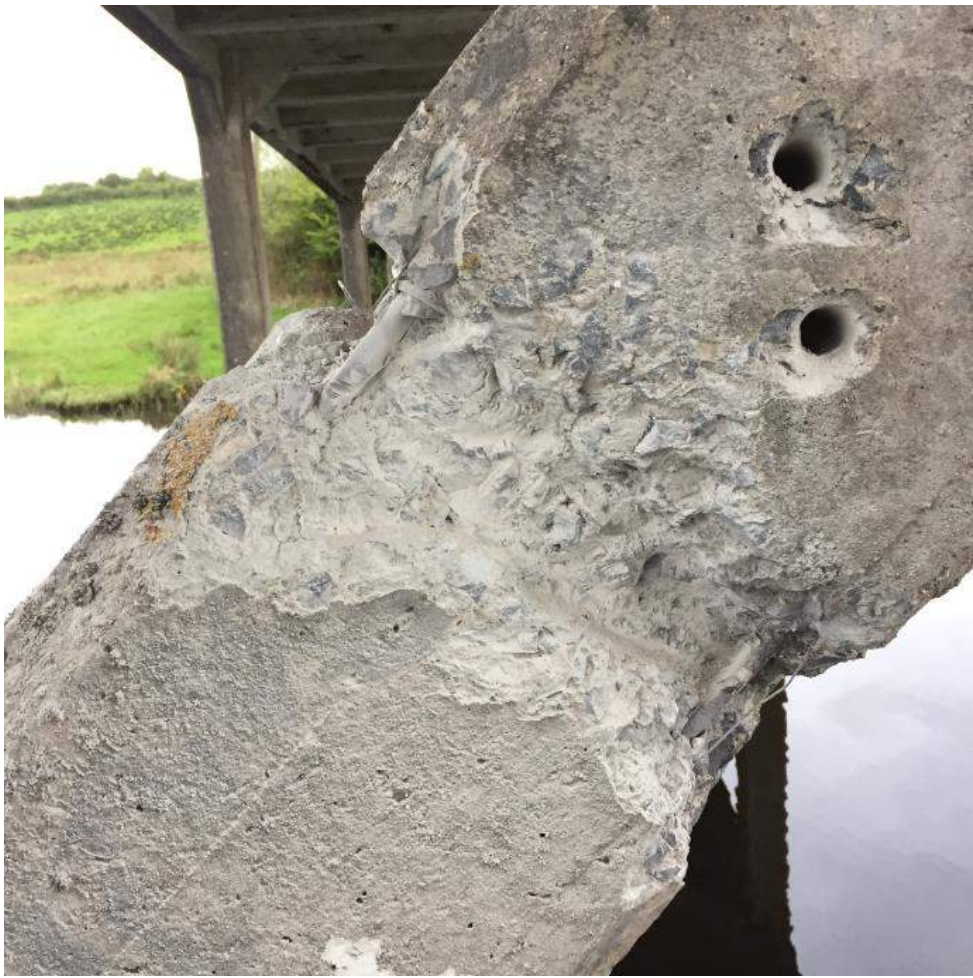
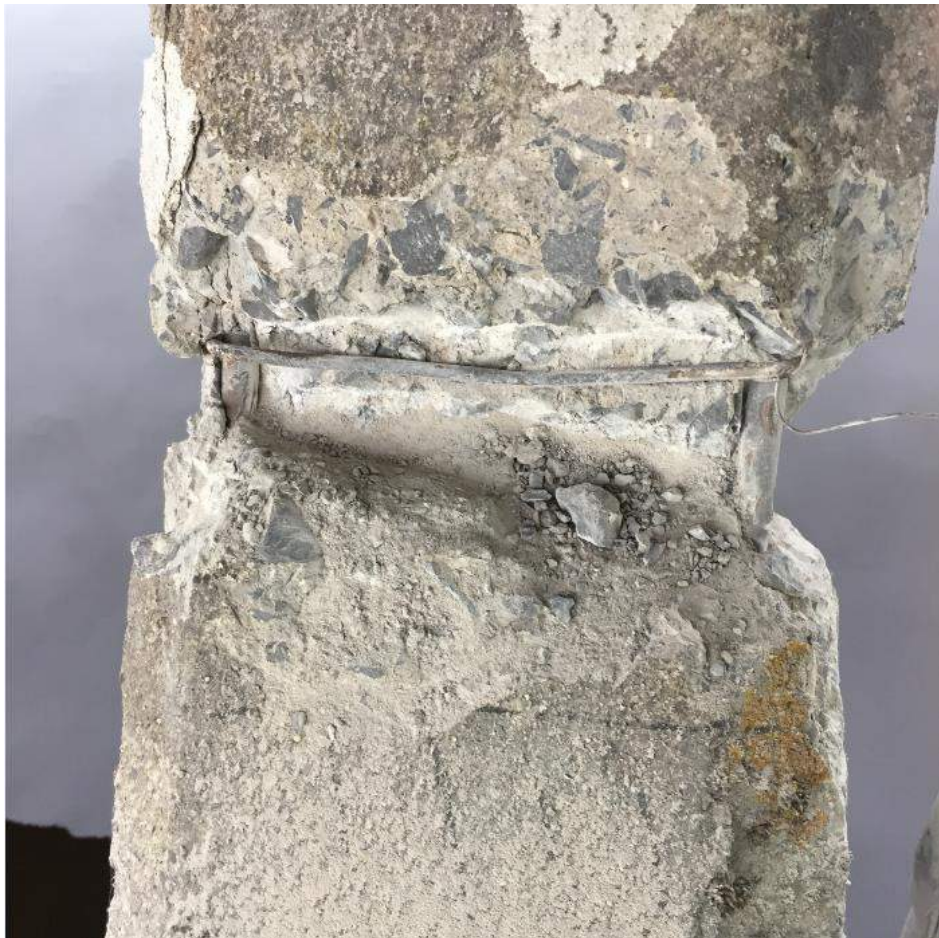
As part of the survey work required at location CS3 and CB3, BHP surveyed the diagonal support beam that runs from the bottom of the south side column to the top of the column on the north side. This diagonal is made up of 4No. 12mm Ø smooth reinforcement bars that are linked with 5mm Ø link bars. The frame of reinforcement is quite uniform throughout the beam surveyed. There is concrete cover to all four bars in the range of 37-44mm at select locations. The links are placed tightly around these main bars so cover is approximately 32-39mm. The links are spaced at approximately 220mm.

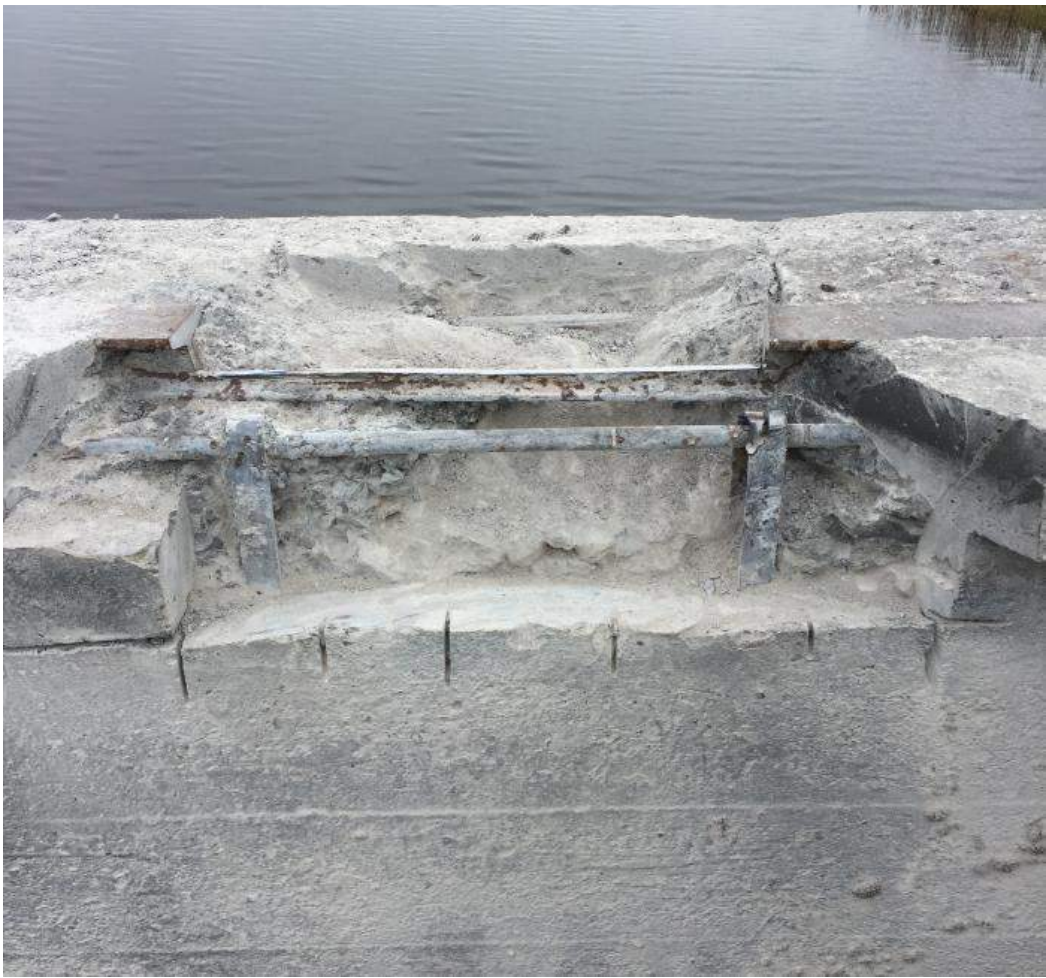
**Breakout of top of wall (please note beam was cut for tensile test)**

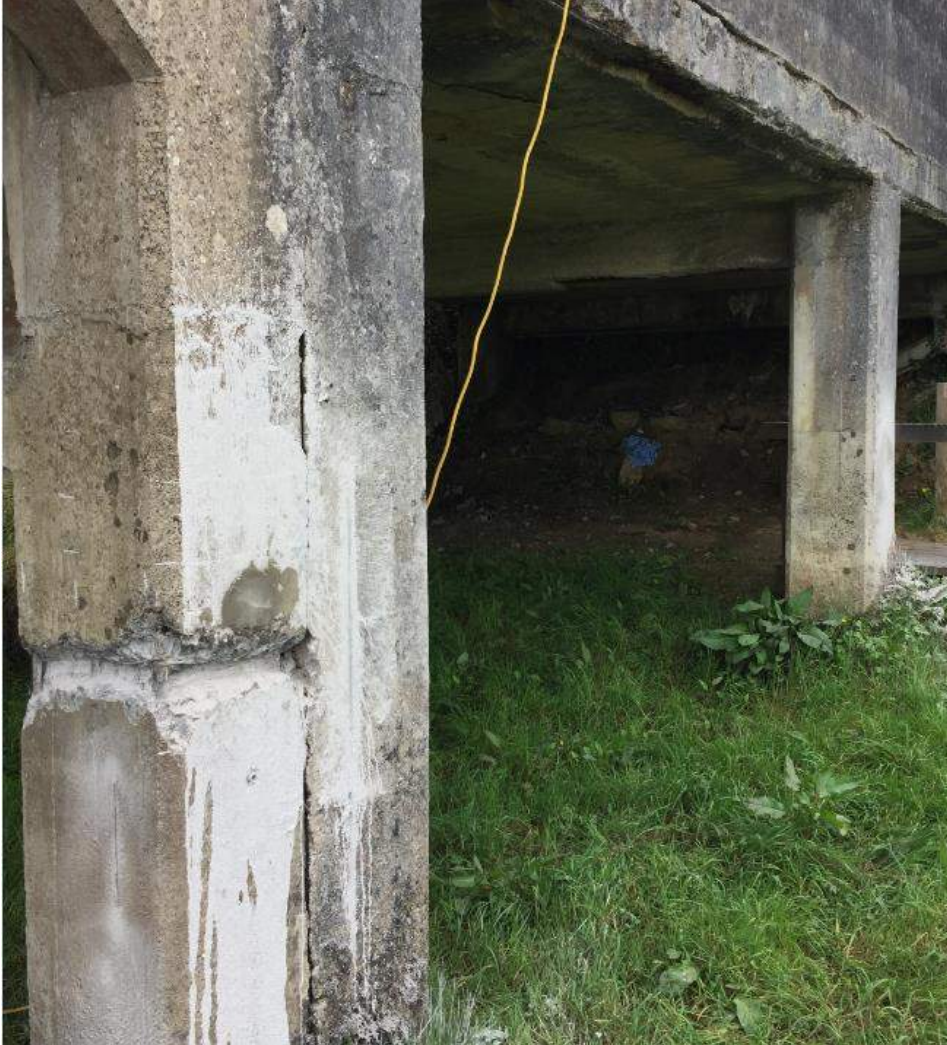
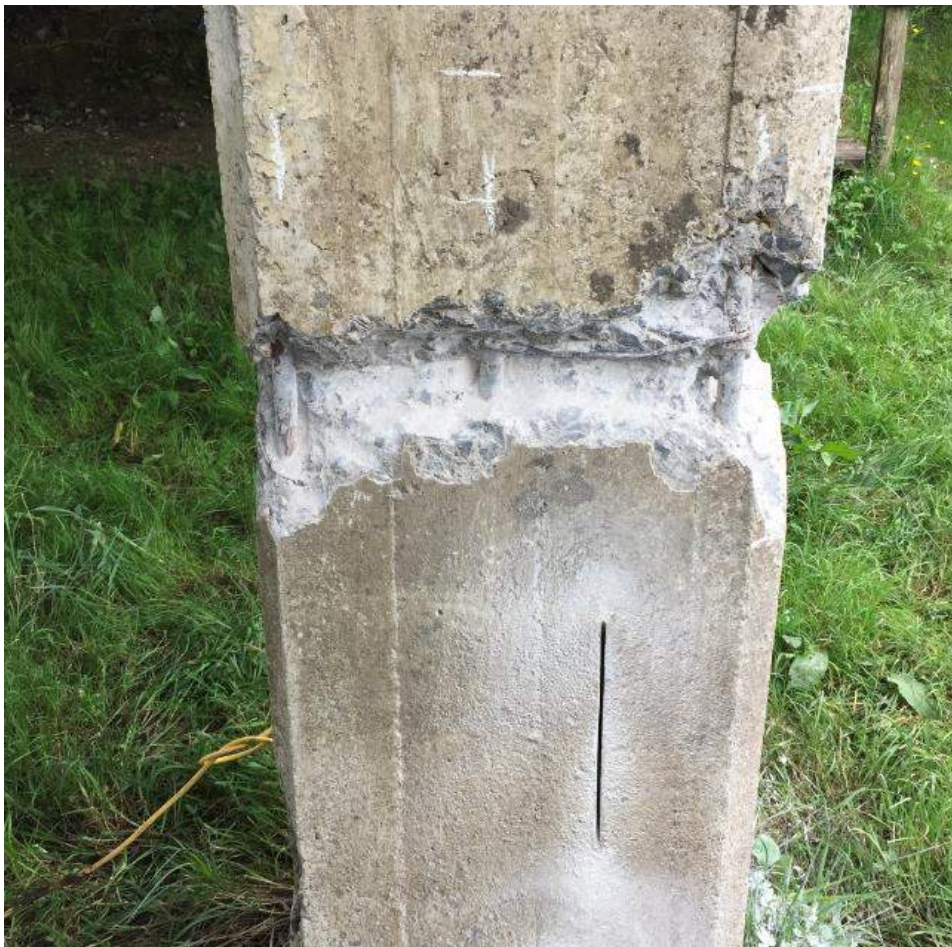
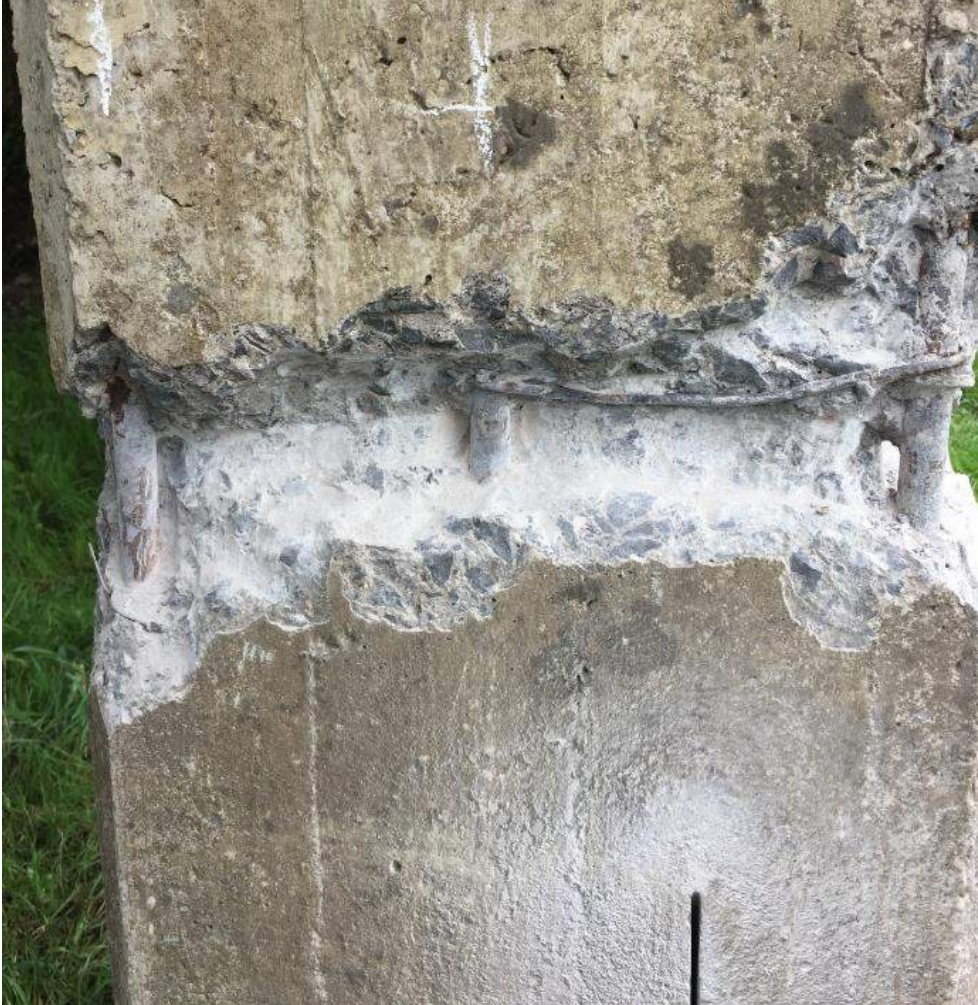
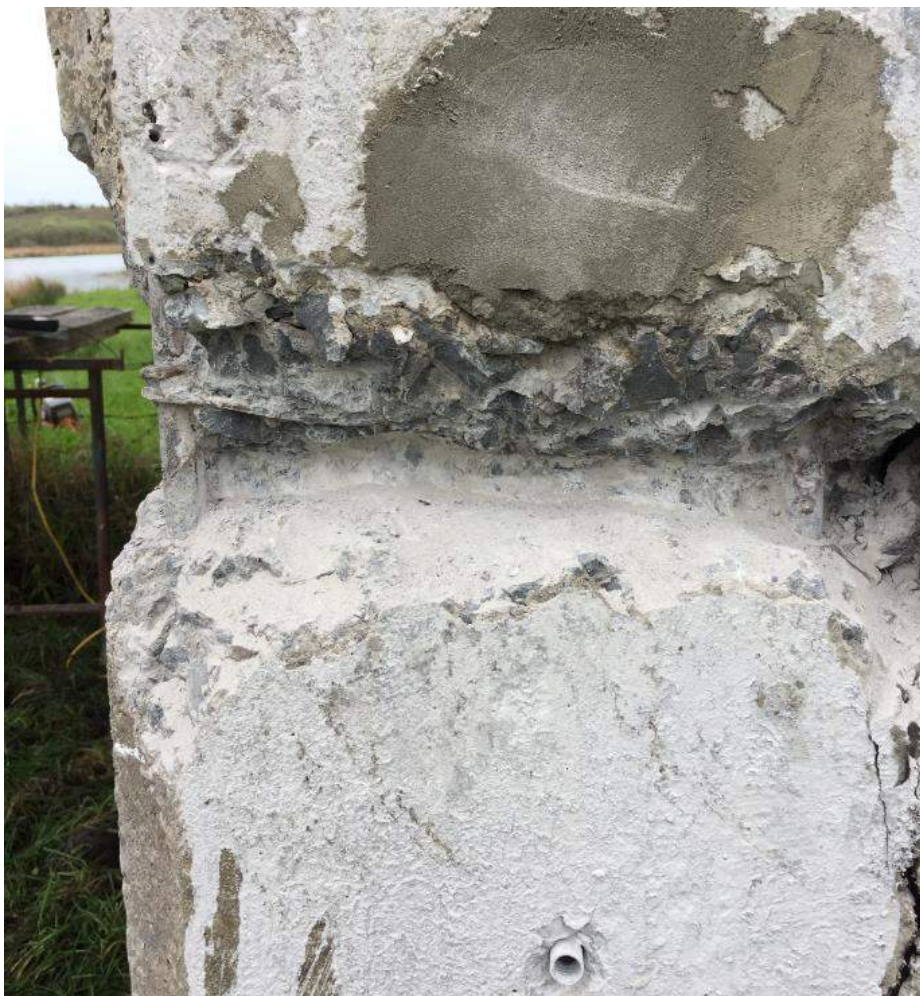
The results of the column scanning at this location backed up those found in the centre of the bridge. Similar to many locations throughout the bridge, much of the reinforcement was visible. This was due to concrete spalling. At each location of spalling, the reinforcement clearly demonstrated that corrosion was taking place. To confirm the reinforcement within the deck slab, we undertook two further scans for transverse and longitudinal bars. The transverse reinforcement was clearly visible again due to spalling along its base. The longitudinal reinforcement was identified and logged as follows:

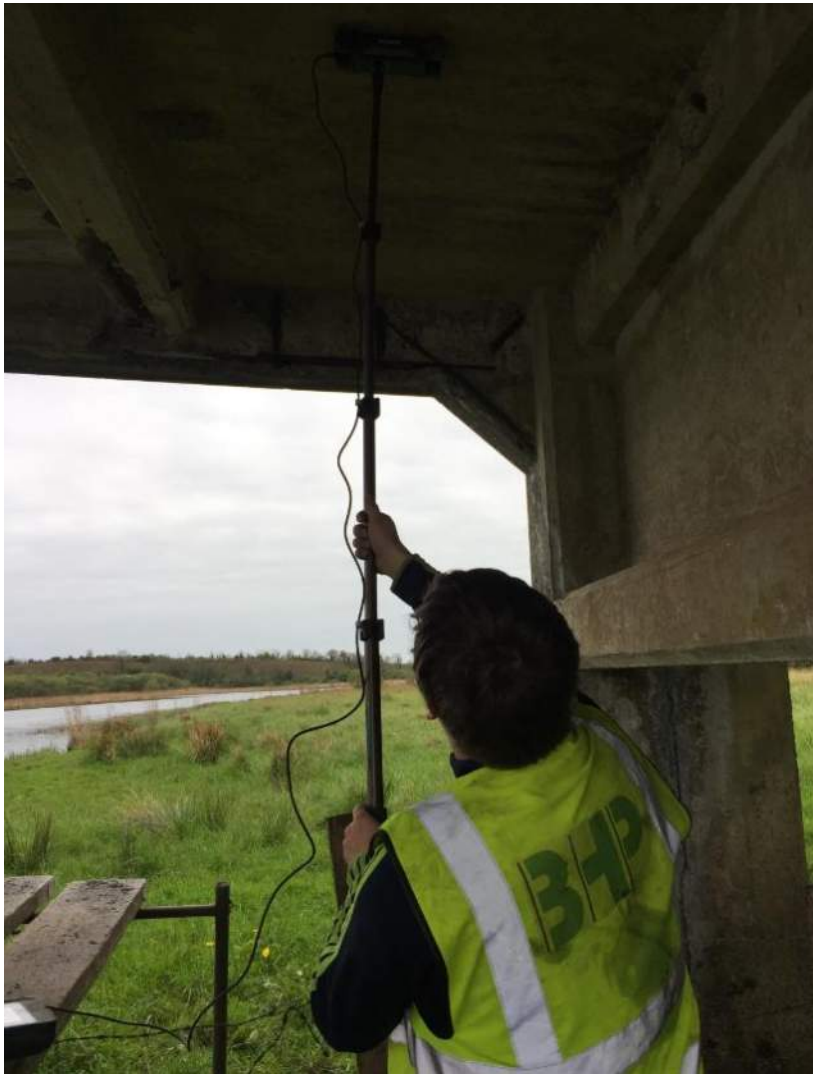
Conducting of Scan 1

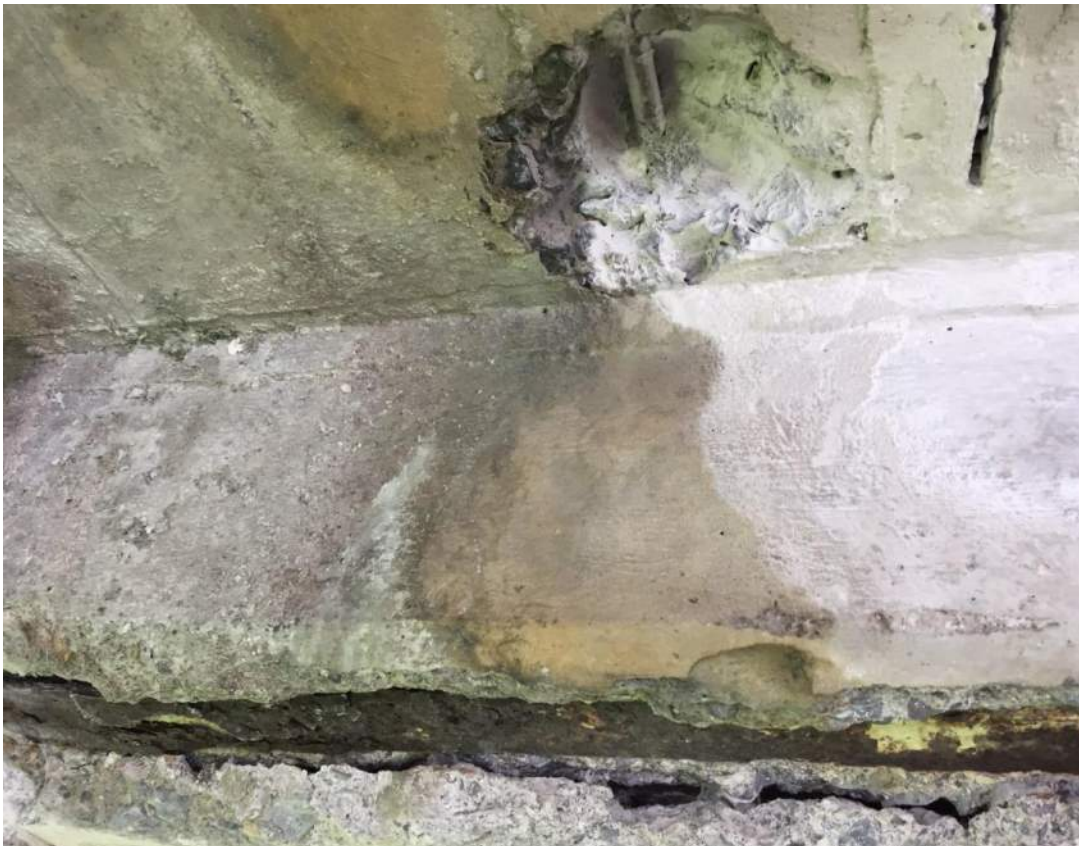
Breakout to confirm transverse reinforcement

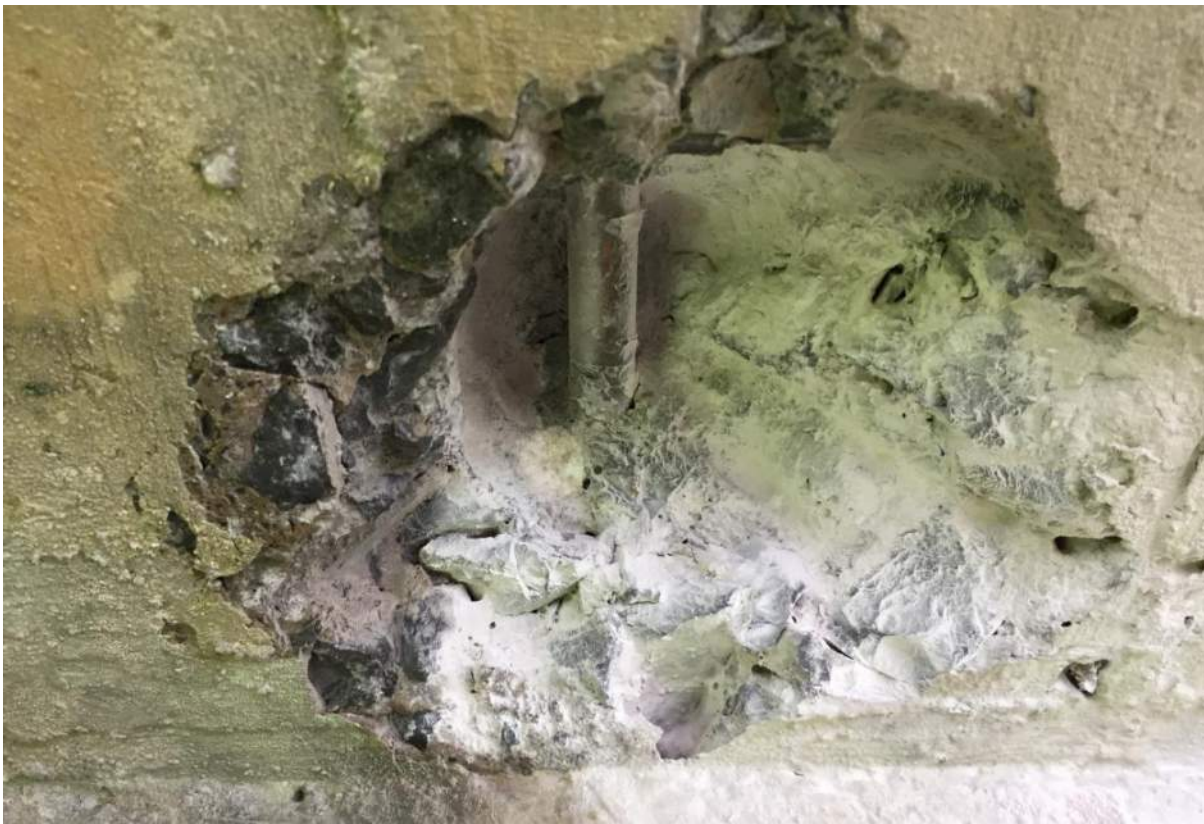
**Close up of transverse reinforcement**

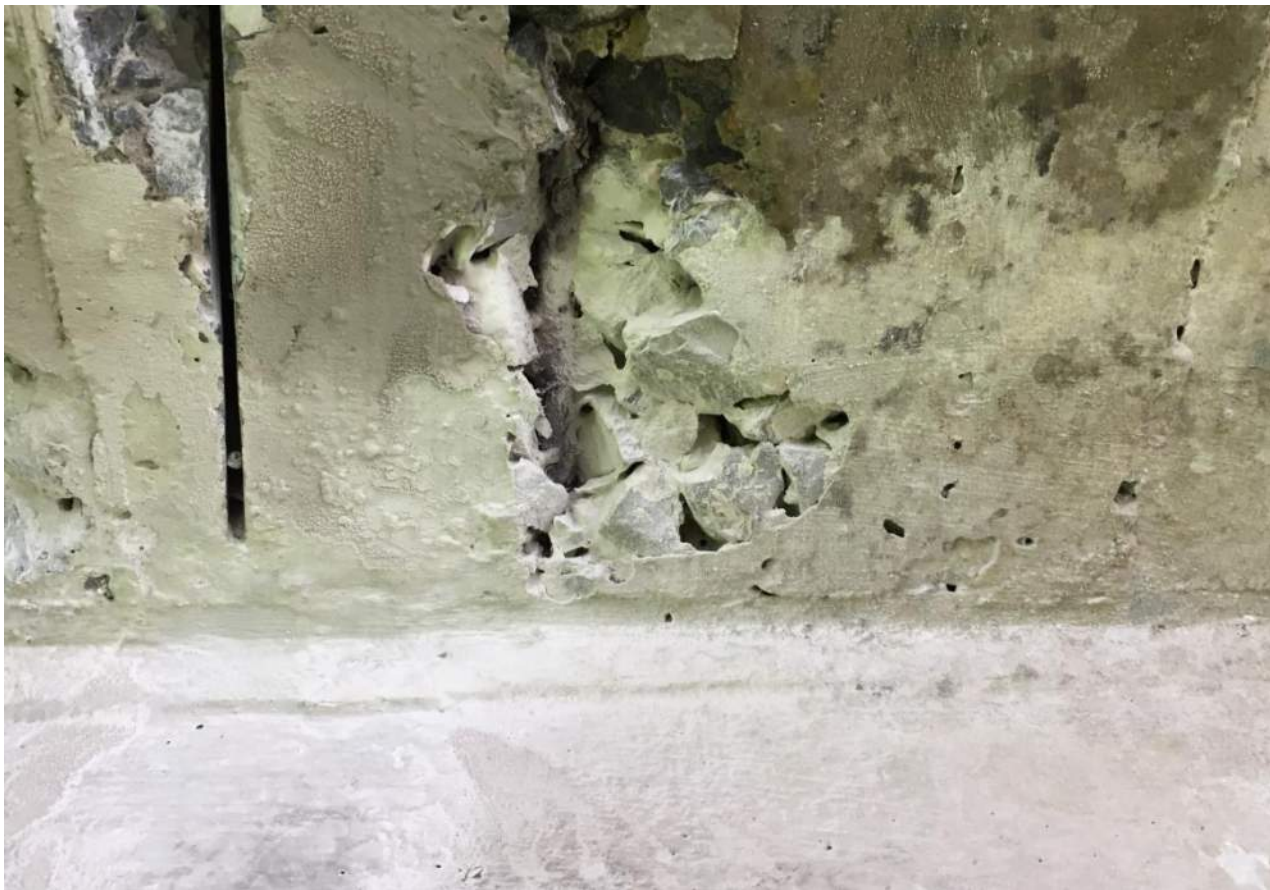
**Evidence of honeycombed concrete surrounding corrode longitudinal reinforcement bar in deck**

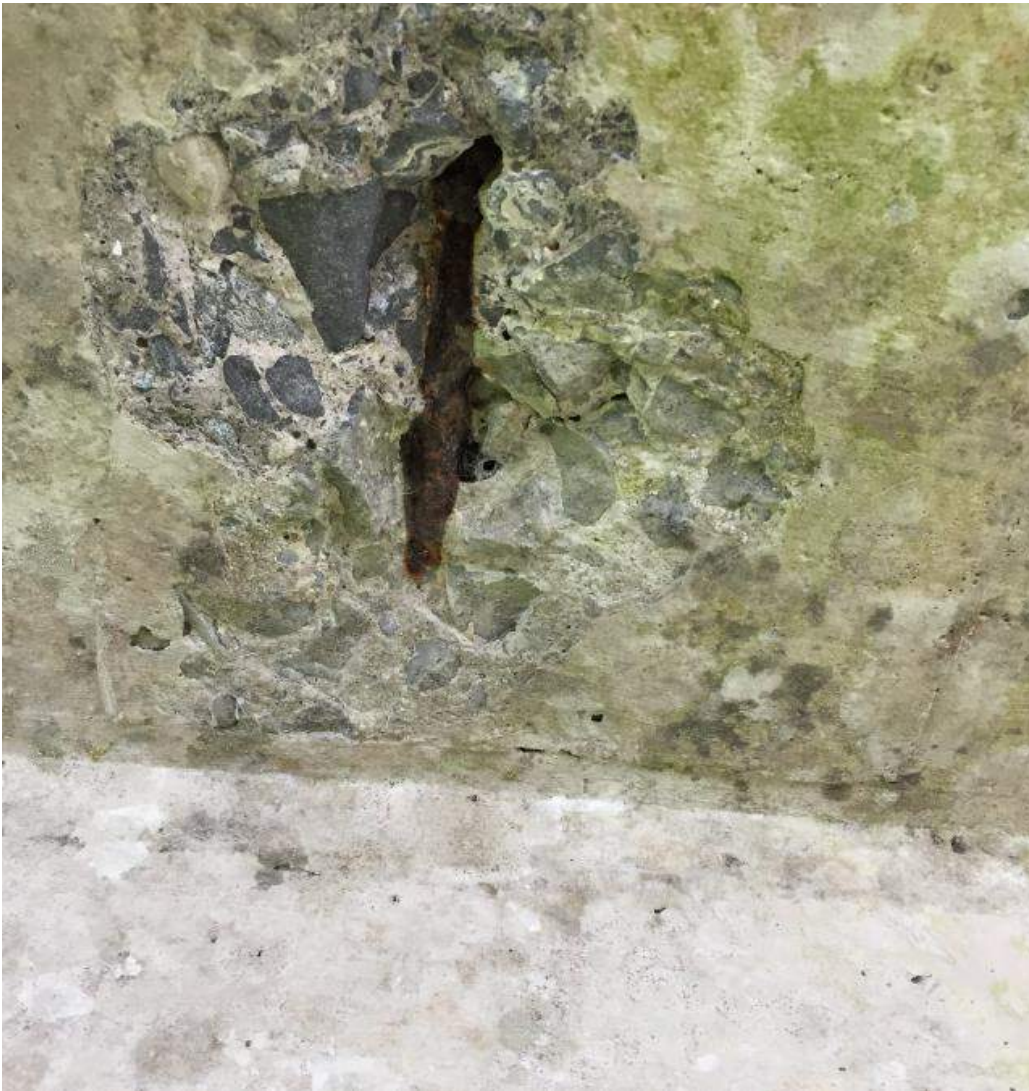
**Evidence of corroded reinforcement bar in the deck slab soffit which has led to spalled concrete**
