## Hartley Bridge Structural Investigation & Assessment

### Stage 2 Assessment Report

DRAFT ISSUE 1 | AUGUST 2017

**Document No:**..... 16.181.10 – DL-LP2784-001

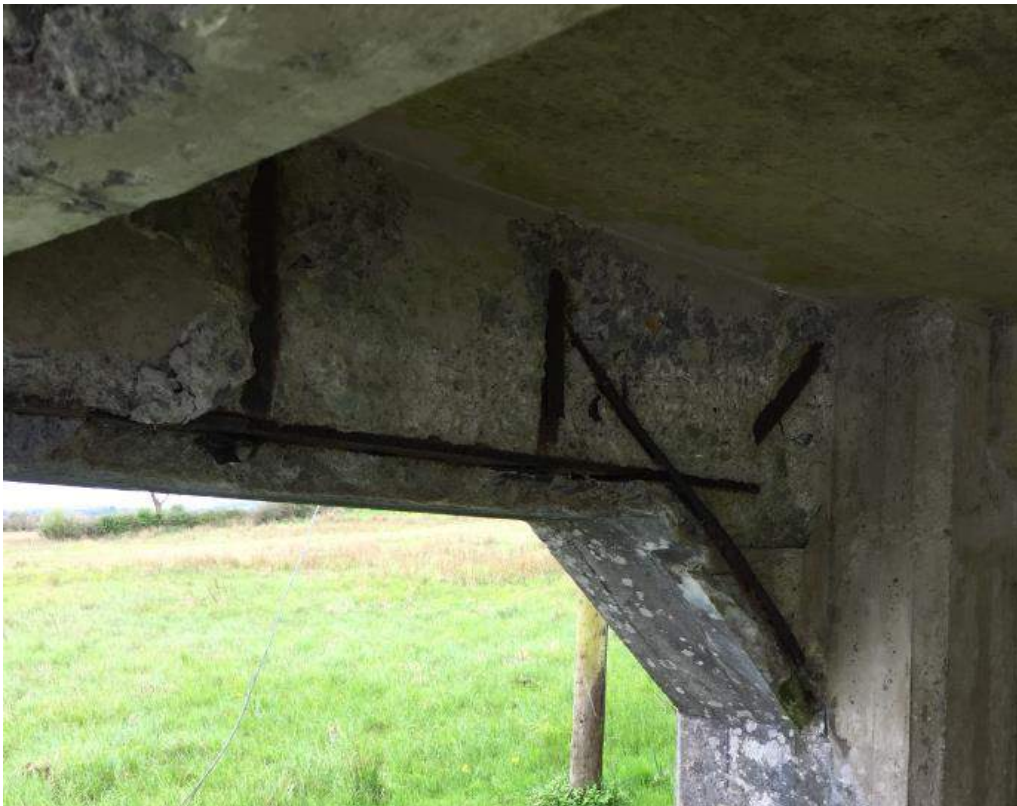
At this location there was adequate space to complete a comprehensive breakout of the transverse support beam (in between piers). The photographs confirm the transverse beam continues into the edge beam and rests on top of the main longitudinal steel beam.

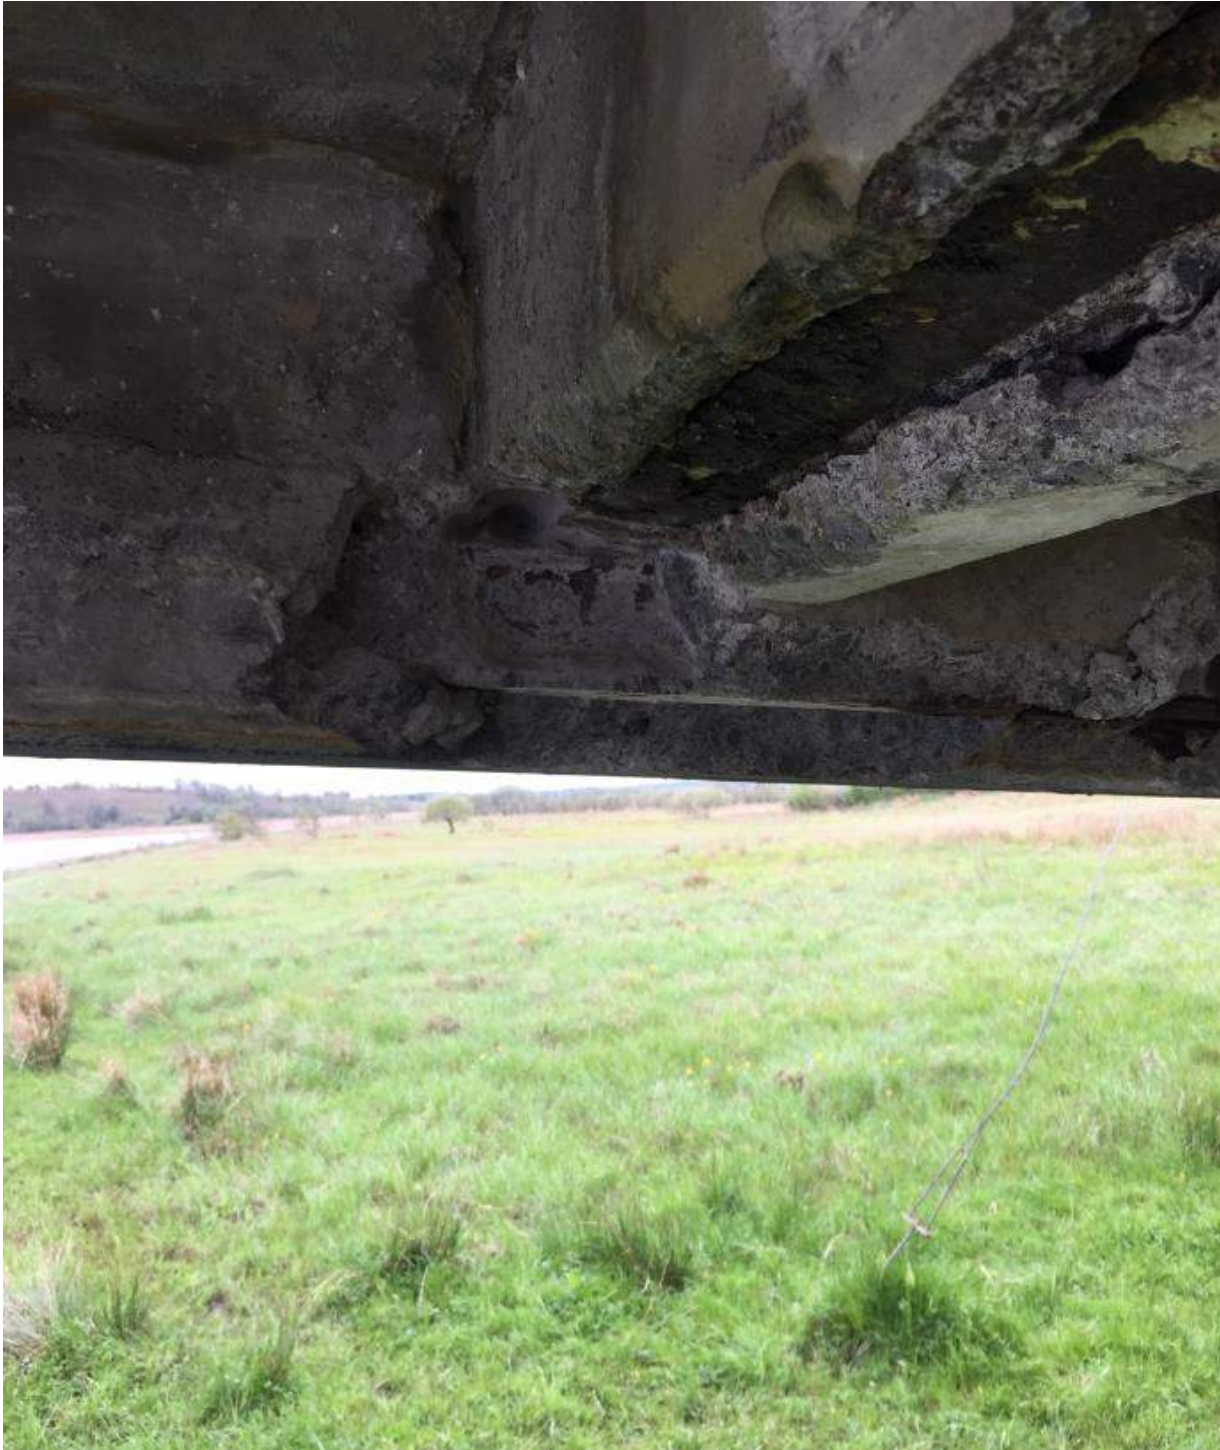
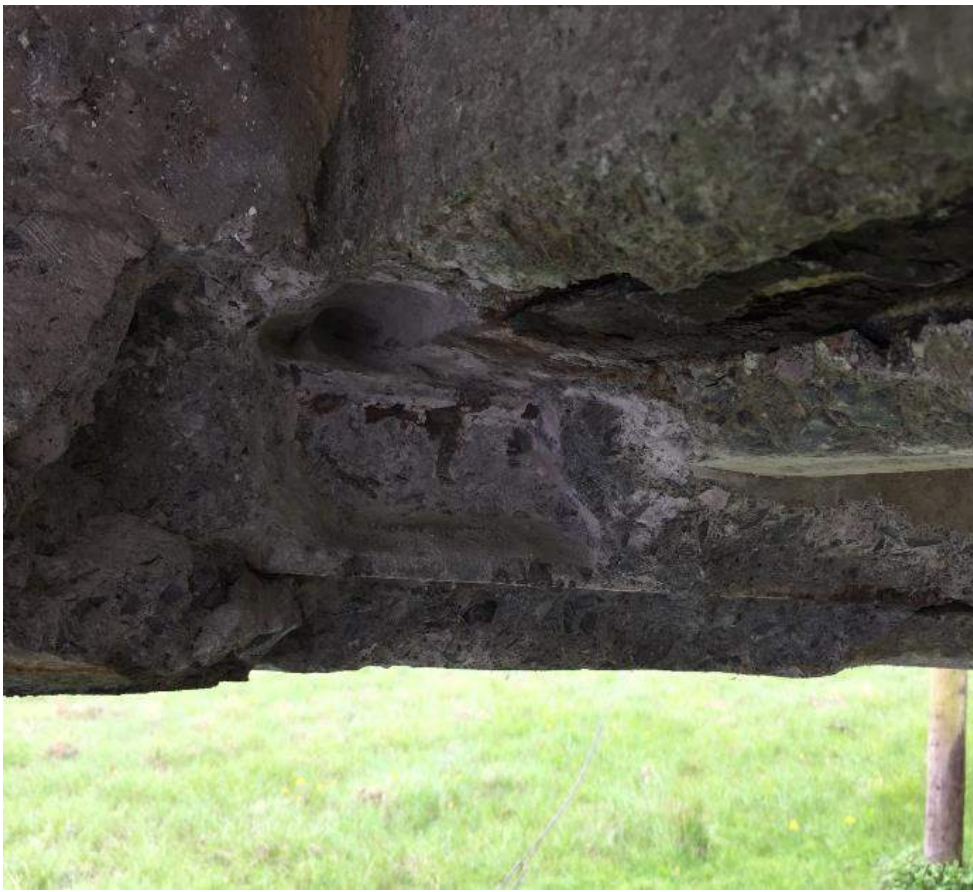
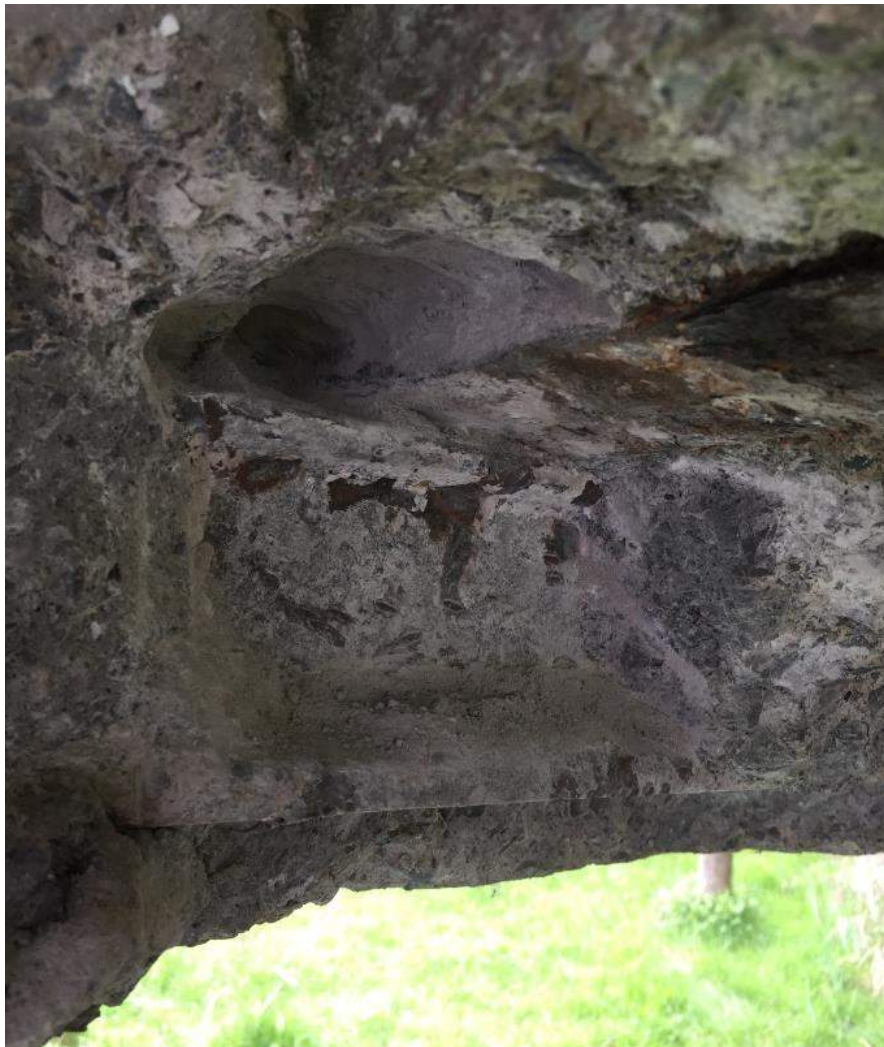
Due to widespread corrosion of beams at this location, BHP chiseled away some of the corroded steel on beams. The thickness of the edge flange did not fall below 9-10mm at these locations. The edge thickness of the flange was measured to be 12mm at a non-corroded area.

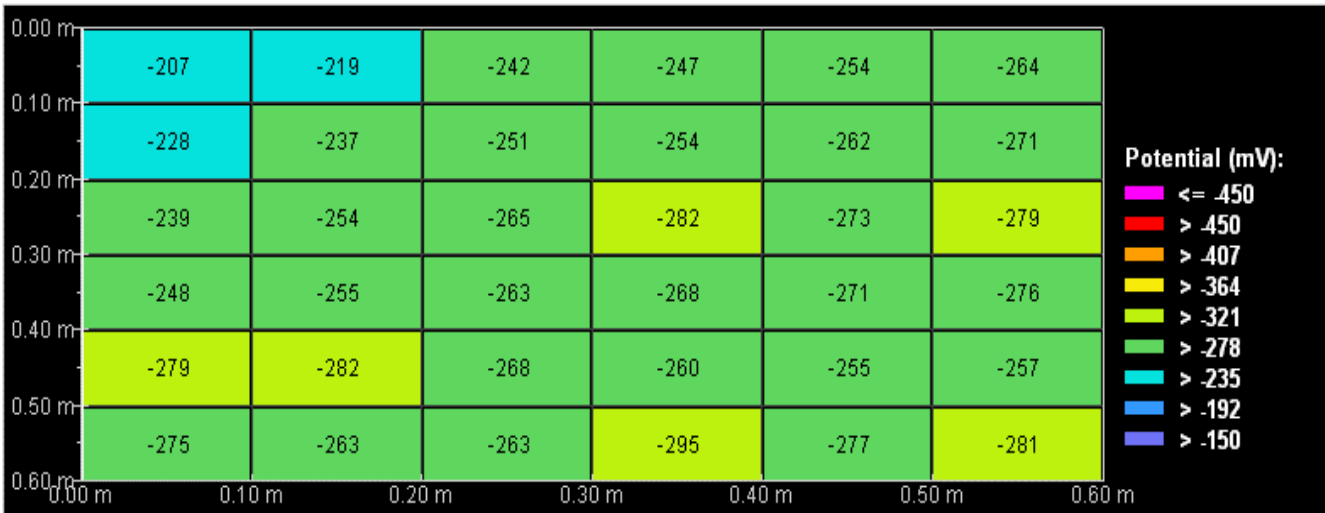
Sample Reference : 17/05/137-1  
Structural Element : Deck slab (CS4 & CB4)  
Test Number : Half Cell Test 1  
Reinforcement Condition : Mild surface corrosion

This test was performed using a Copper-Copper Sulphate Electrode.  
The range of values is -207 to -295 with a mean value of -260 and a standard deviation of 18.3.  
Authorised By:

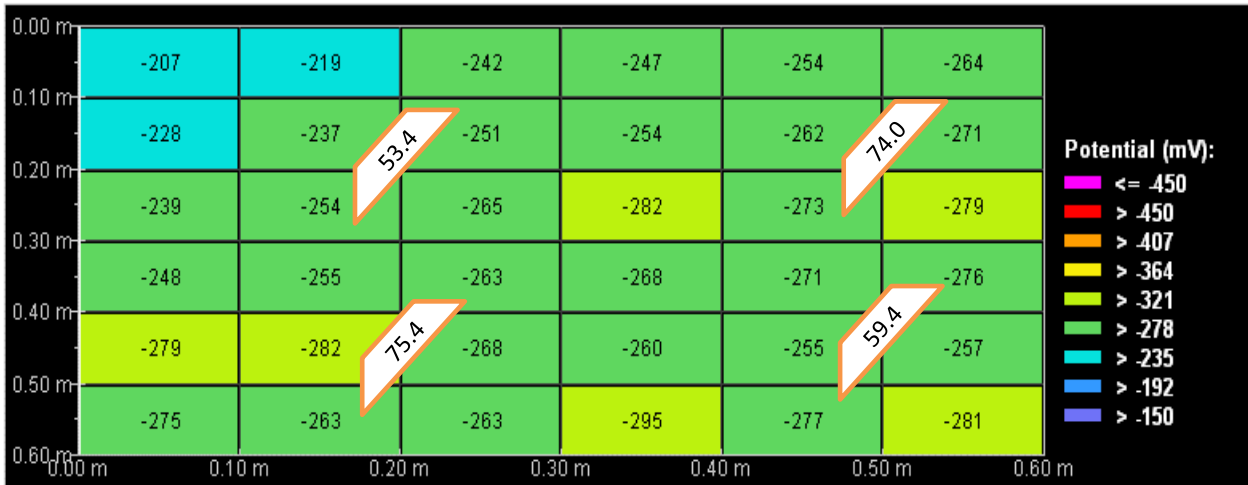
Sample Reference	:	17/05/137-1
Structural Element	:	Deck slab (CS4 & CB4)
Test Number	:	Half Cell Test 1
Equipment Used	:	Proceq Resipod
Serial Number	:	RP01-005-0041
Measurement Mode	:	Surface
Contact Spacing	:	50mm
Specimen Shape	:	Rough surface
Minimum Measurement	:	53.4 kΩcm
Maximum Measurement	:	75.4 kΩcm
Mean Value	:	65.6 kΩcm

Resistivity measurements can be used to estimate the likelihood of corrosion. When the electrical resistivity of the concrete is low, the likelihood of corrosion increases. When the electrical resistivity is high, the likelihood of corrosion decreases.

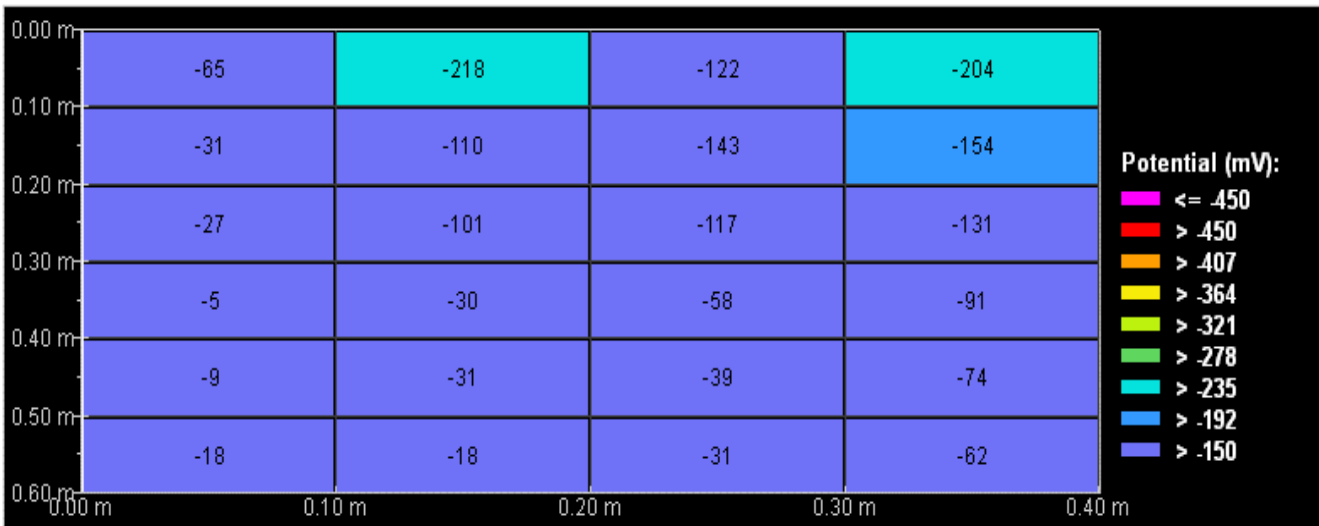
Sample Reference : 17/05/137-2  
Structural Element : Column, east face (CS3 & CB3)  
Test Number : Half Cell Test 2

Reinforcement Condition : No to mild surface corrosion

This test was performed using a Copper-Copper Sulphate Electrode.  
The range of values is -5 to -218 with a mean value of -78.7 and a standard deviation of 59.4.  
Authorised By:

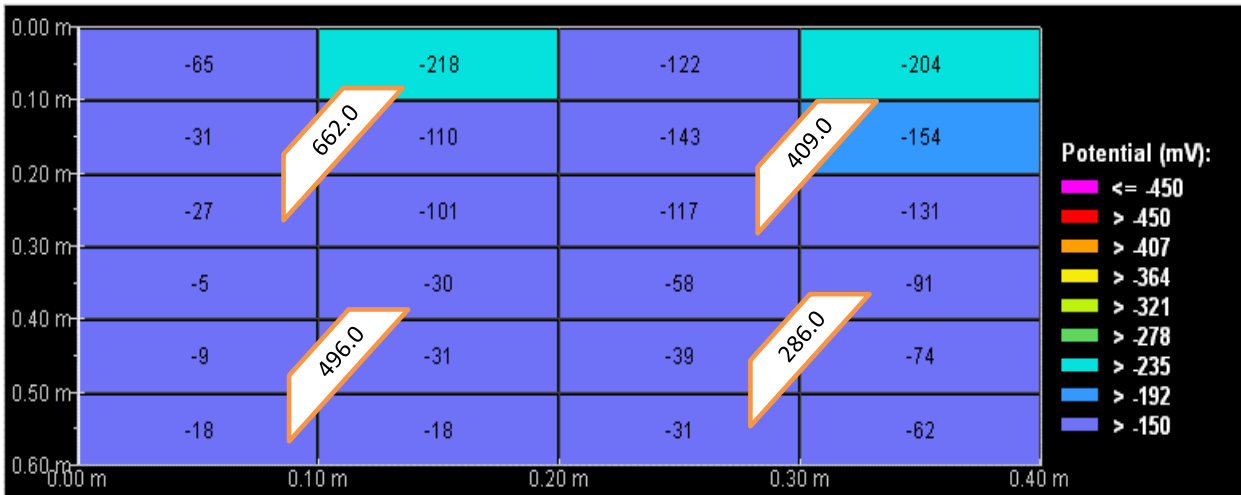
Sample Reference	:	17/05/137-2
Structural Element	:	Column, east face (CS3 & CB3)
Test Number	:	Half Cell Test 2
Equipment Used	:	Proceq Resipod
Serial Number	:	RP01-005-0041
Measurement Mode	:	Surface
Contact Spacing	:	50mm
Specimen Shape	:	Rough surface
Minimum Measurement	:	286.0 kΩcm
Maximum Measurement	:	662.0 kΩcm
Mean Value	:	463.3 kΩcm

Resistivity measurements can be used to estimate the likelihood of corrosion. When the electrical resistivity of the concrete is low, the likelihood of corrosion increases. When the electrical resistivity is high, the likelihood of corrosion decreases.

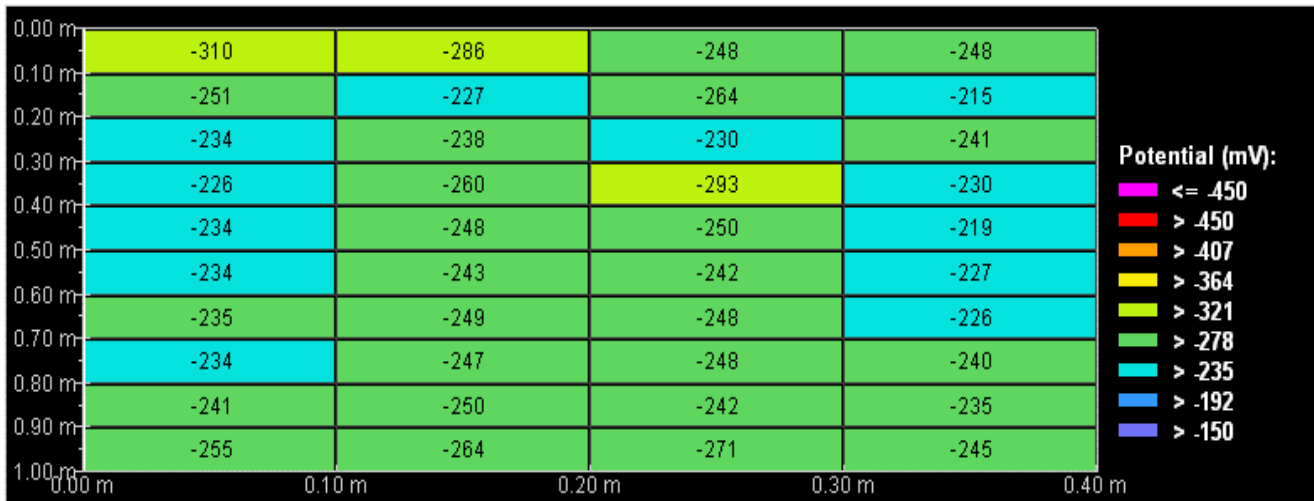
Reinforcement Condition : Mild surface corrosion

This test was performed using a Copper-Copper Sulphate Electrode.  
The range of values is -215 to -310 with a mean value of -245.7 and a standard deviation of 18.9.

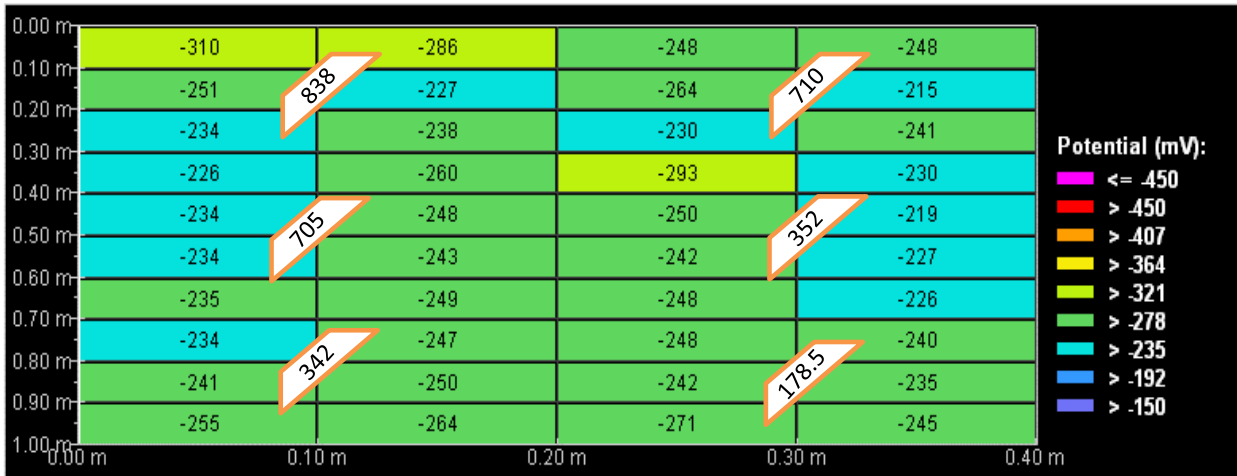
Sample Reference	:	17/05/137-3
Structural Element	:	Column, east face (Over Land)
Test Number	:	Half Cell Test 3
Equipment Used	:	Proceq Resipod
Serial Number	:	RP01-005-0041
Measurement Mode	:	Surface
Contact Spacing	:	50mm
Specimen Shape	:	Rough surface
Minimum Measurement	:	178.0 kΩcm
Maximum Measurement	:	838.0 kΩcm
Mean Value	:	520.9 kΩcm

Resistivity measurements can be used to estimate the likelihood of corrosion. When the electrical resistivity of the concrete is low, the likelihood of corrosion increases. When the electrical resistivity is high, the likelihood of corrosion decreases.

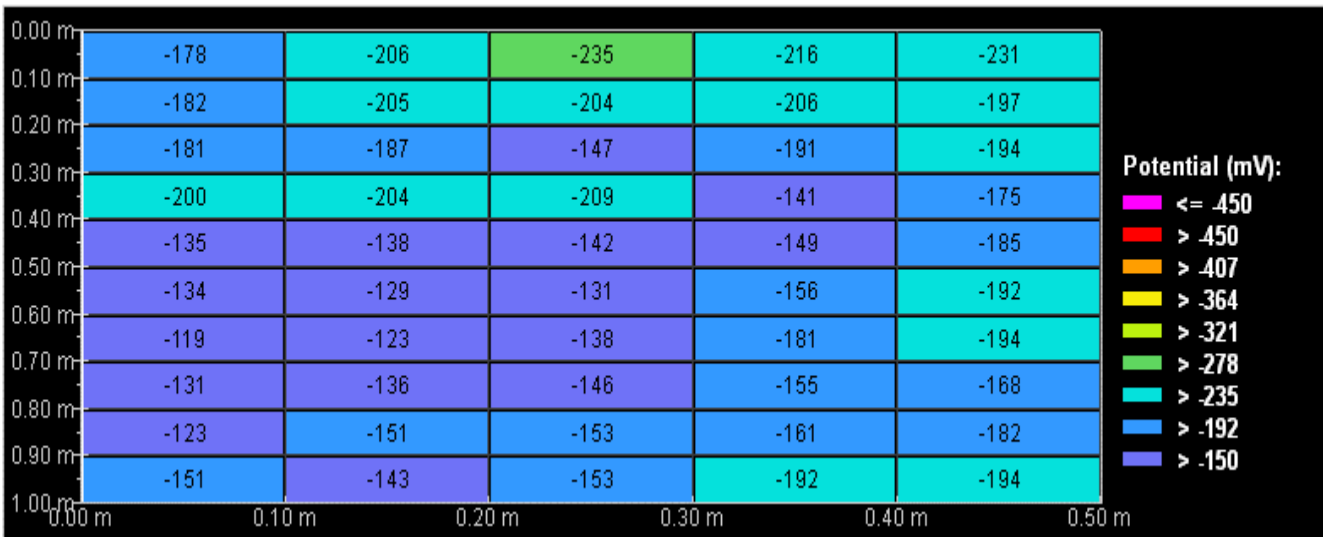
Reinforcement Condition : Mild surface corrosion

This test was performed using a Copper-Copper Sulphate Electrode.  
The range of values is -119 to -235 with a mean value of -169.5 and a standard deviation of 30.6.

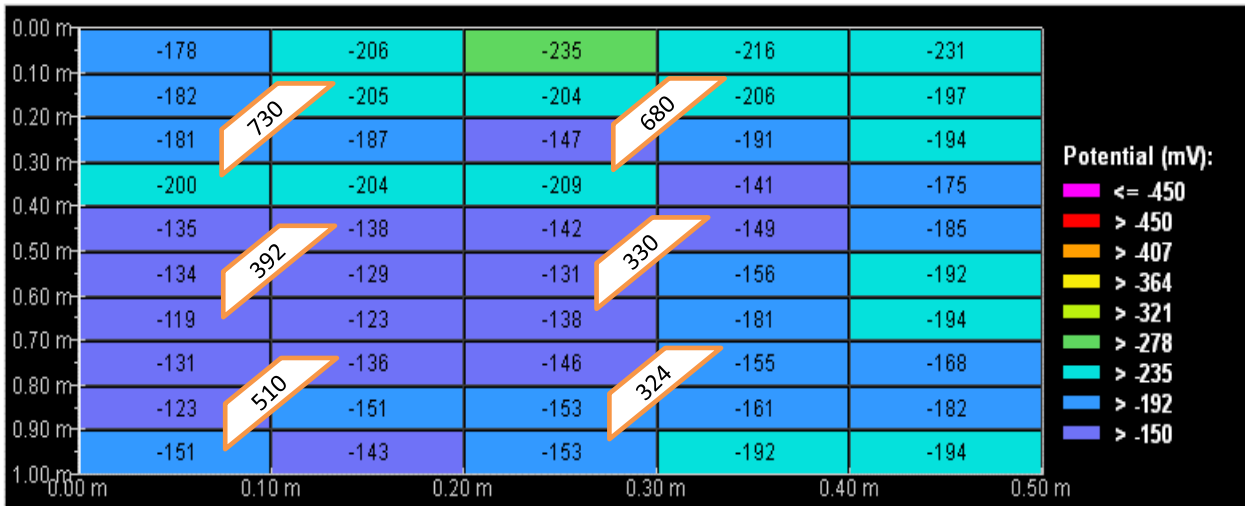
Sample Reference	:	17/05/137-4
Structural Element	:	Deck Slab Soffit (Over Land)
Test Number	:	Half Cell Test 4
Equipment Used	:	Proceq Resipod
Serial Number	:	RP01-005-0041
Measurement Mode	:	Surface
Contact Spacing	:	50mm
Specimen Shape	:	Rough surface
Minimum Measurement	:	324.0 kΩcm
Maximum Measurement	:	730.0 kΩcm
Mean Value	:	494.3 kΩcm

Resistivity measurements can be used to estimate the likelihood of corrosion. When the electrical resistivity of the concrete is low, the likelihood of corrosion increases. When the electrical resistivity is high, the likelihood of corrosion decreases.
