## **Drumshanbo Town Centre Regeneration**

# **Structural Assessment Survey and Site Investigation Report**

**for former Bank of Ireland Building, Early's Building  
and Adjacent Derelict Building, Drumshanbo, Co  
Leitrim**

**December 2023**

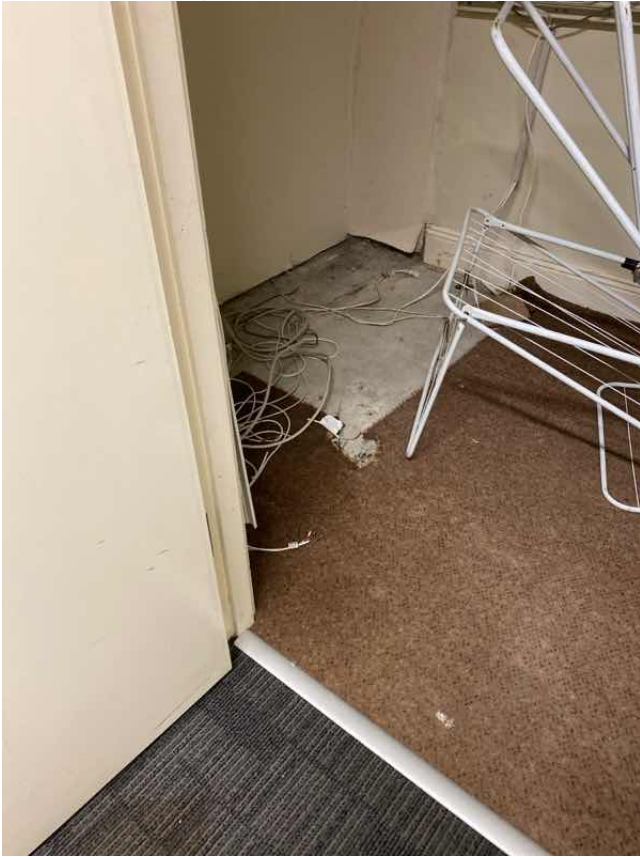
28

Carpeted floor on ground bearing concrete slab

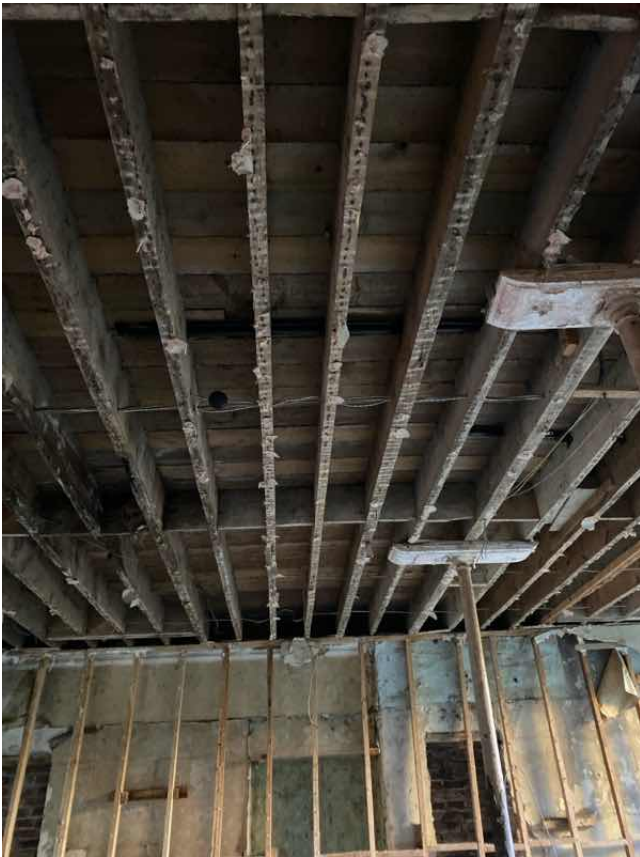
73

Floor Joist are 250x50 @ 300 centres.

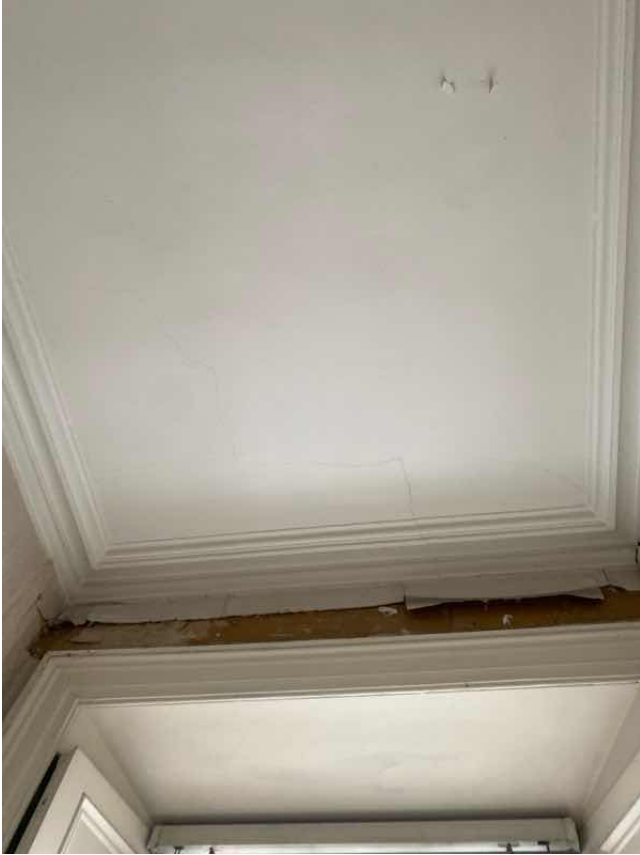
31

Observed hairline cracks in Cieling, generally in satisfactory condition

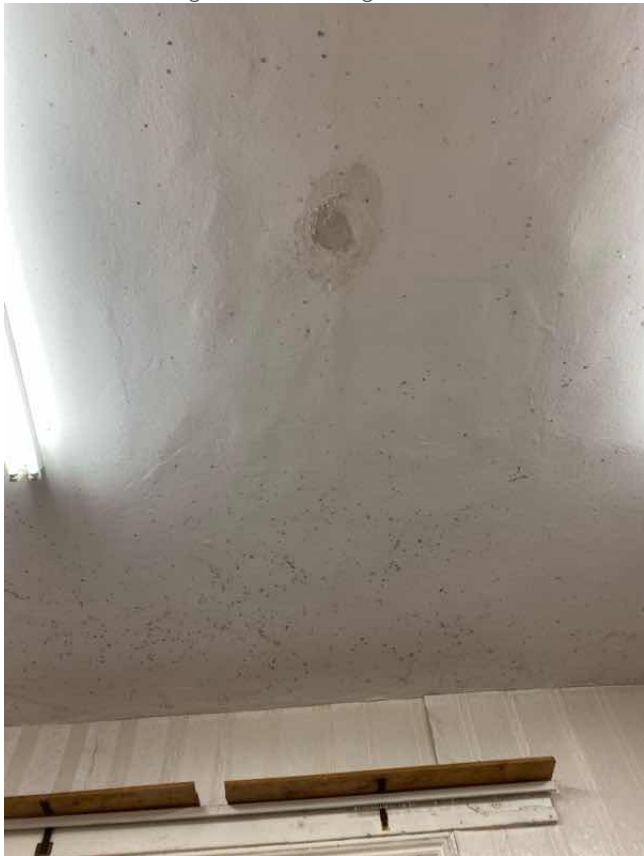
35

Extensive mould growth on Cieling

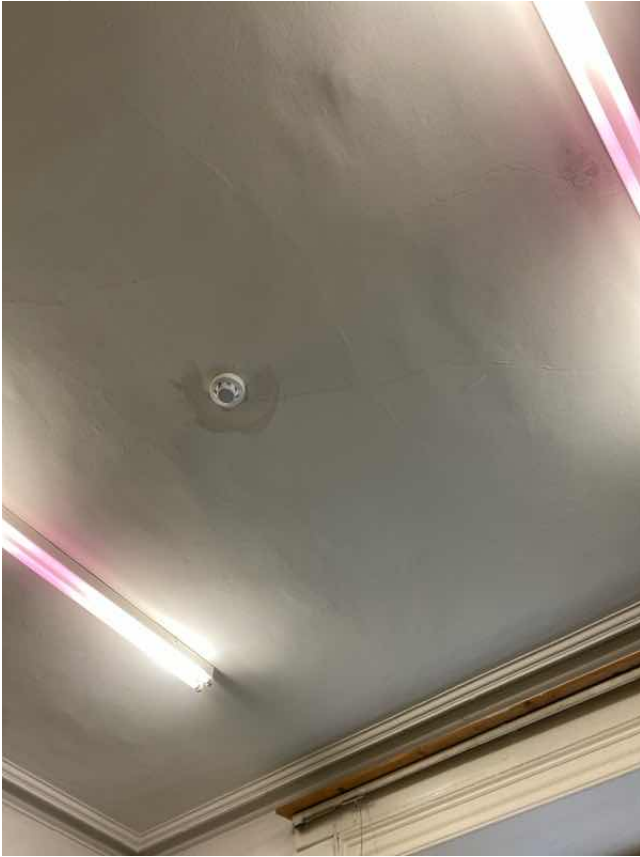
39

Cieling in satisfactory condition, observed hairline cracks at the lights

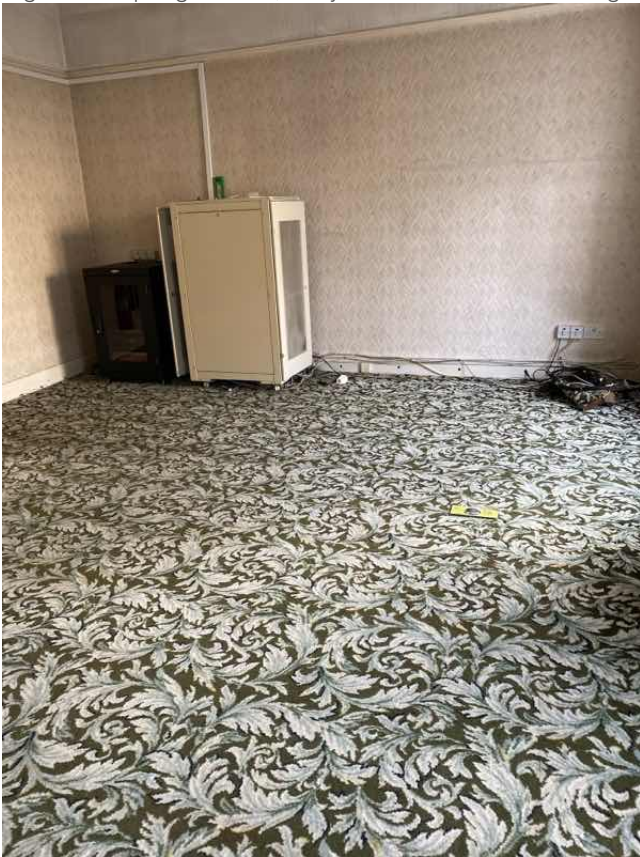
40

Significant spring in floor , likely as a result of under designed timber joist which span parallel to front exterior wall

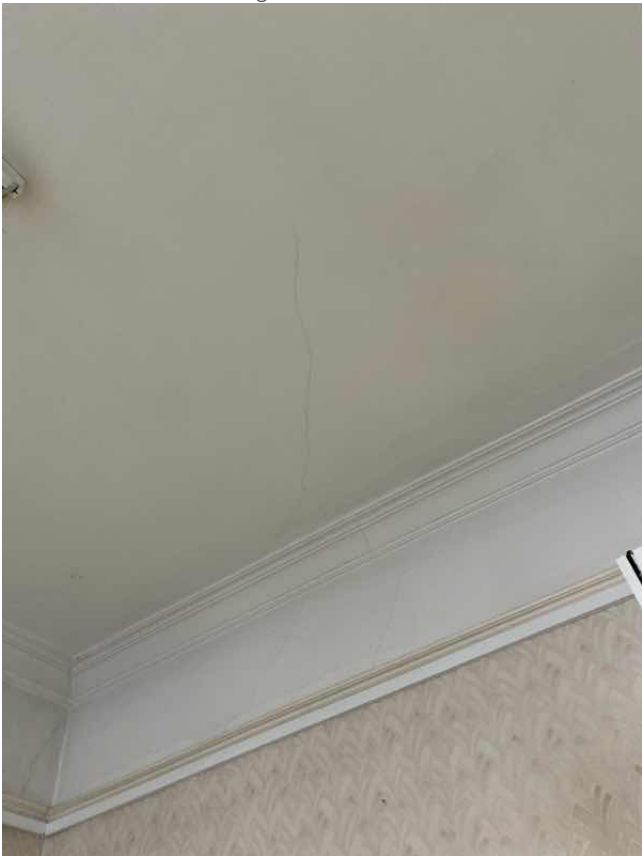
43

Hairline cracks in Cieling

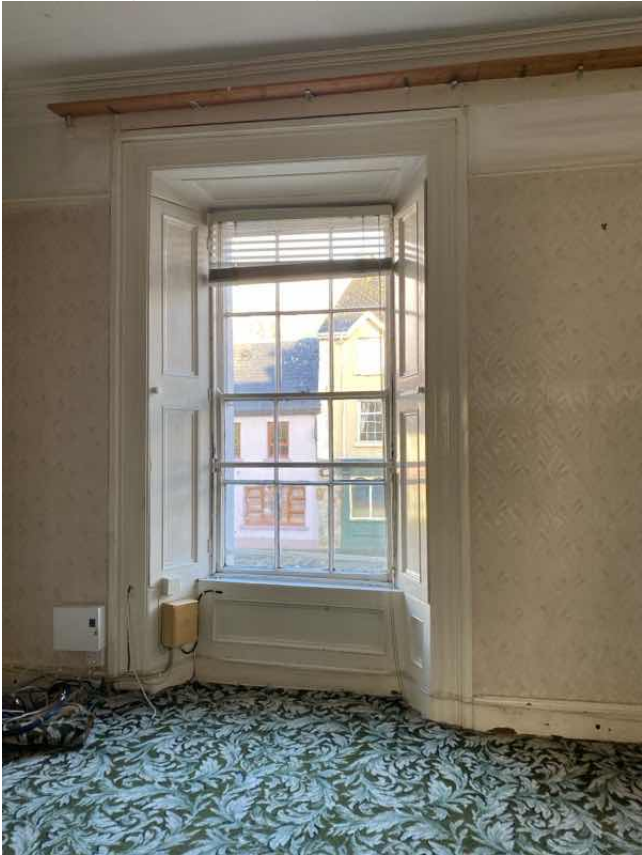
44

Timber linings around existing sash windows

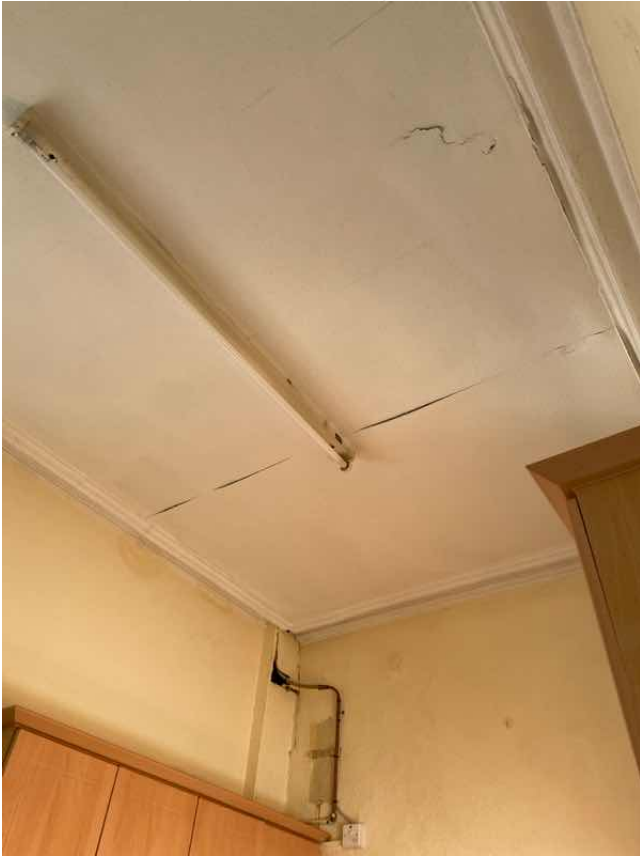
47

Wallpaper coming away from ceiling

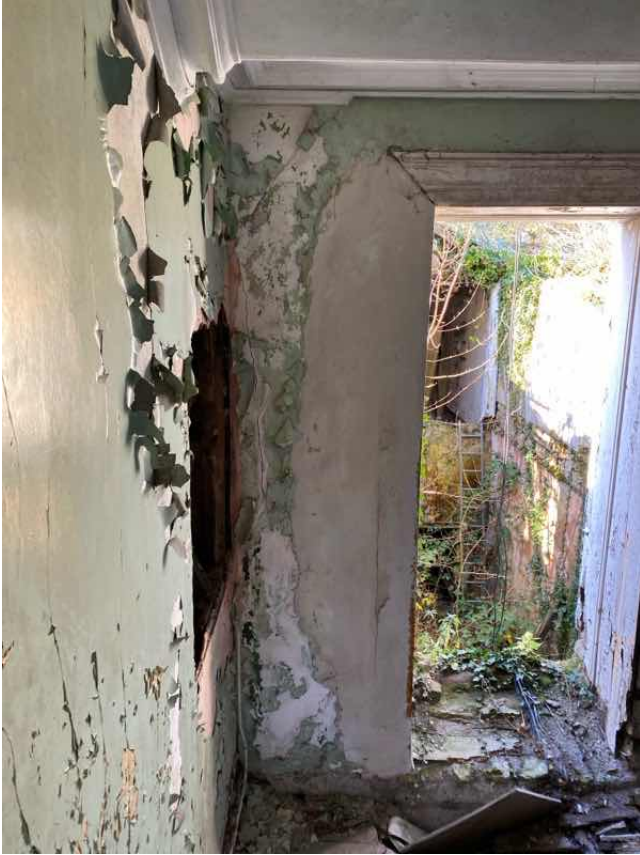
98

Evidence of significant damp ingress on wall adjacent to window

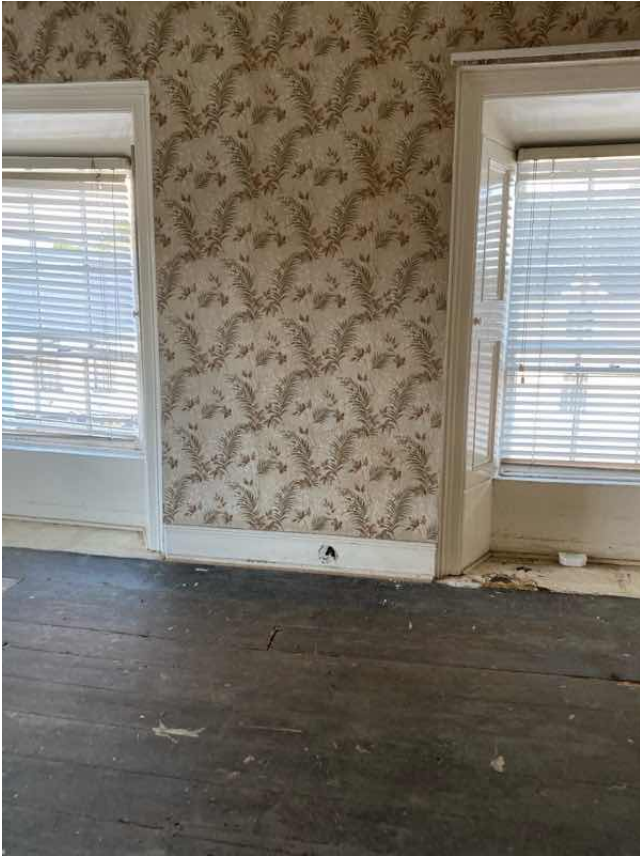
61

All external walls dry lined

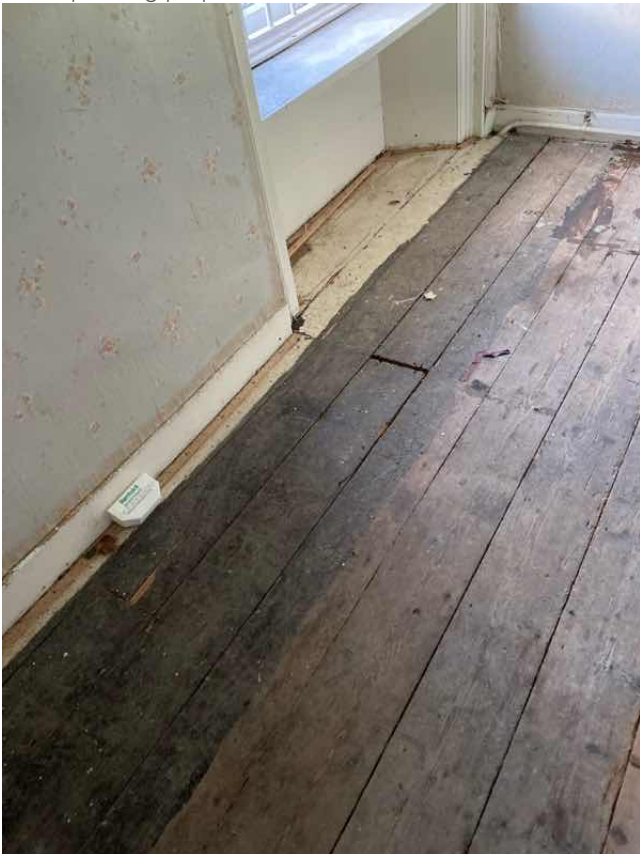
62

Joist spanning perpendicular to the rear exterior wall.

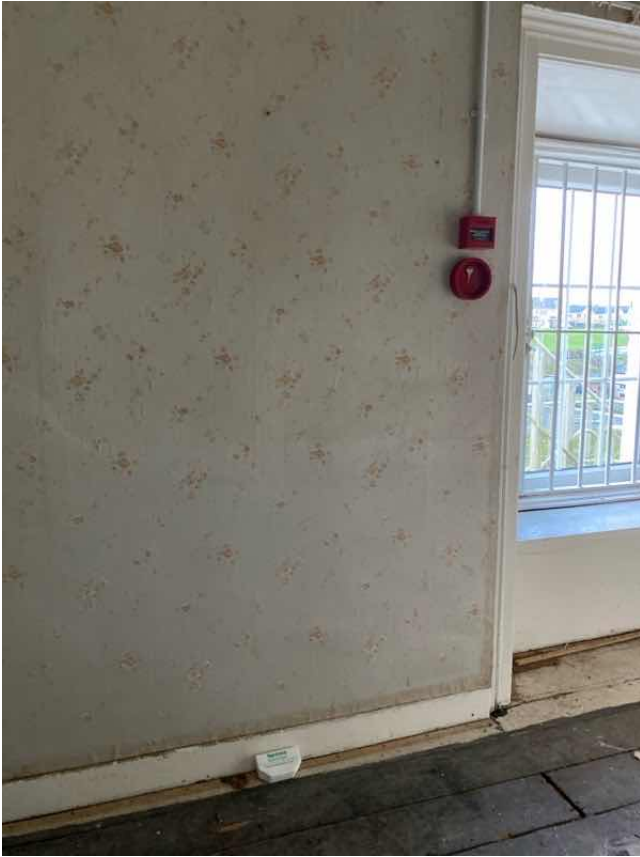
65

Rear wall drylined

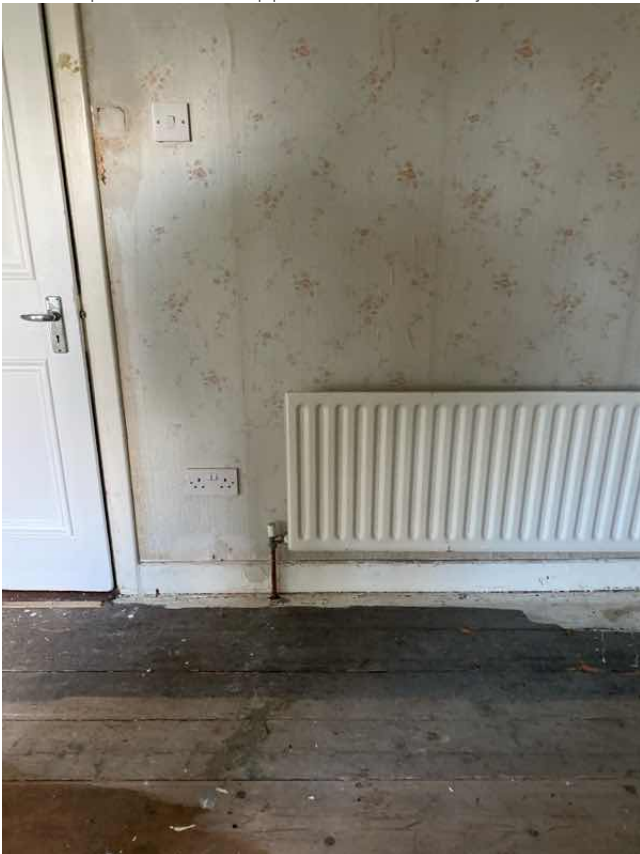
66

Internal partition wall supported off the floor joist

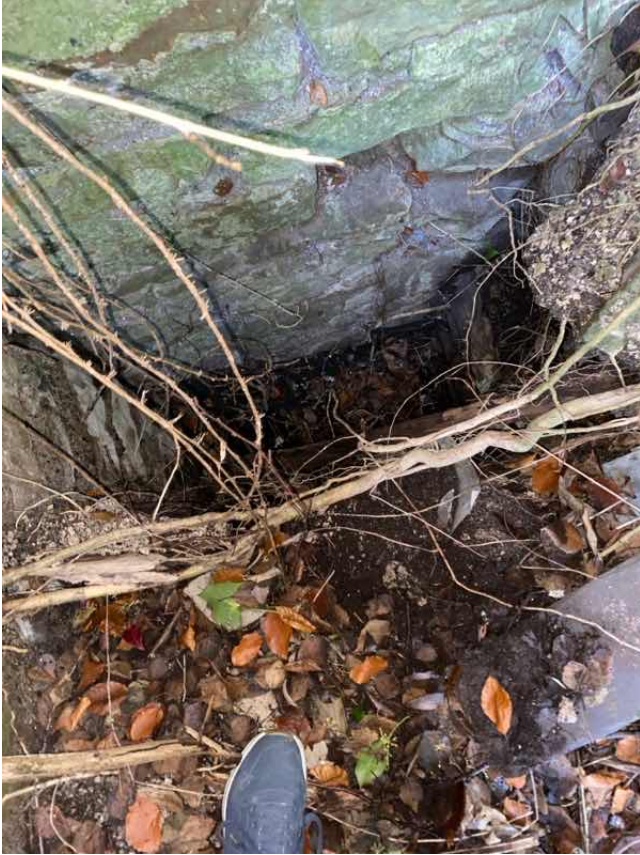
172

Deep pit and drainage hole in wall at back wall
