ARCHITECTURAL HERITAGE IMPACT ASSESSMENT

BOUNDARY WALL OF ST. MARY'S, MAIN STREET, MOHILL, CO. LEITRIM

DERMOT NOLAN
CONSERVATION ARCHITECT

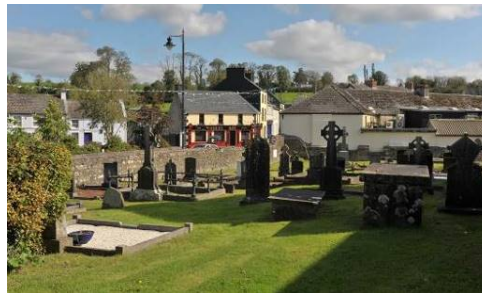
PIC.1; GENERAL VIEW, LOOKING EAST, OF GRAVEYARD, BOUNDARY WALL TO LEFT.

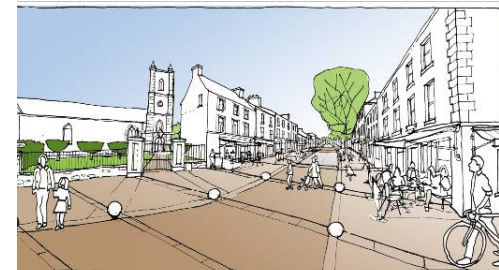
PIC. 2; SHERIDAN WOODS PROPOSAL.

It is considered this would be of benefit in that it opens up the church grounds as observed from this public area at the confluence of these streets.

1.7 To achieve this, it is proposed to form openings in the wall; these openings would be protected by metal railings.

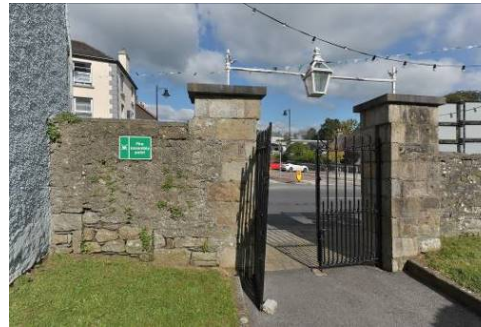
1.9 The writer is aware of suggestions, from parishioners, that the entrance should be widened to facilitate access for hearses & other vehicles.

PIC. 3; ENTRANCE (FROM WITHIN)
