## **Drumshanbo Town Centre Regeneration**

# **Structural Assessment Survey and Site Investigation Report**

**for former Bank of Ireland Building, Early's Building  
and Adjacent Derelict Building, Drumshanbo, Co  
Leitrim**

**December 2023**

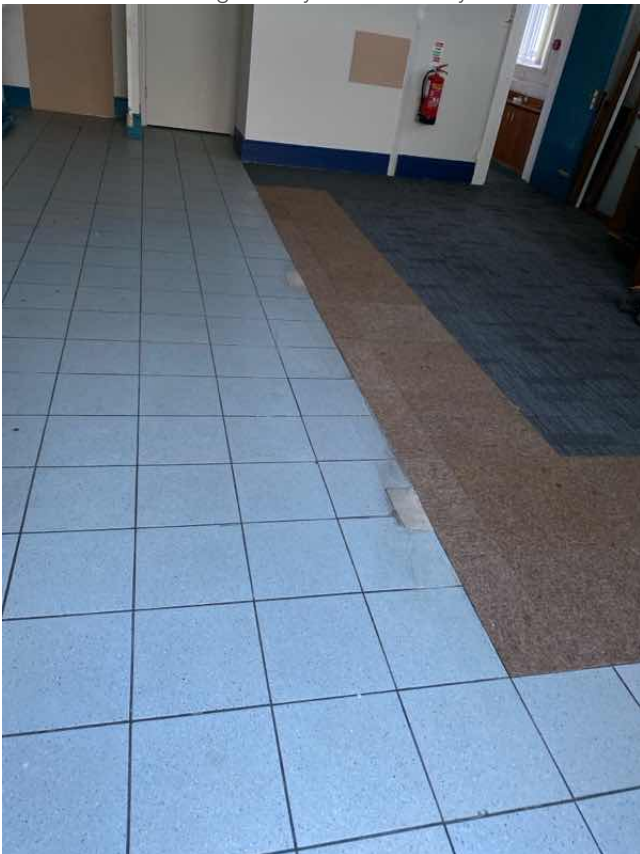
2

Tiled concrete floor generally in satisfactory condition.

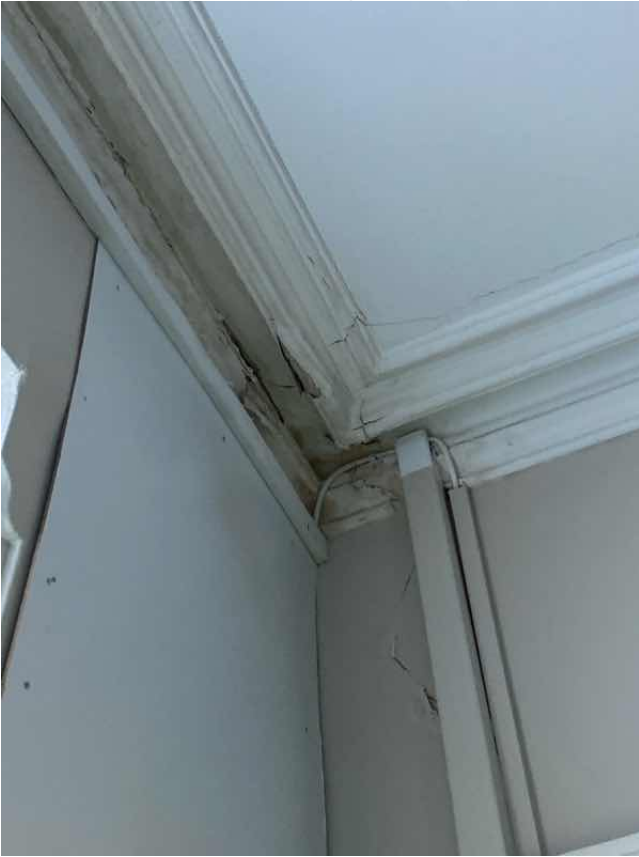
3

Signs of damp ingress at the edge of ceiling.

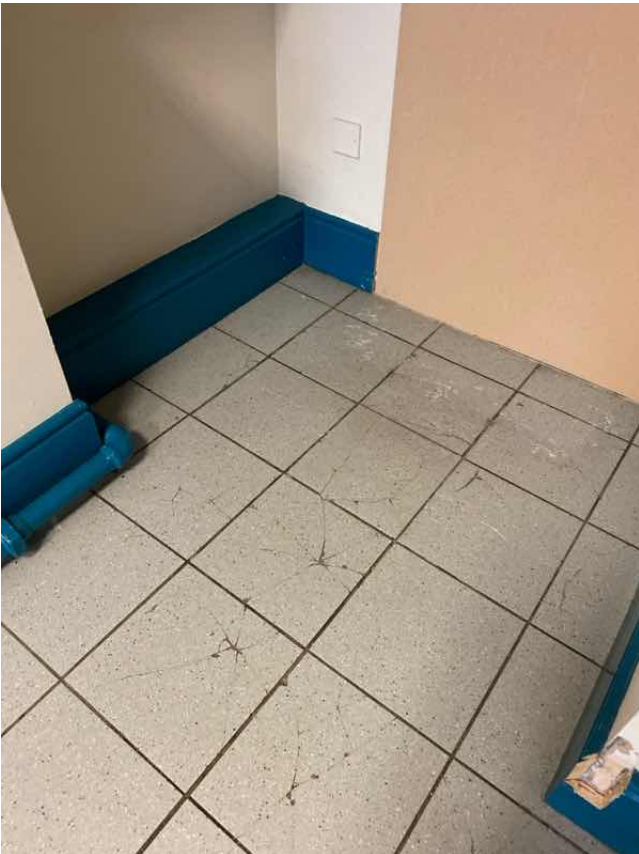
4

There are few hairline cracks in tiles

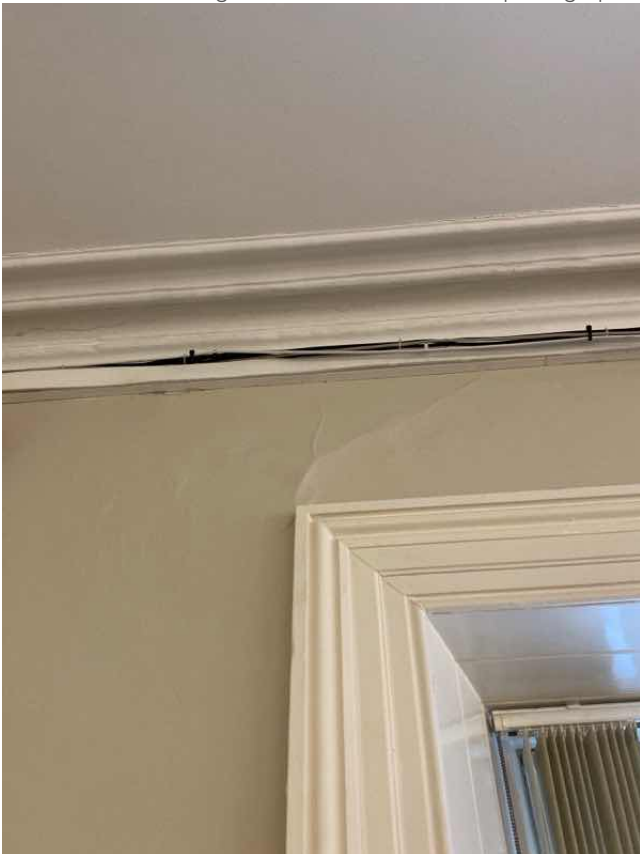
6

Evidence of cracking to the head of window. Opening up will be required to confirm the condition of the existing lintels

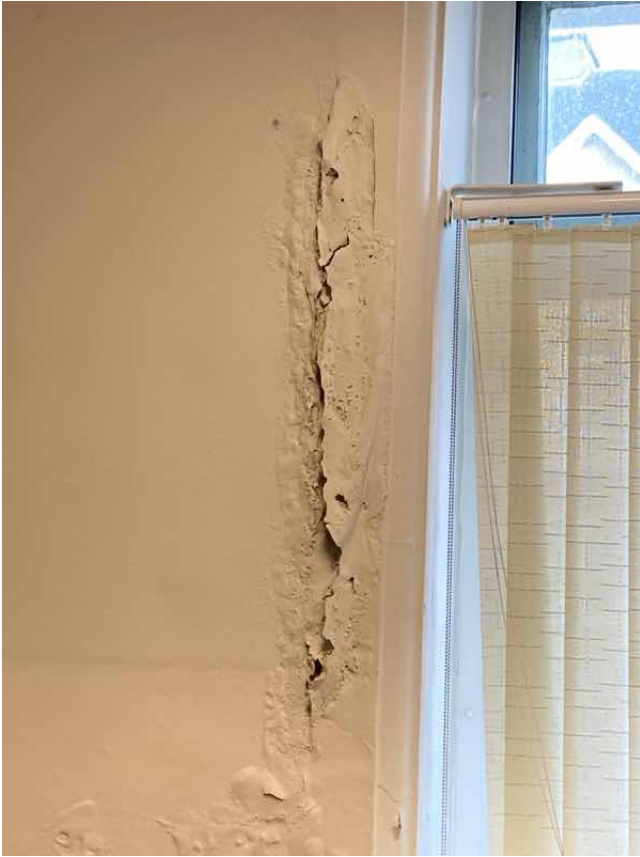
7

Damp ingress through out the sides of window

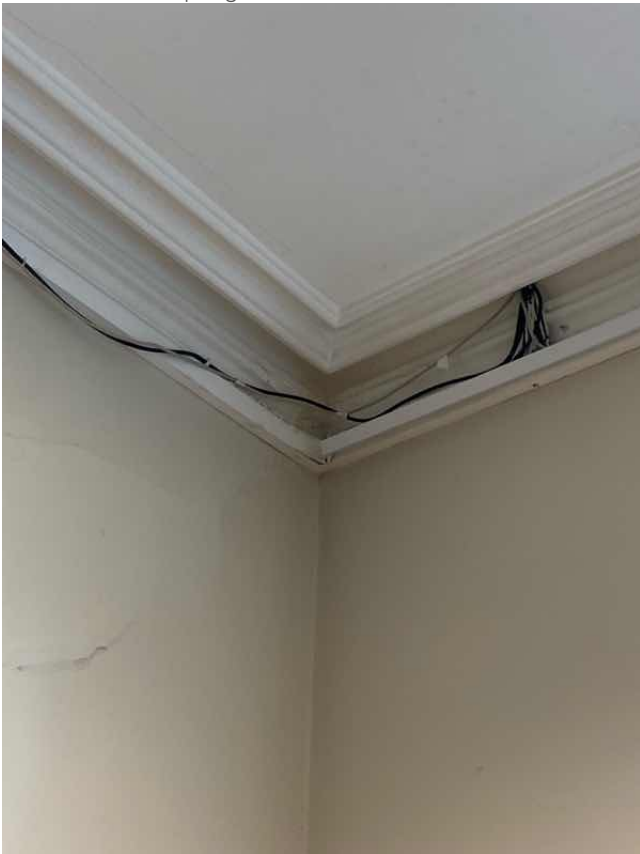
8

Evidence of damp ingress at the corner

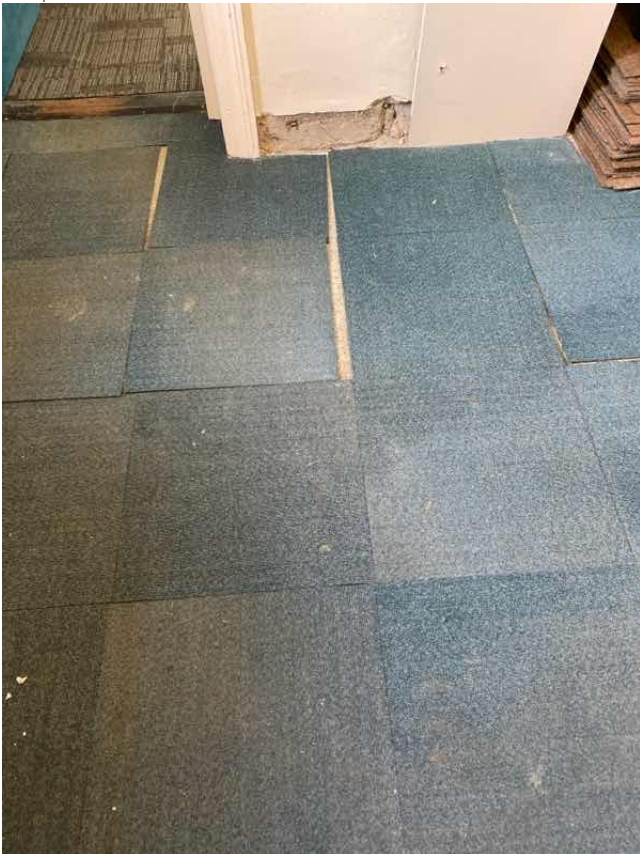
10

Carpet tiles on concrete floors

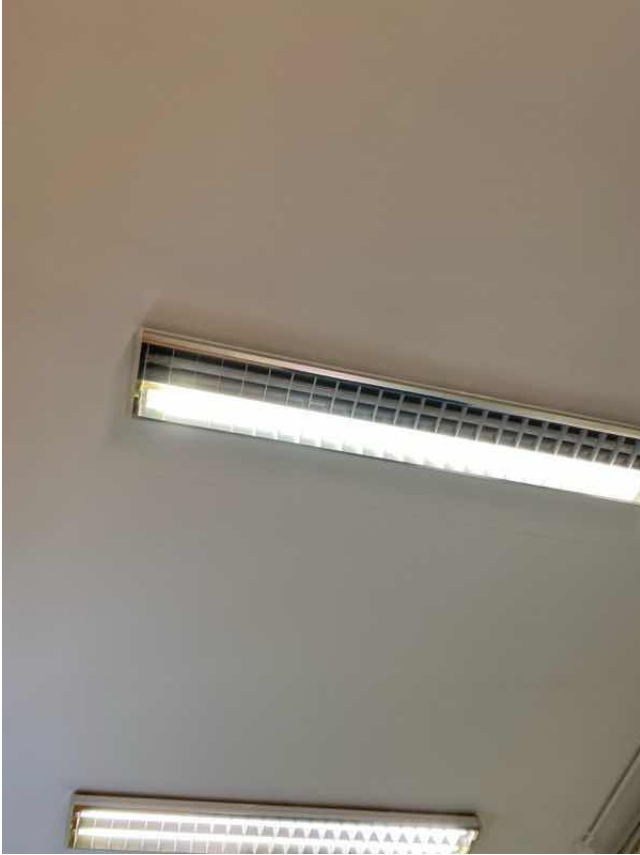
12

Ceiling generally in good condition, hairline cracks observed at the centre of ceiling

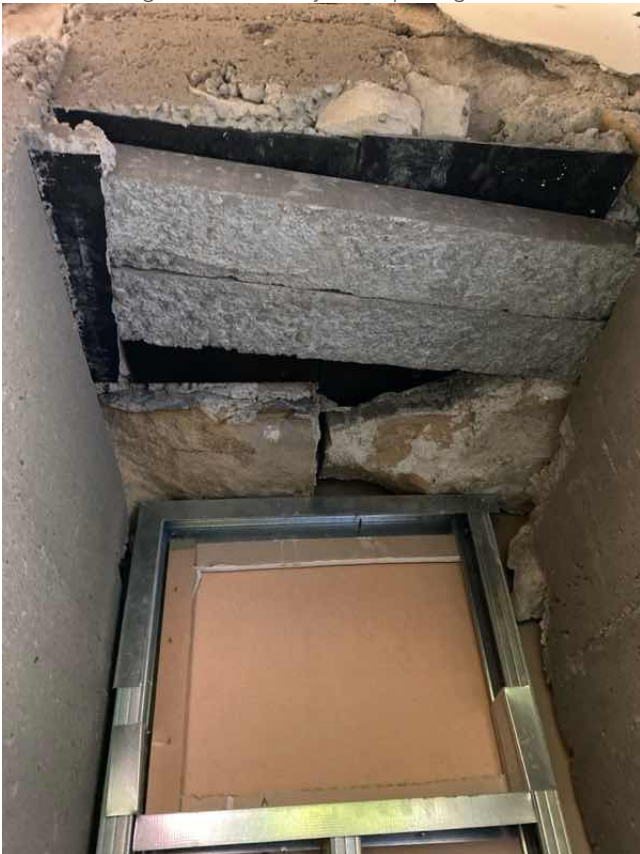
13

Lintel missing under masonry wall opening

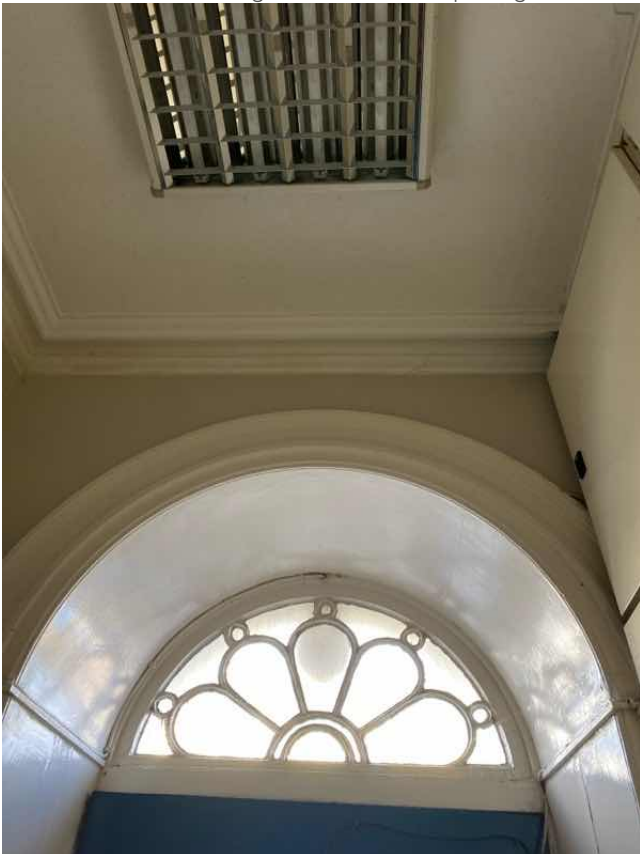
15

No evidence of cracking above the arch opening of the front door

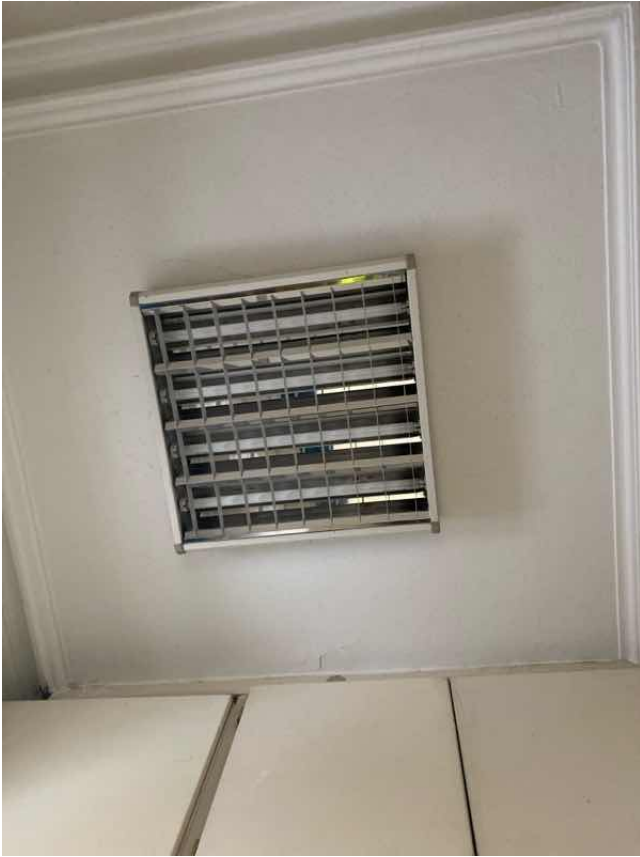
16

Ceiling appears in satisfactory condition

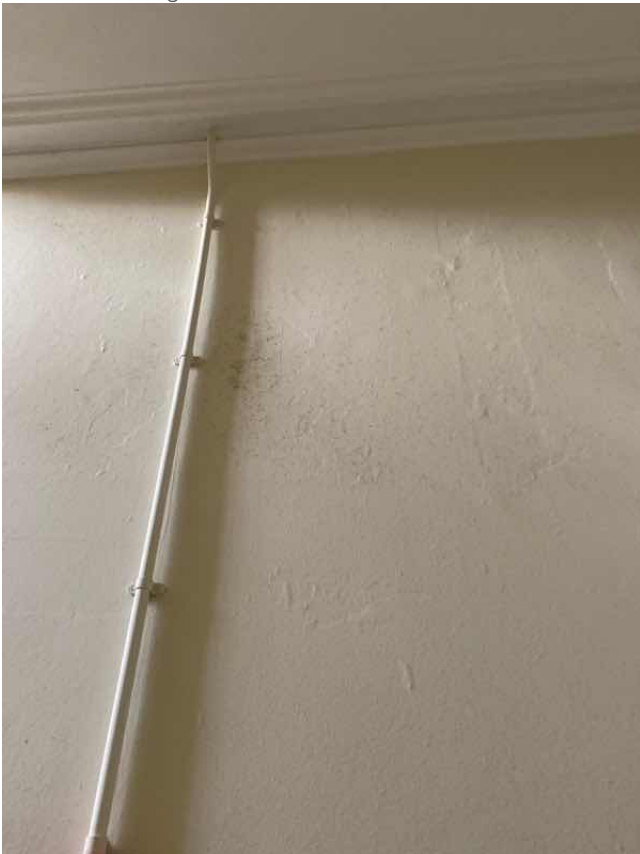
17

Surface mould growth on walls

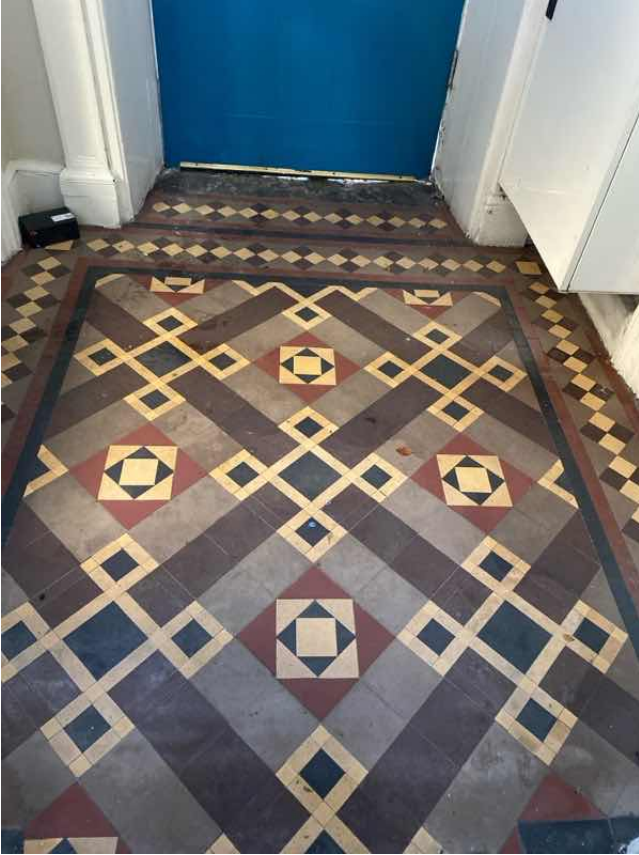
18

Tiled flooring on presumed concrete ground bearing slab in reasonable condition

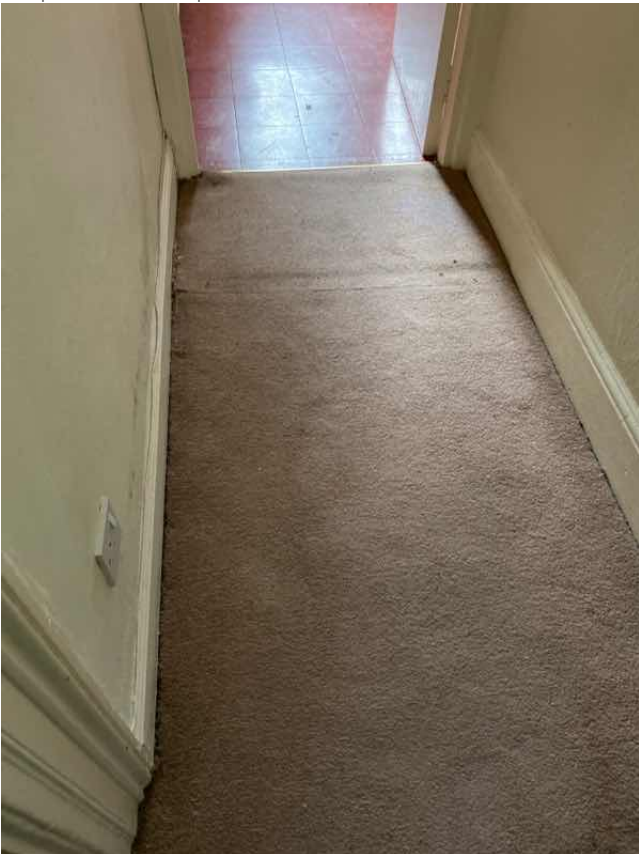
19

Carpeted floor on presumed concrete slab

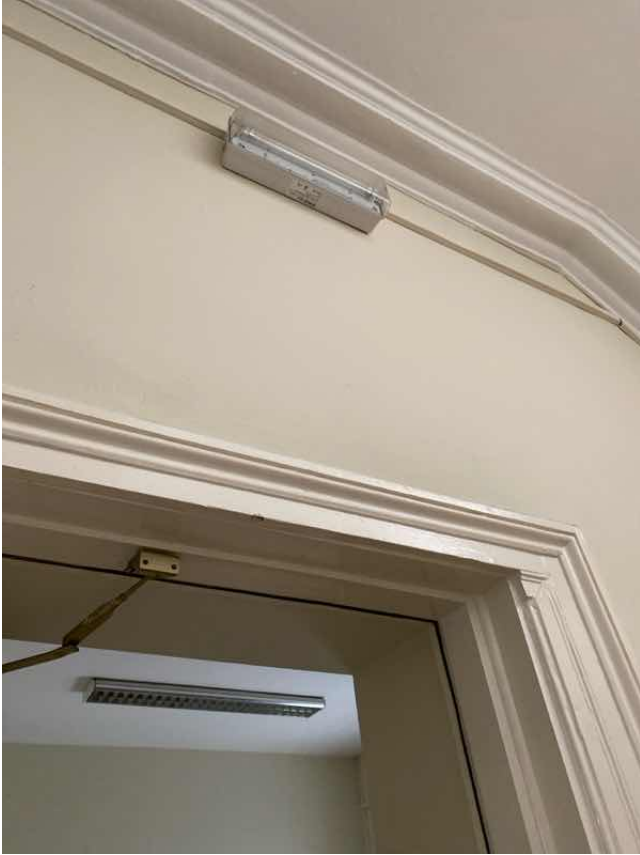
20

Evidence of cracking to the head of door. Opening up will be required to confirm the condition of the existing lintels

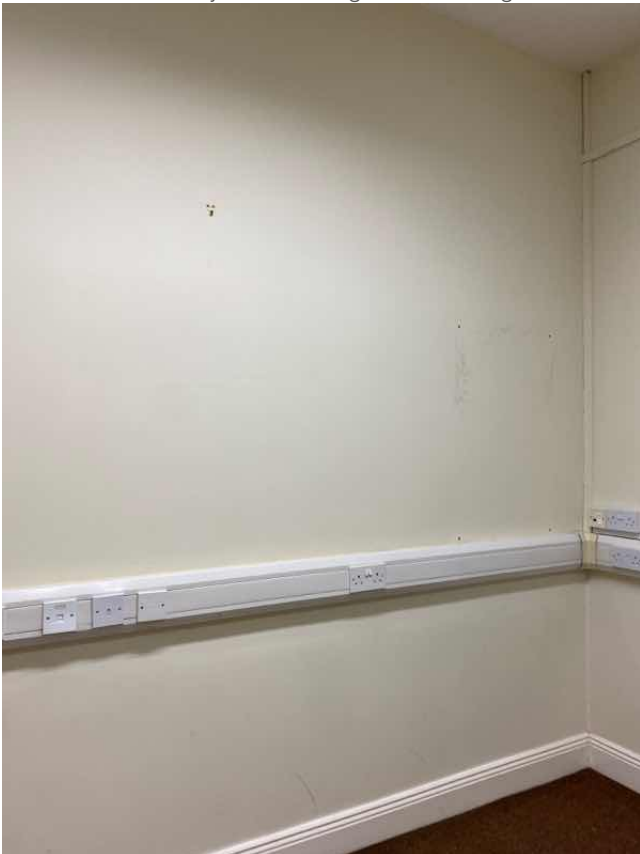
21

Walls have been dry lined. No signs of cracking.

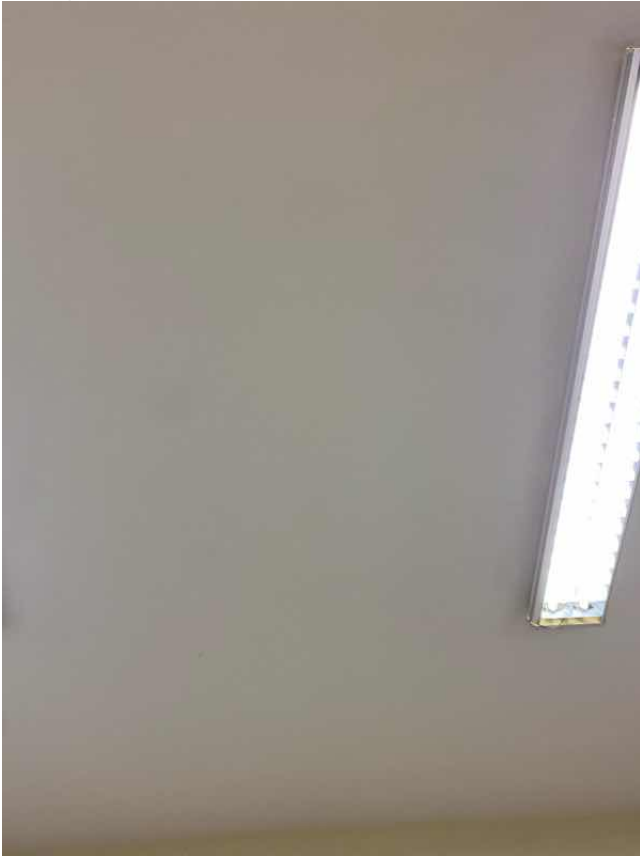
22

Ceiling in satisfactory condition.

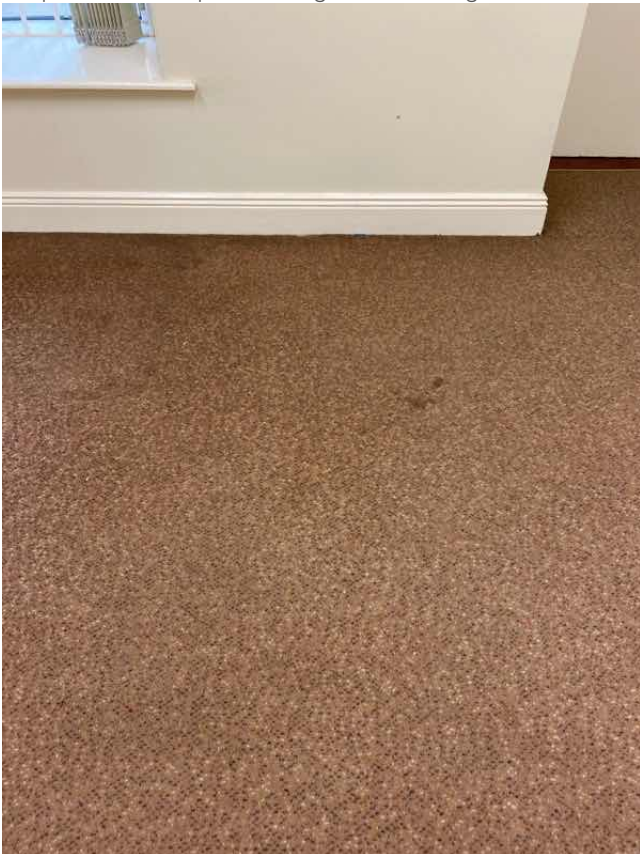
23

Carpeted floor on presumed ground bearing slab

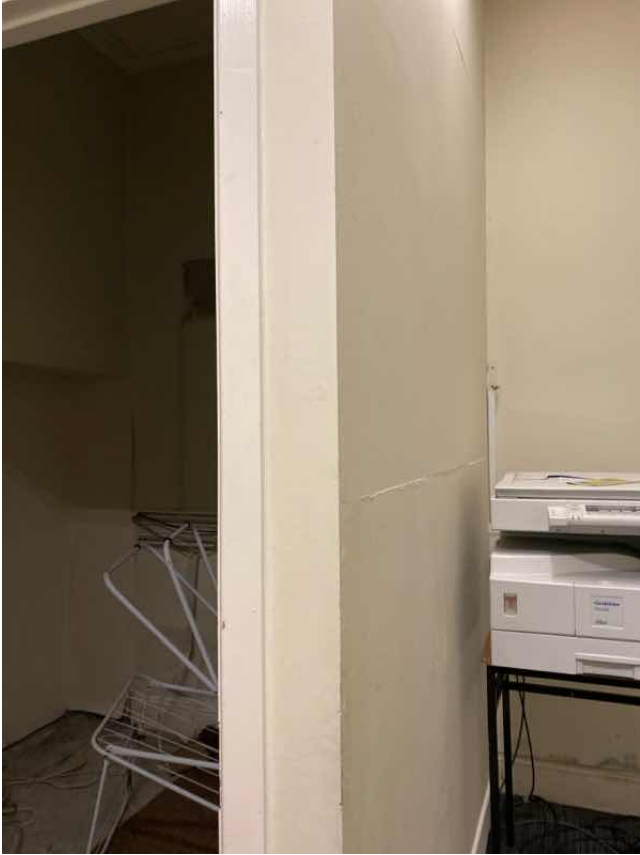
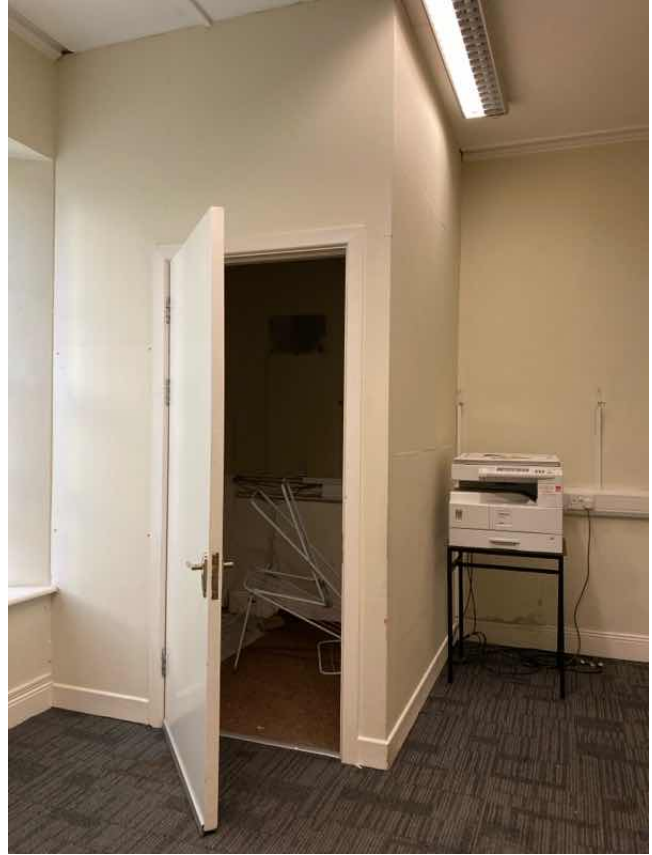
24

Non load bearing stud wall forms the storage room within room.

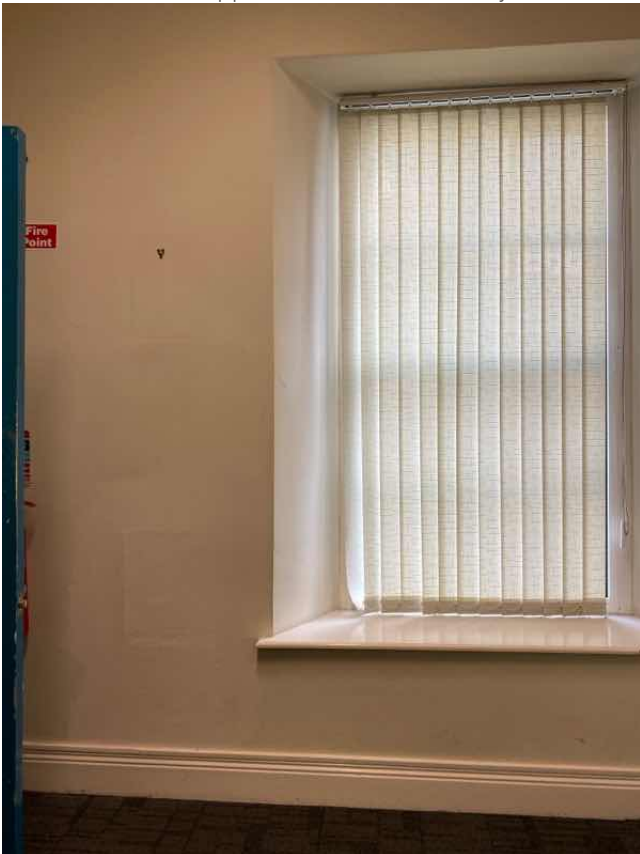
25

Front external wall appears to be in satisfactory condition.

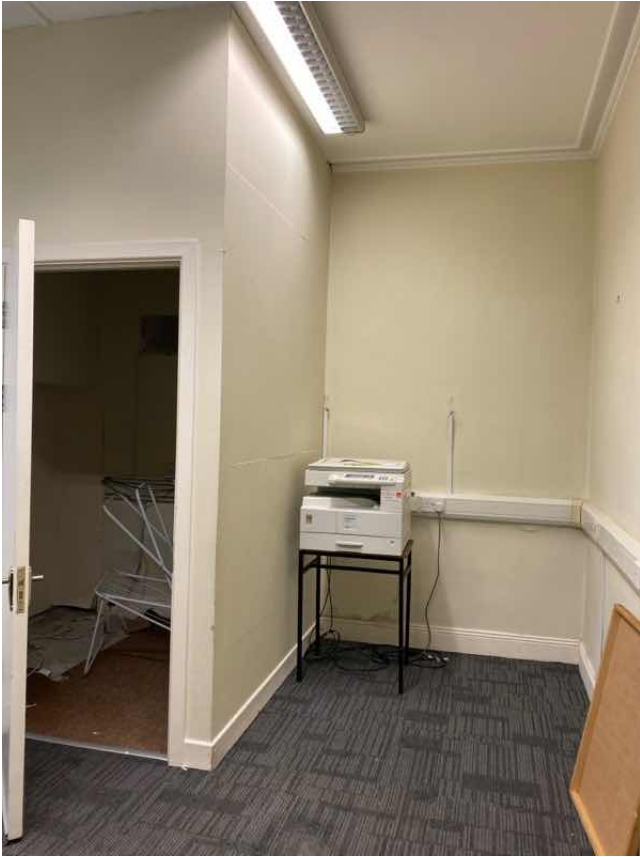
26

Party wall has been dry lined

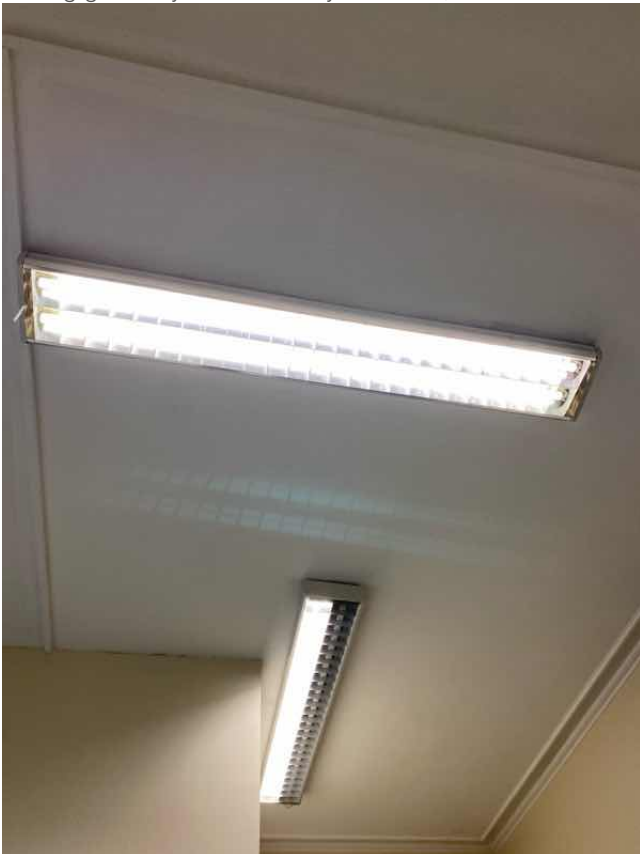
27

Ceiling generally in satisfactory condition, a few hair line cracks observed.

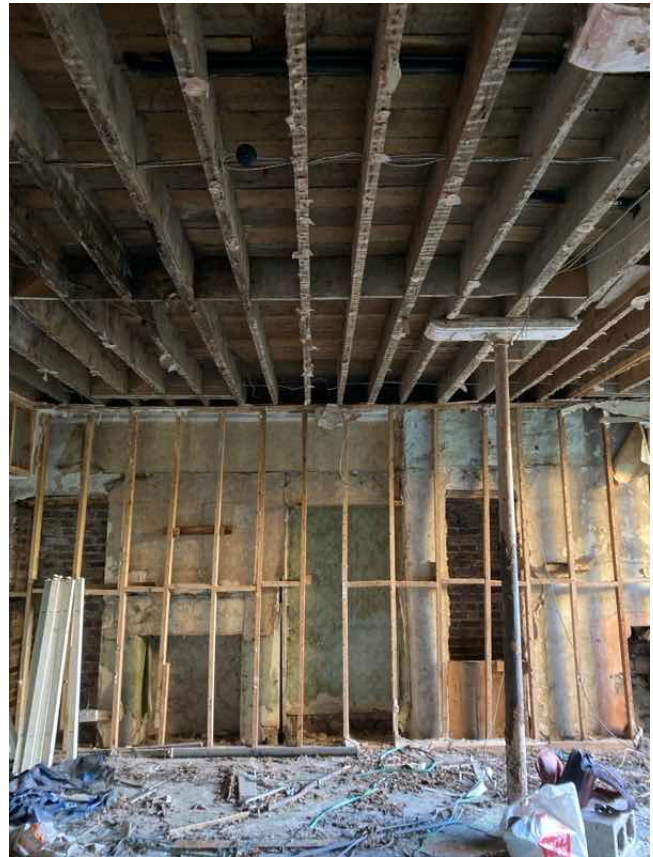
73

Floor Joist are 250x50 @ 300 centres.

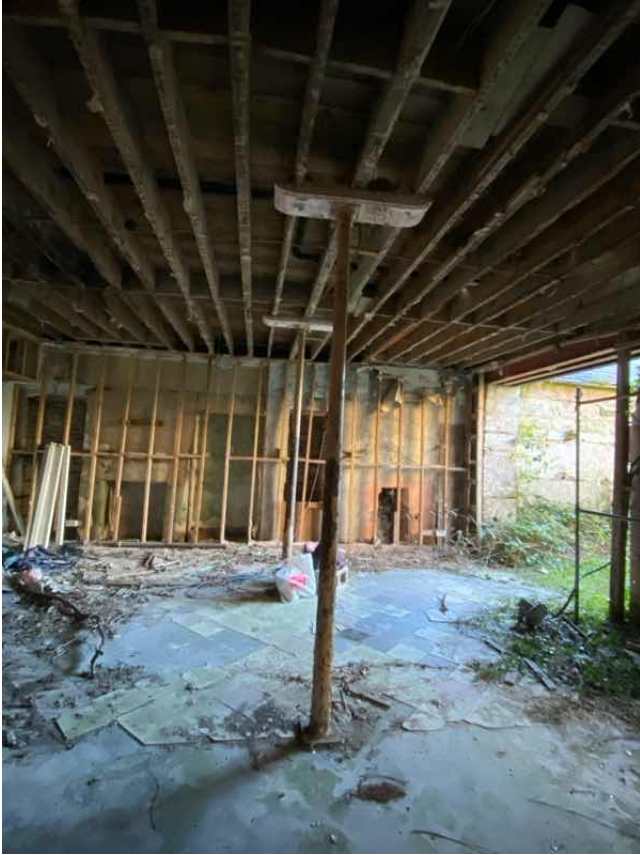
74

100mm diameter tapered cast iron columns (2 number) propping floor in middle of span.

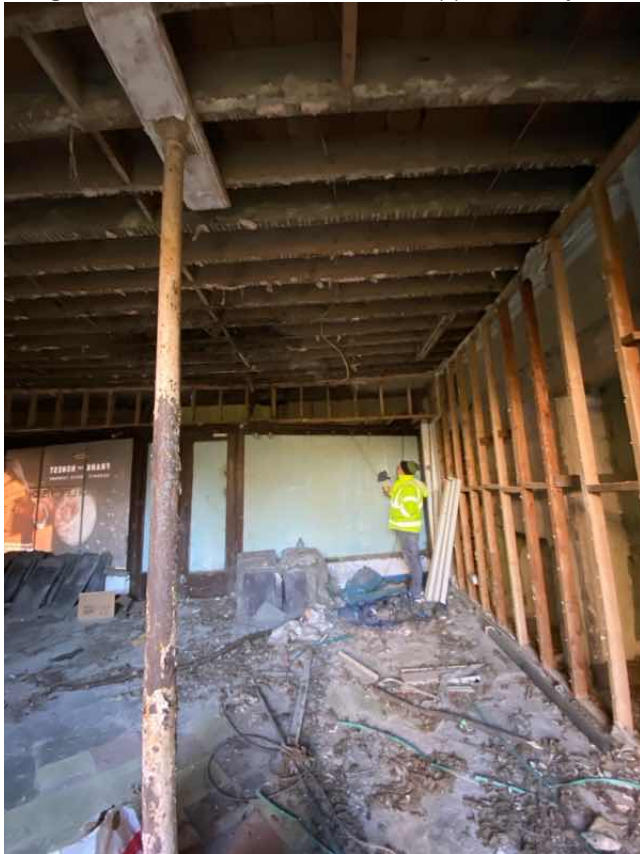
76

Timber beam used to form head of shop front. Bearing ends of beam to be checked for deterioration. Timber beams supported using two number cast iron columns at approximately one third points on span.

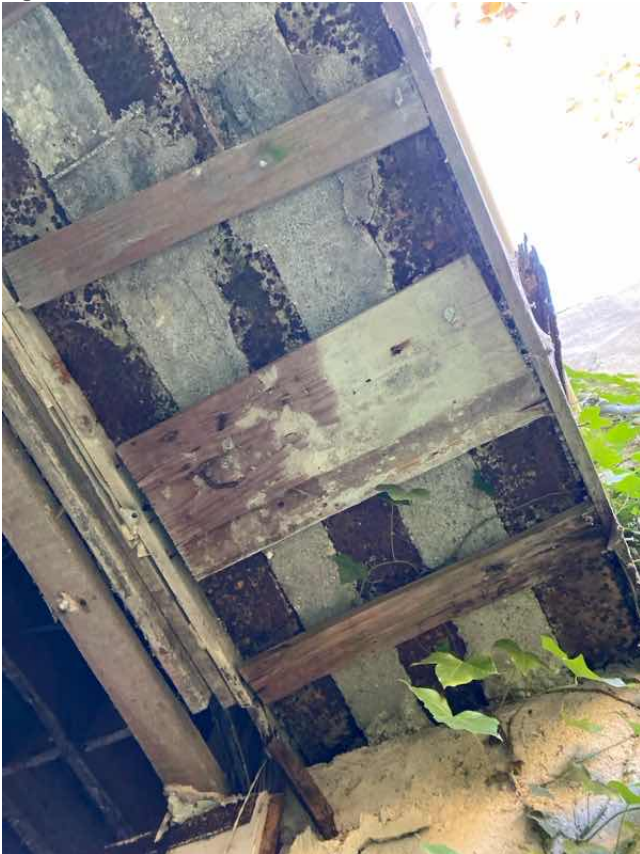
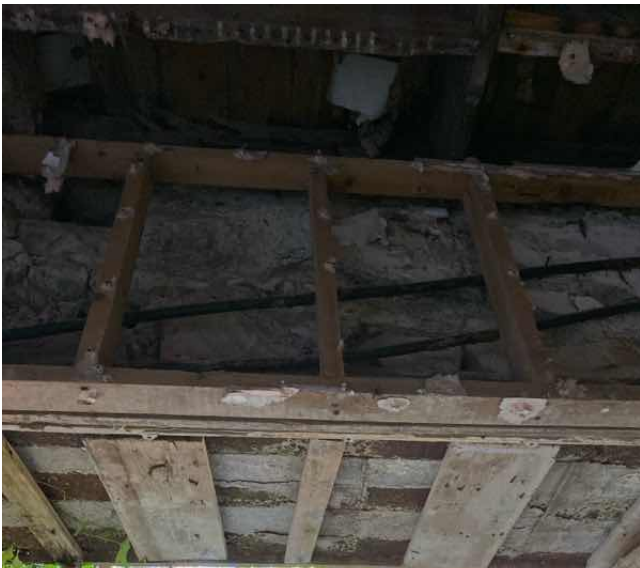
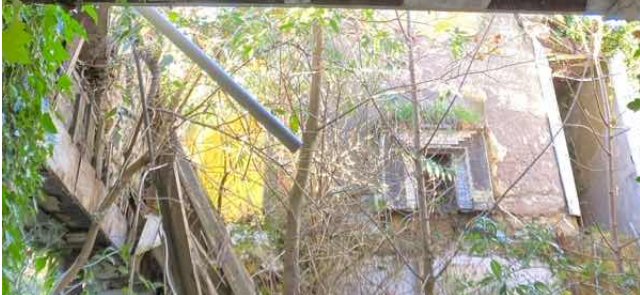
78

3 number steel beams are used to form the head of opening. Further opening required to confirm the condition of the lintel as significant amount of corrosion evident to underside of steel beams.

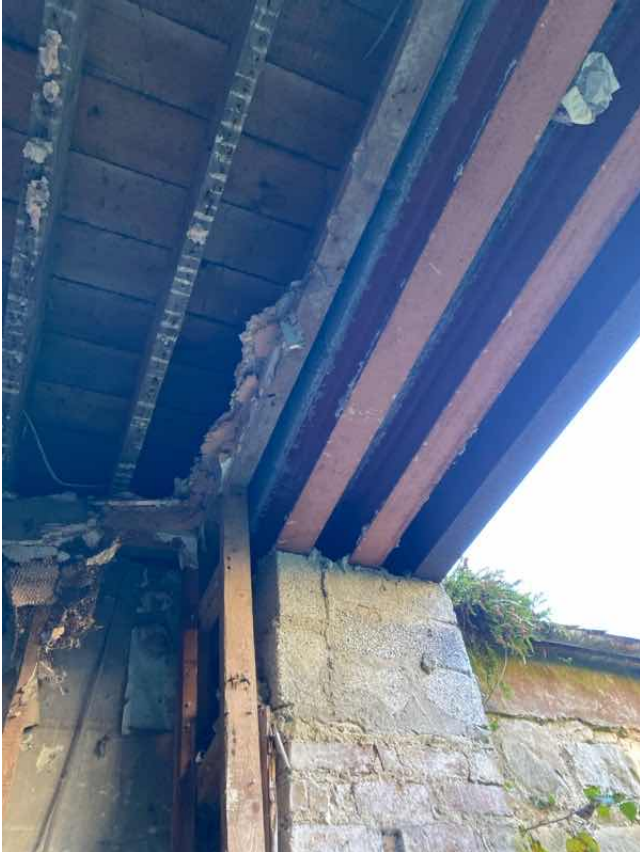
79

Steel beams 225x115 wide, appear to be in good condition apart from some surface rust. No concrete bearing pads where steel bears onto masonry.

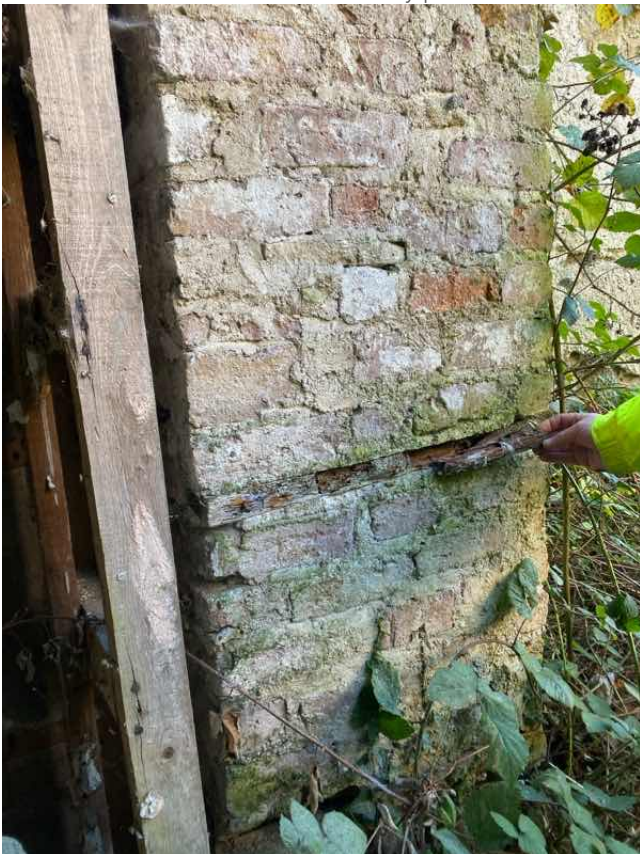
80

Rotten timber embedded into masonry pier.

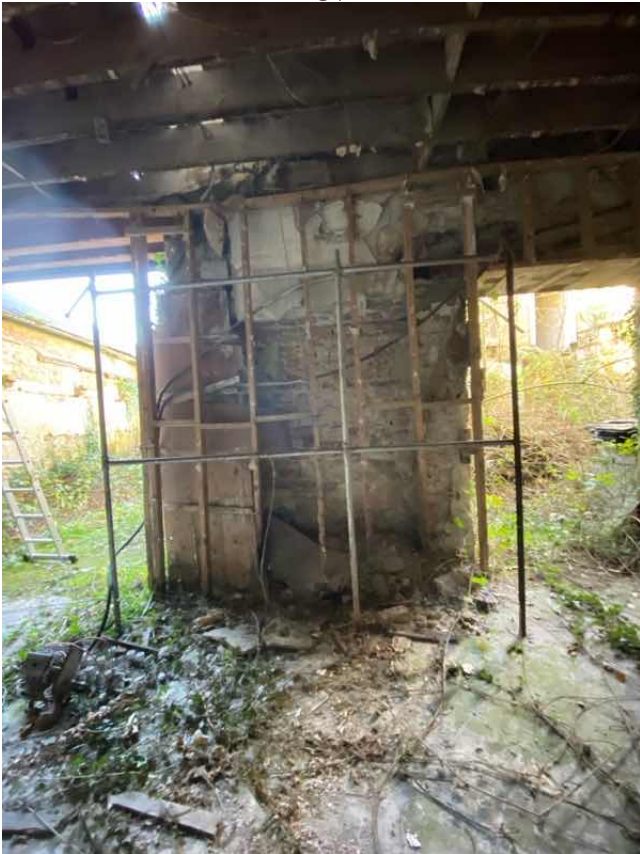
**81** Middle masonry pier on back wall has opening in middle of same (most likely an original window that has been bricked up). This weakens the load bearing pier, so we would be recommending to build up the opening to strengthen the pier.

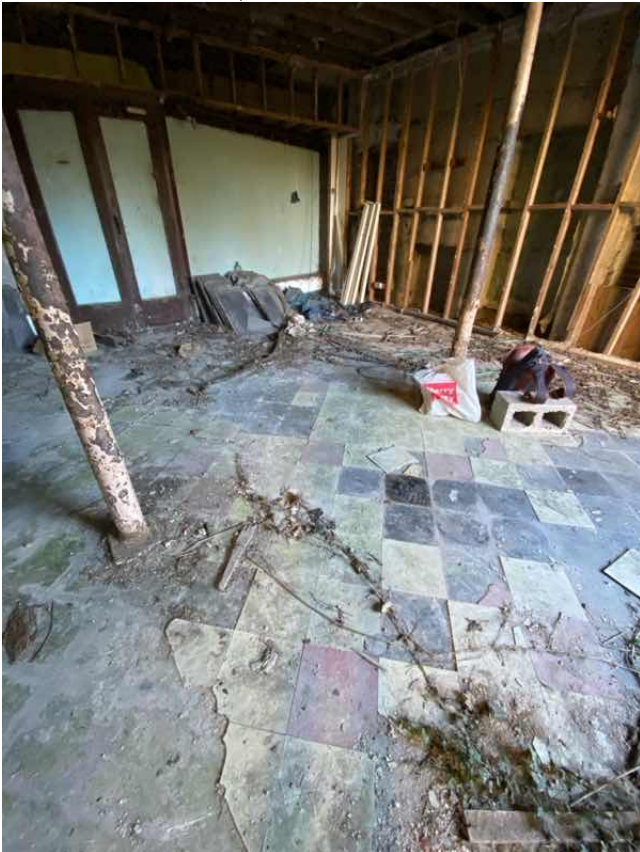
**82** Concrete floor slab in place. Unclear if DPM and insulation exist under the same. Opening up required to verify this.

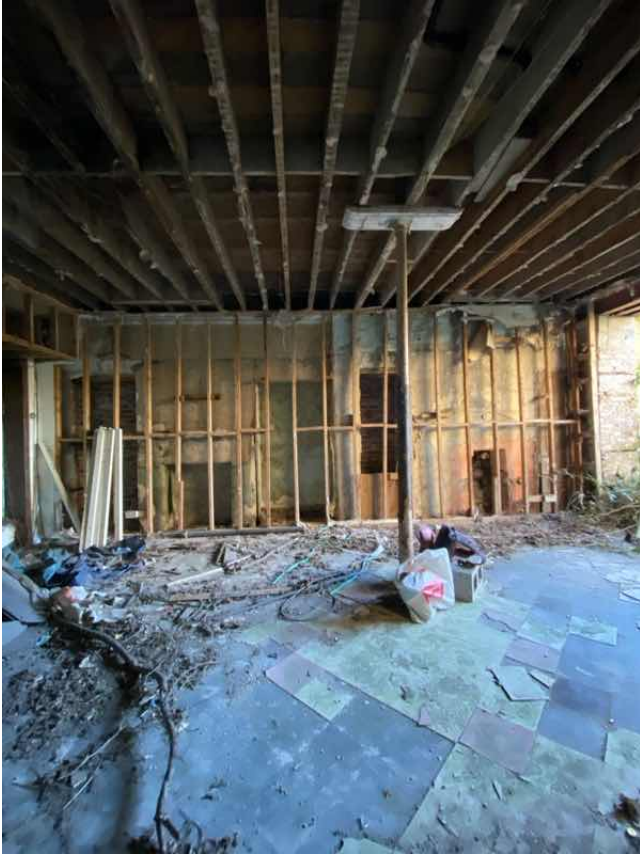
83

Disused fireplace with flue, a number of recesses in masonry with timber lintels over same. All timber lintels to be opened up to inspect the condition of same.

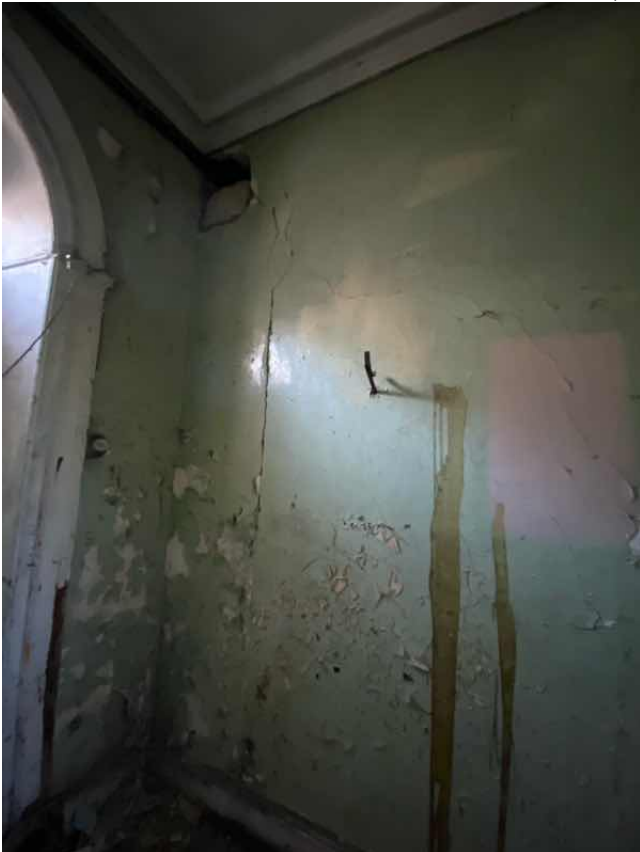
84

Vertical crack in wall coincides with location of blocked up door.

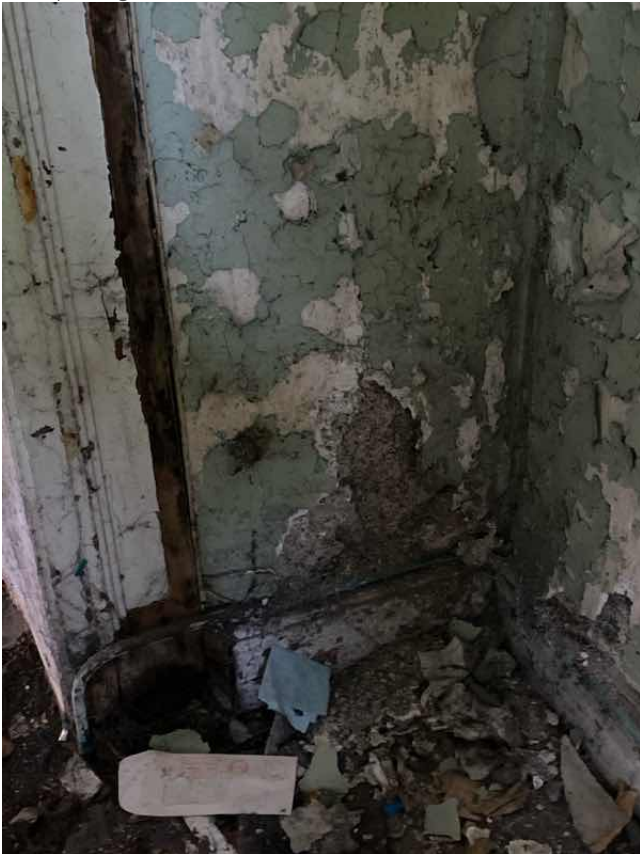
85

Evidence of rising dampness in masonry either side of front door. Plaster coming away and evidence of rotten timber liners to the opening.

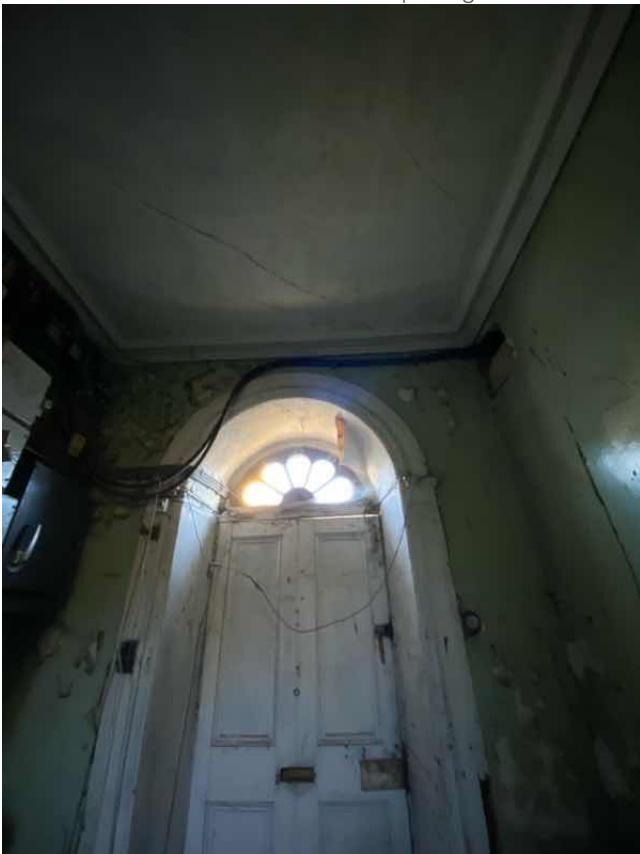
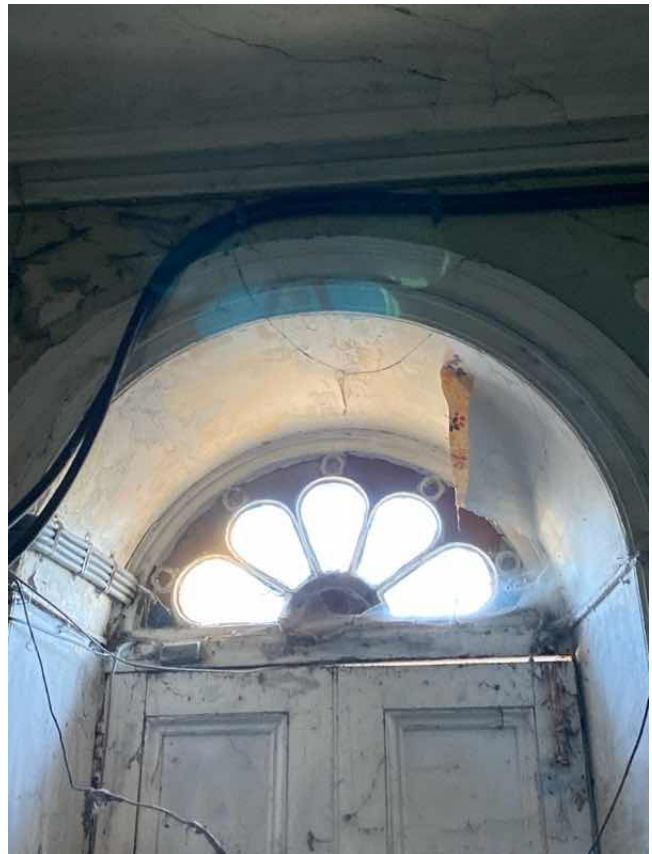
86

Plastered brick arch over front door opening is intact and in reasonable condition.

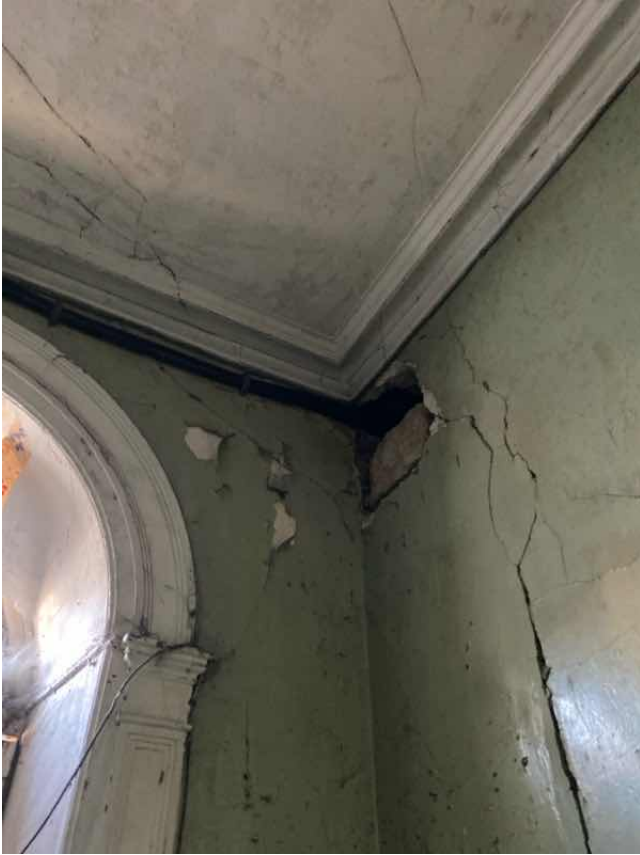
87

Diagonal crack to top right hand side of front door opening. This crack appears to have been as a result of opening formed in internal wall for electrical cables.

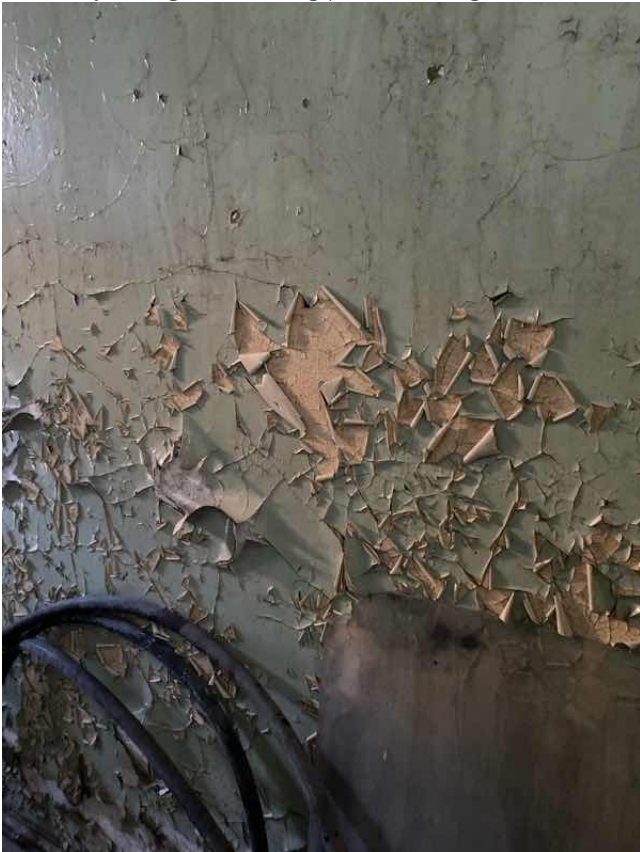
88

Generally throughout building paint is flaking off walls, more than likely due to old age rather than damp ingress.
