## **Drumshanbo Town Centre Regeneration**

# **Structural Assessment Survey and Site Investigation Report**

**for former Bank of Ireland Building, Early's Building  
and Adjacent Derelict Building, Drumshanbo, Co  
Leitrim**

**December 2023**

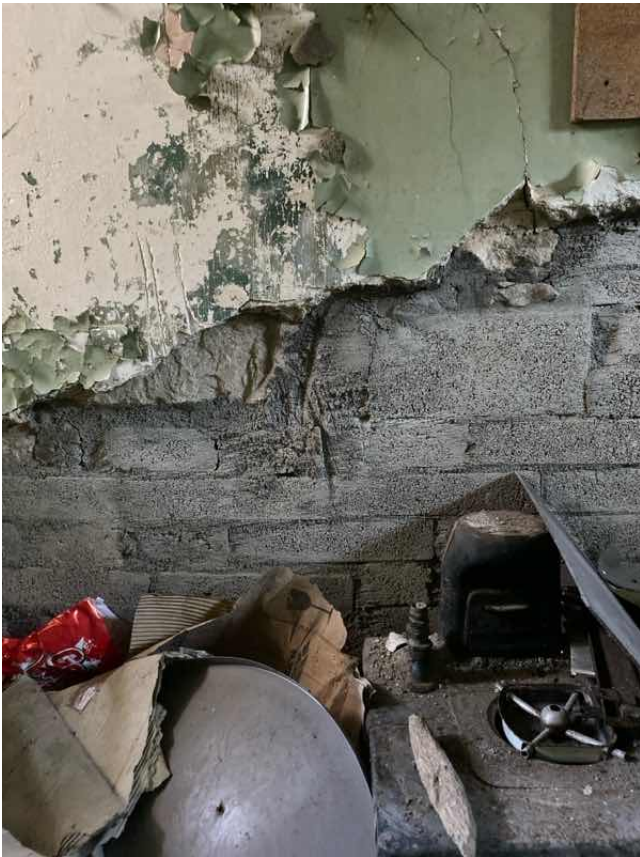
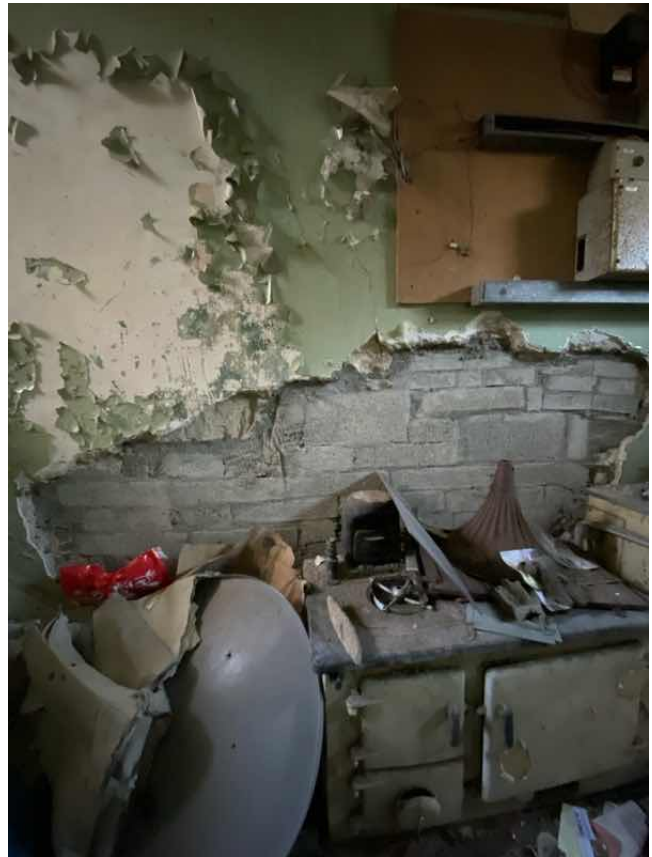
89

Exposed concrete blocks in this area may have been as a result of repair works required to party wall.

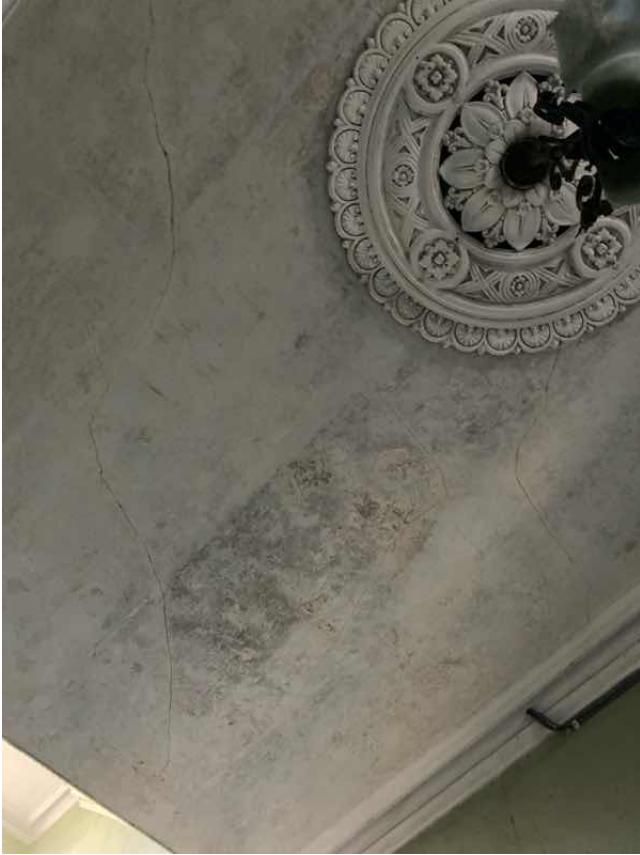
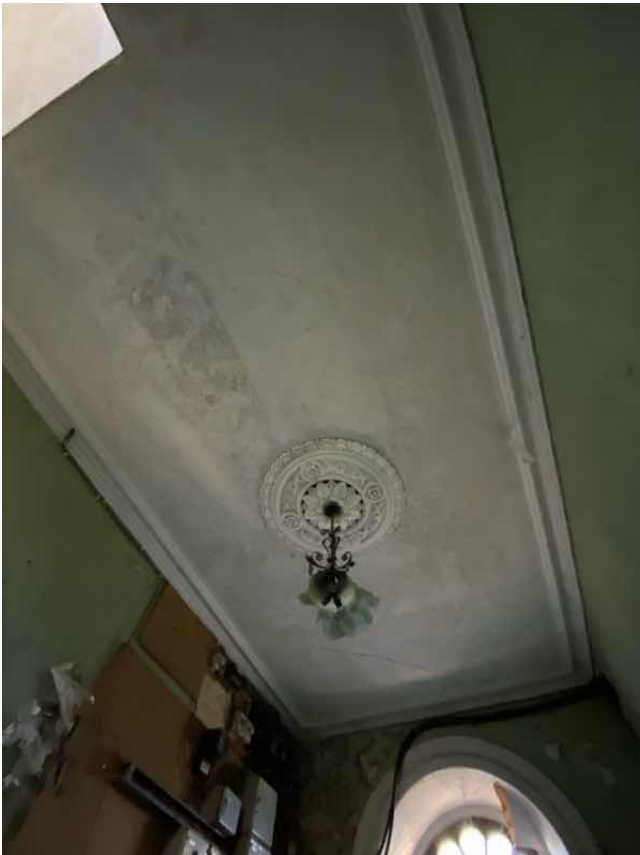
90

Number of cracks in existing ceiling and mould growth on ceiling surface due to the fact that building is opened to weather.

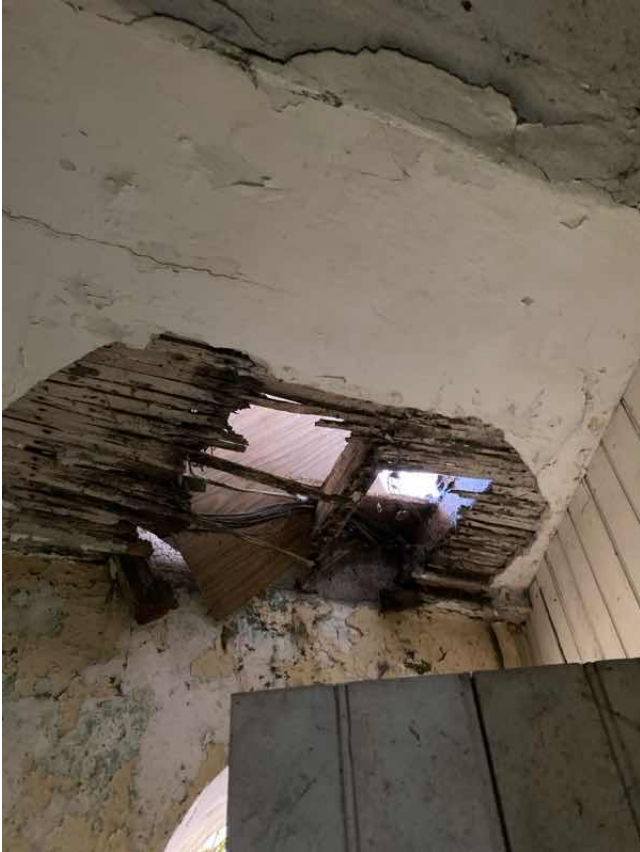
91

Lath and plastered ceiling/stairs landing to storage room under stairs has come away and timber joist supporting ceiling have badly deteriorated and at risk of collapse. Temporary propping required.

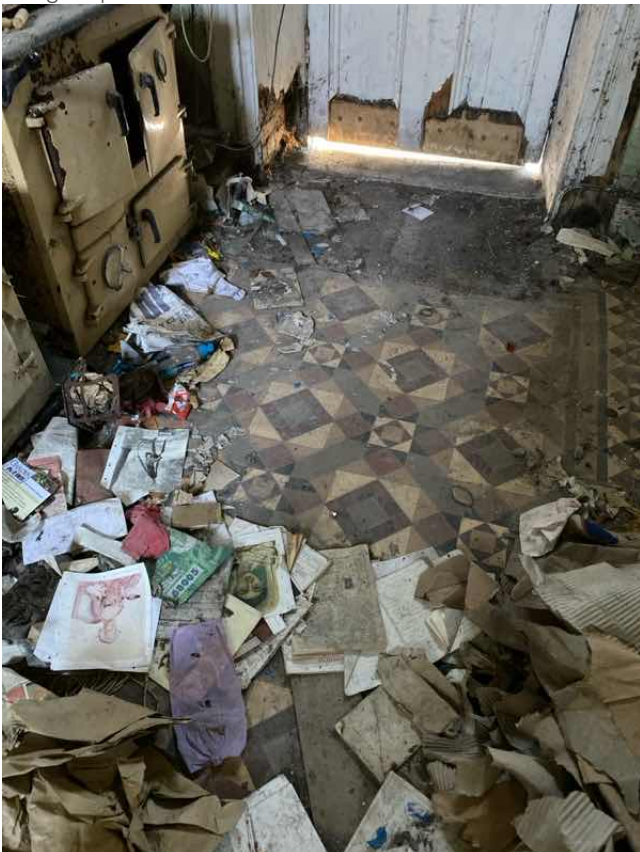
92

Tiling on presumed concrete floor

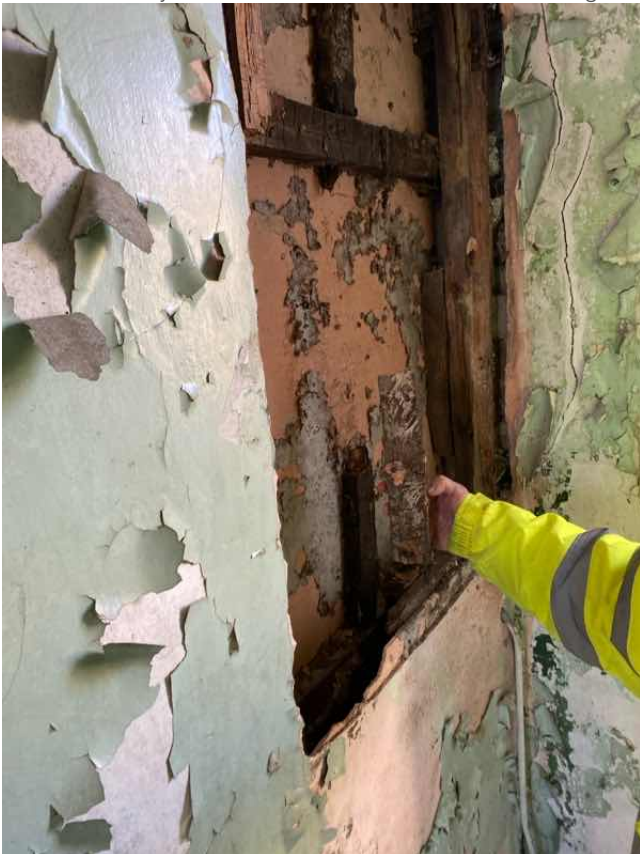
95

Evidence of dry rot of timber in stud wall at stair landing

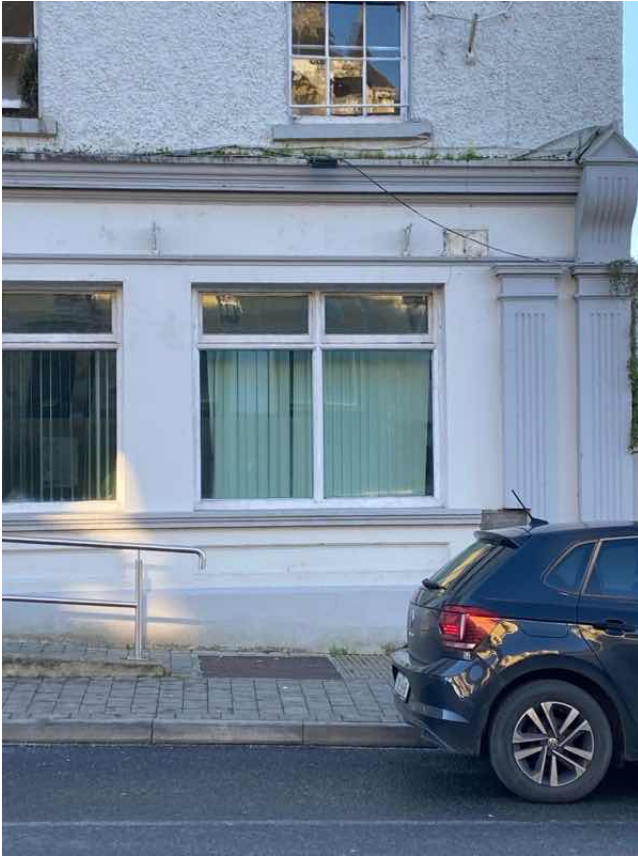
139

Fine cracks to top corners of window opening

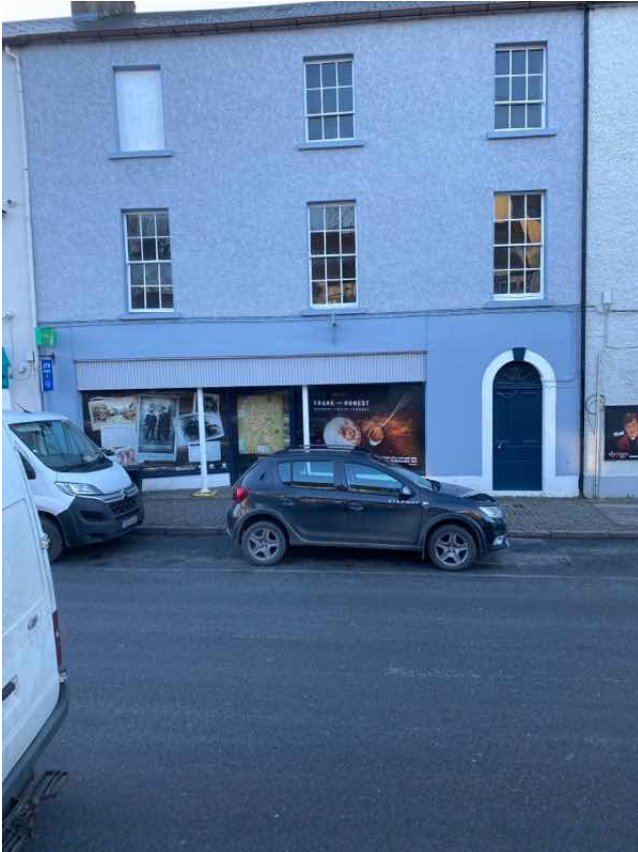
145

Cracking to ends of shopfront lintel could indicate defective end bearings

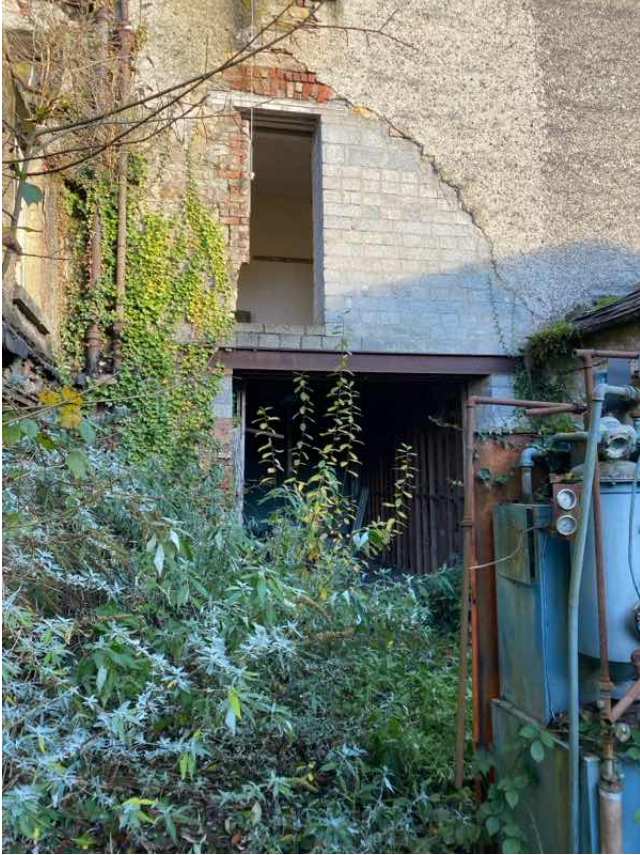
146

Steel beams form lintel over large opening with new blockwork over

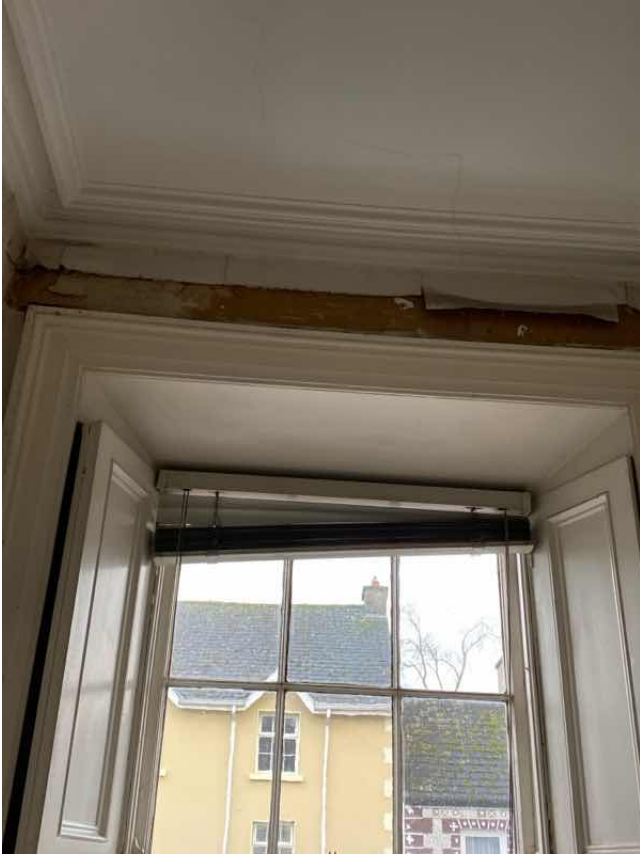
29

Wall Paper has fallen away locally at head of window which could be due to damp ingress

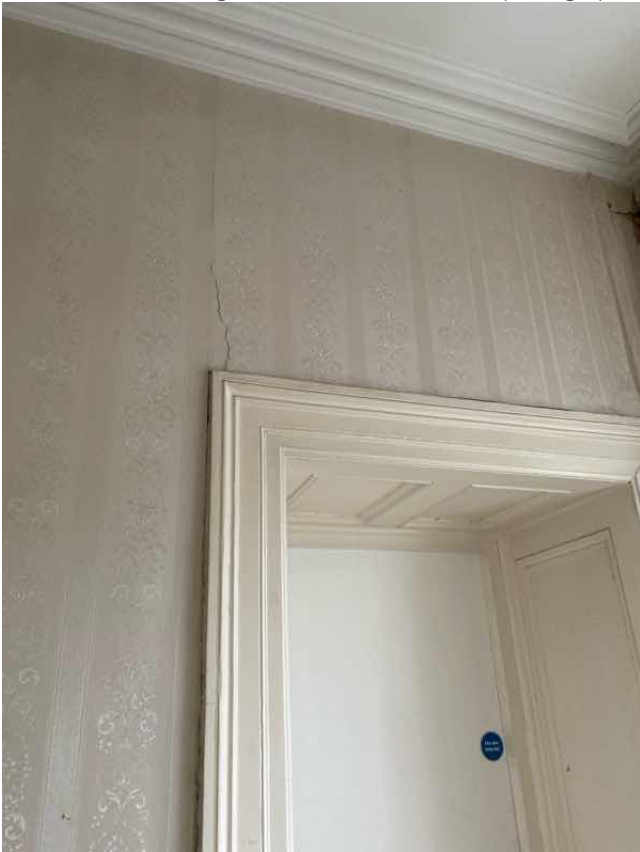
30

Evidence of cracking to the head of window. Opening up will be required to confirm the condition of the existing lintels

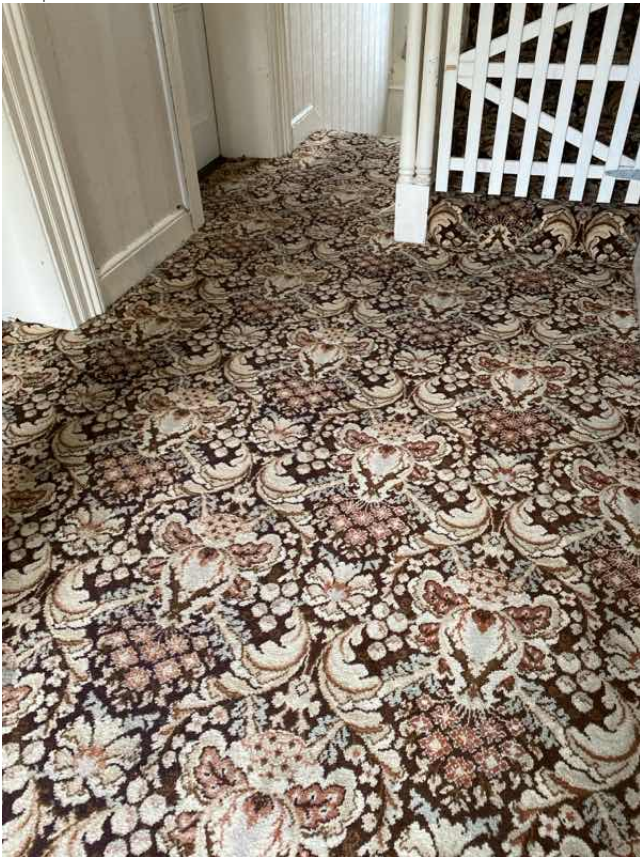
32

Carpeted timber floor feels solid to walk on

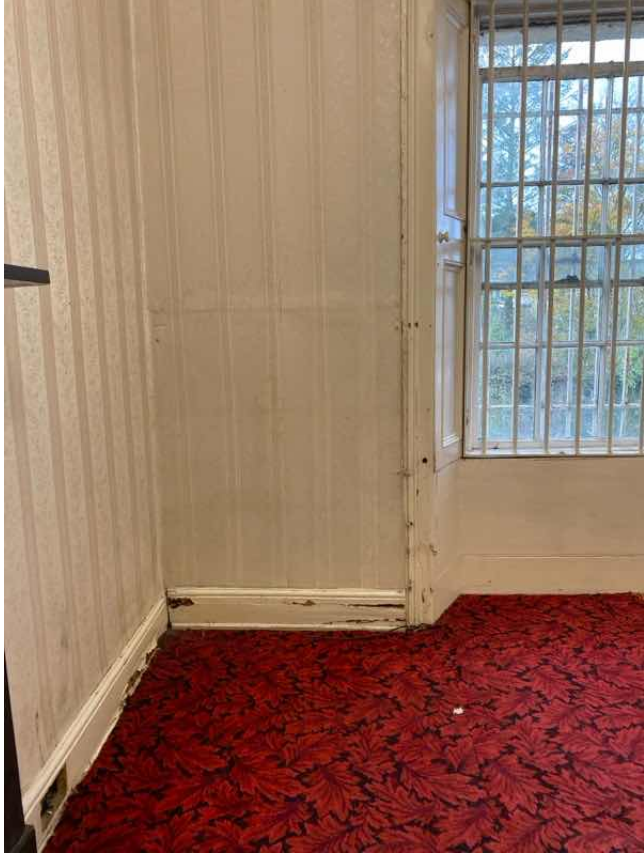
34

Rear external wall has been dry lined

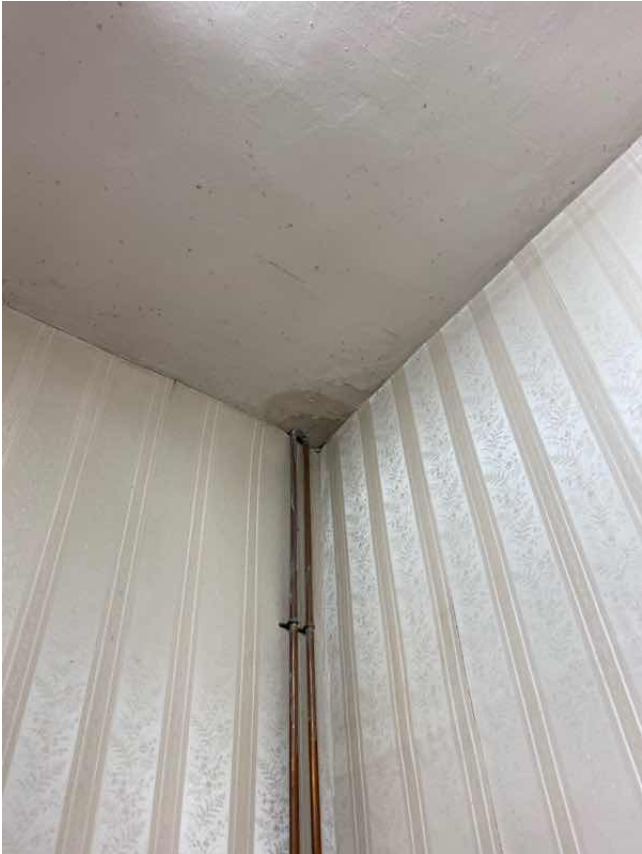
37

Cieling at the corner has been damaged where the pipes penetrates

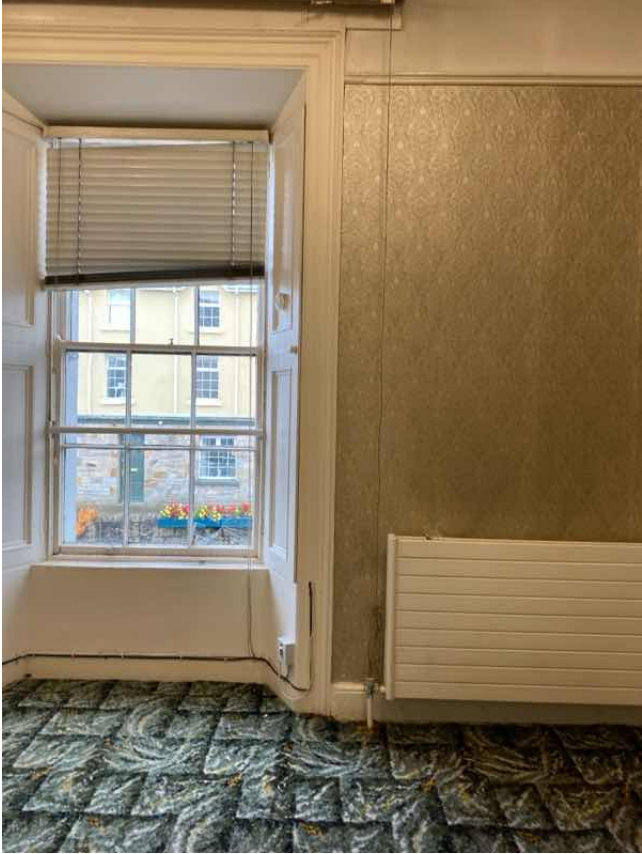
38

Front wall is dry lined

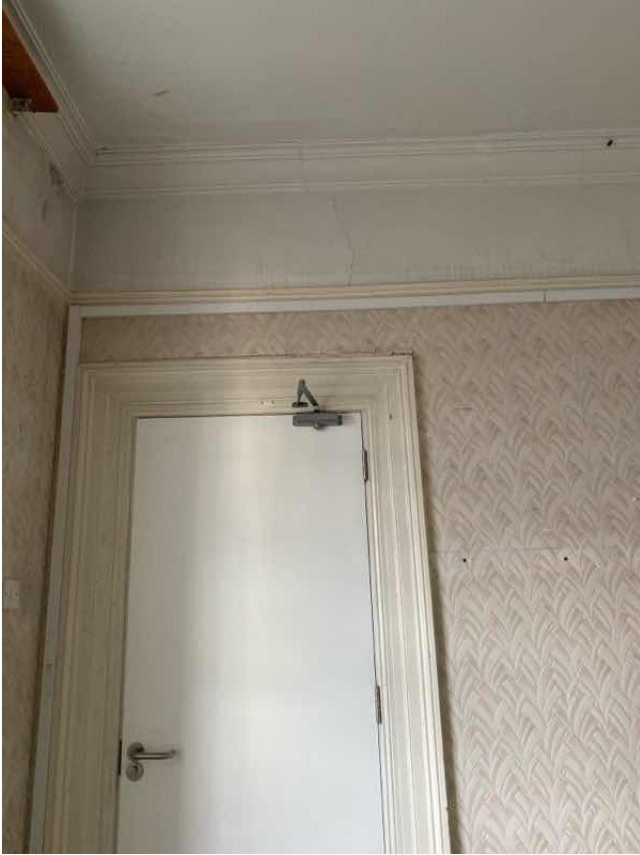
**41**

Evidence of cracking to the head of door. Opening up will be required to confirm the condition of the existing lintels

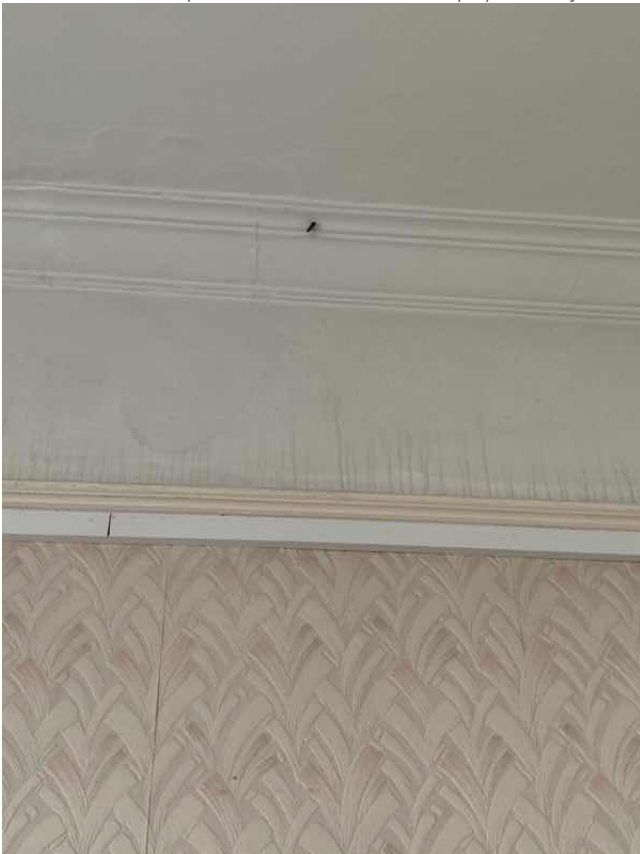
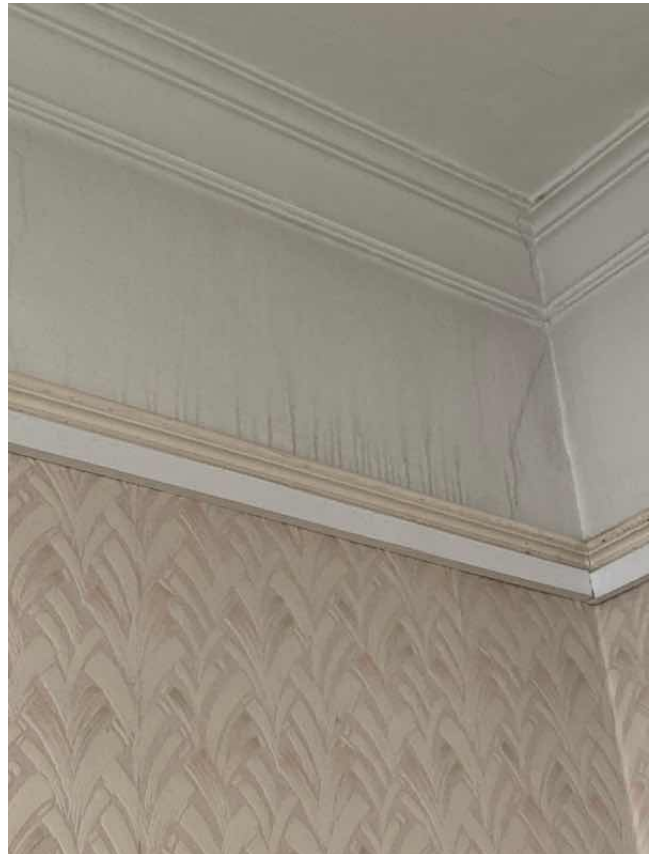
**42**

Black streaks on plastered wall above wallpaper likely from condensation

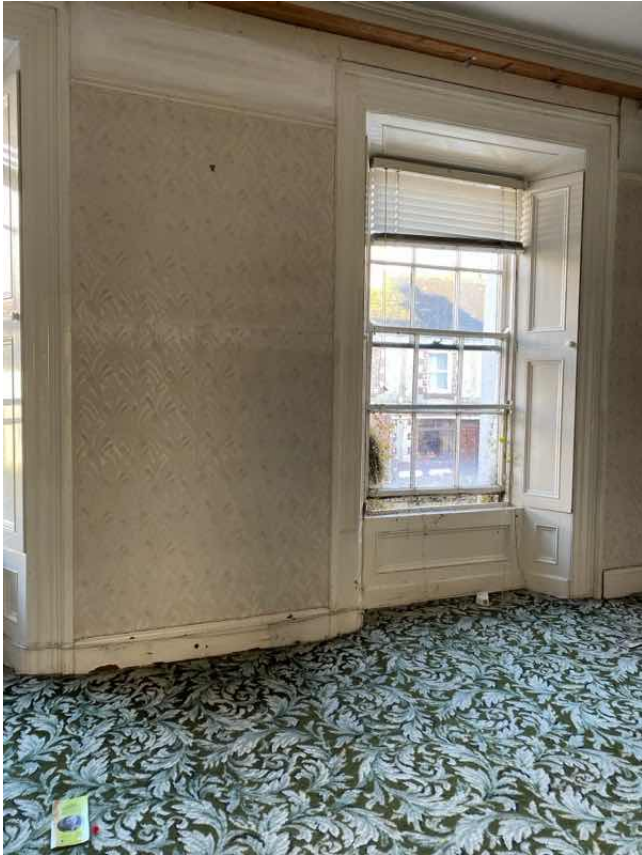
44

Timber linings around existing sash windows

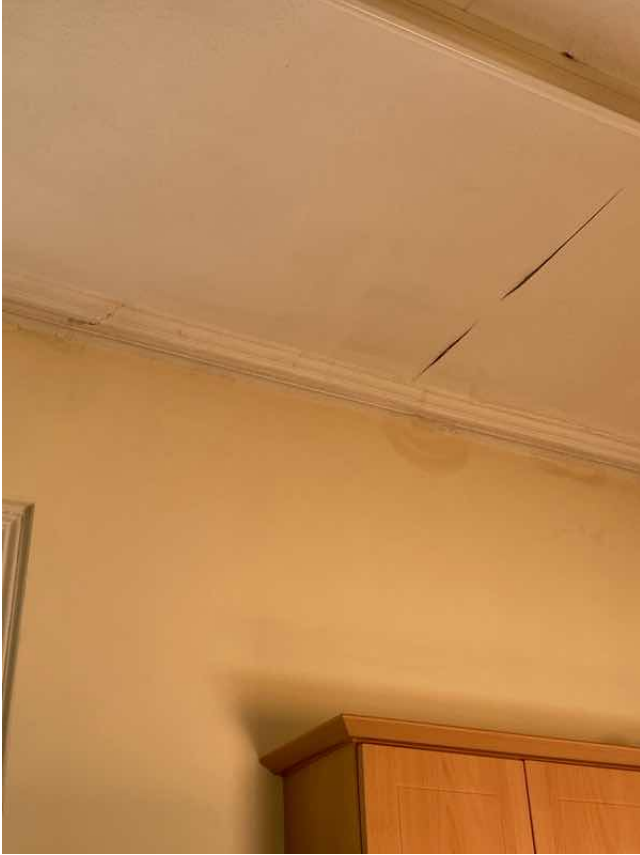
45

Damp ingress observed at interface between external wall and Ceiling.

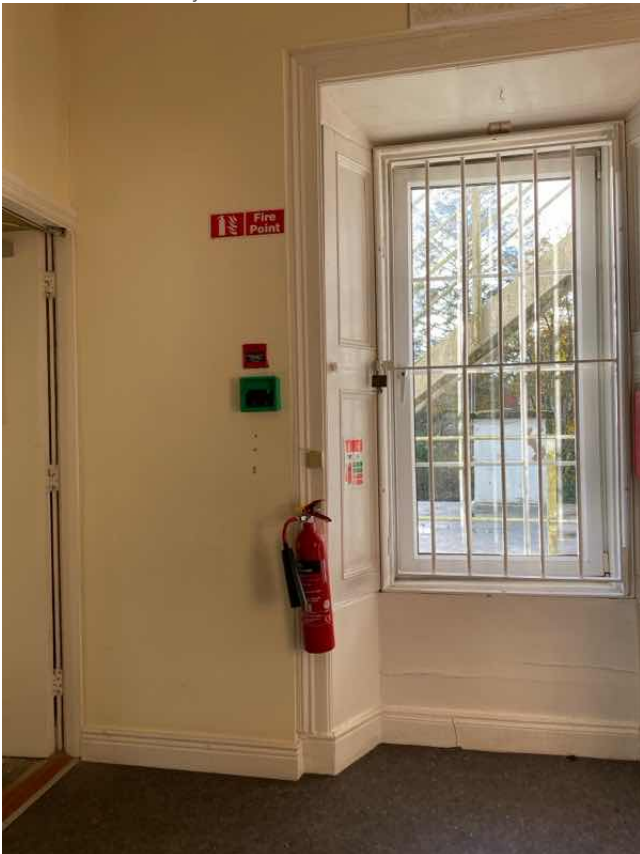
46

External wall is dry lined

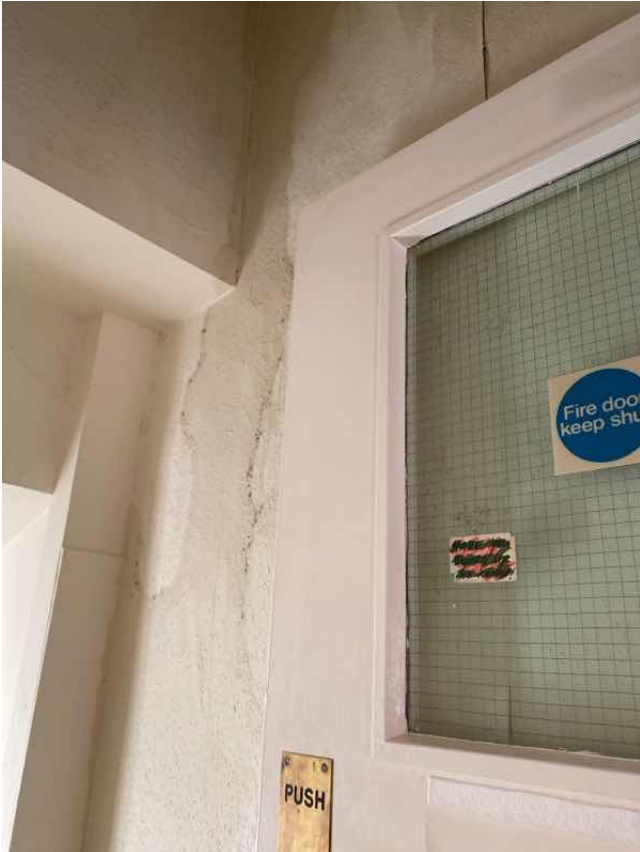
48

Significant ingress of water on rear external wall, wall damp to touch indicates an active leak

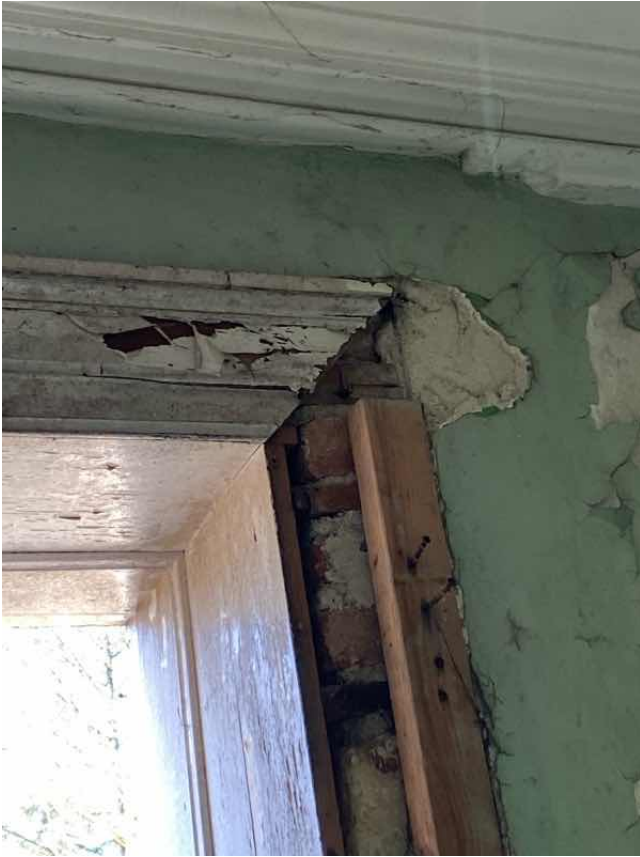
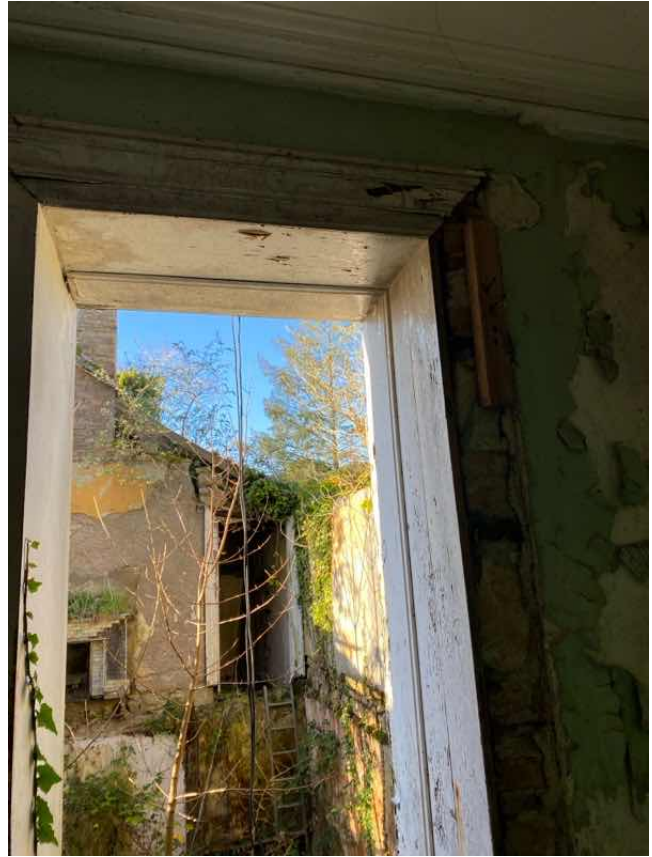
96

Timber lintel over opening to be opened up to inspect condition of same.

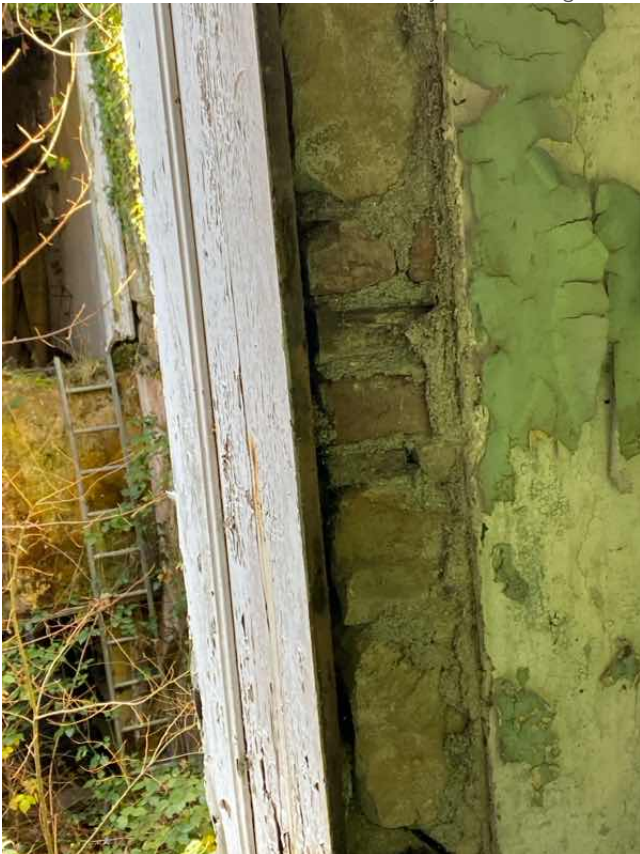
97

Defective embedded timbers in masonry walls throughout the property will need to be removed and gaps filled in with masonry.

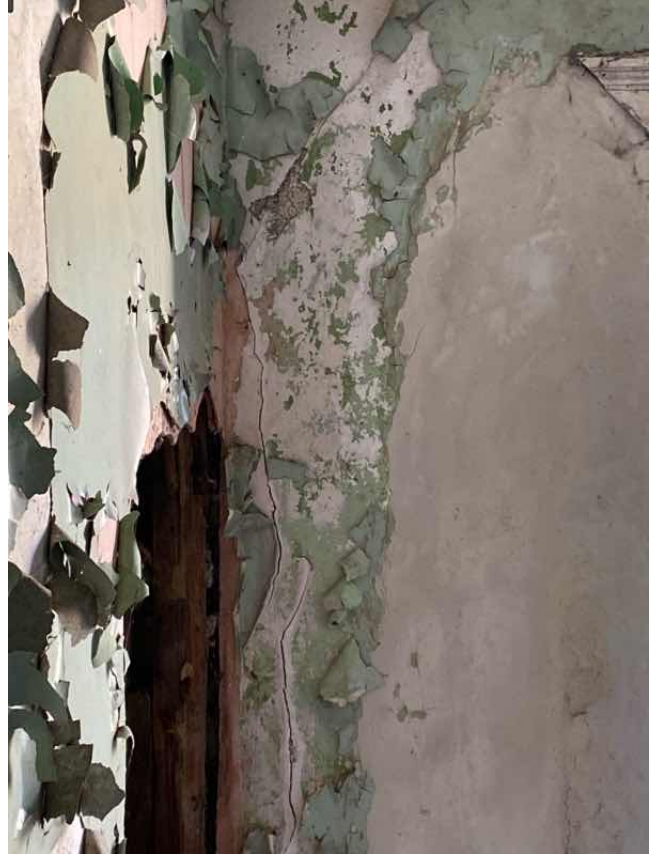
98

Evidence of significant damp ingress on wall adjacent to window

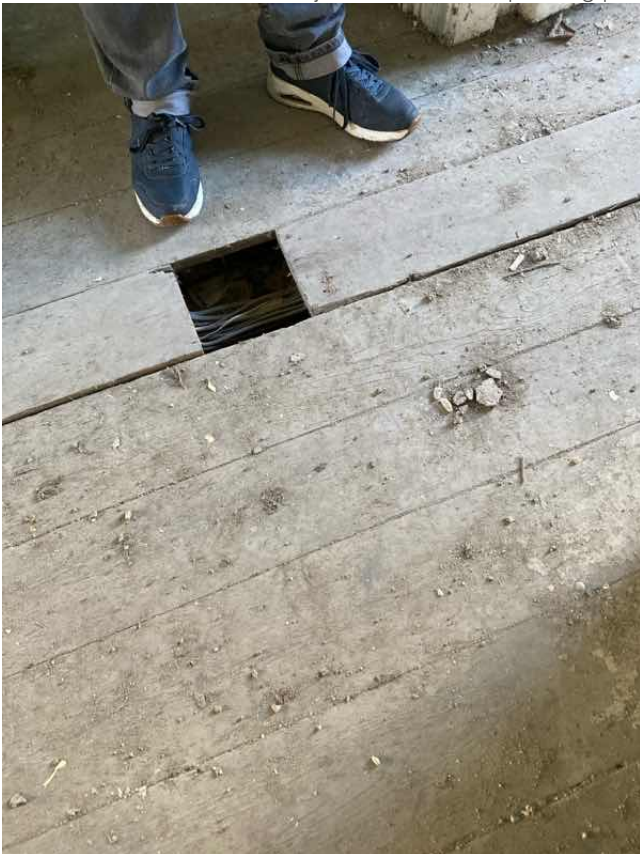
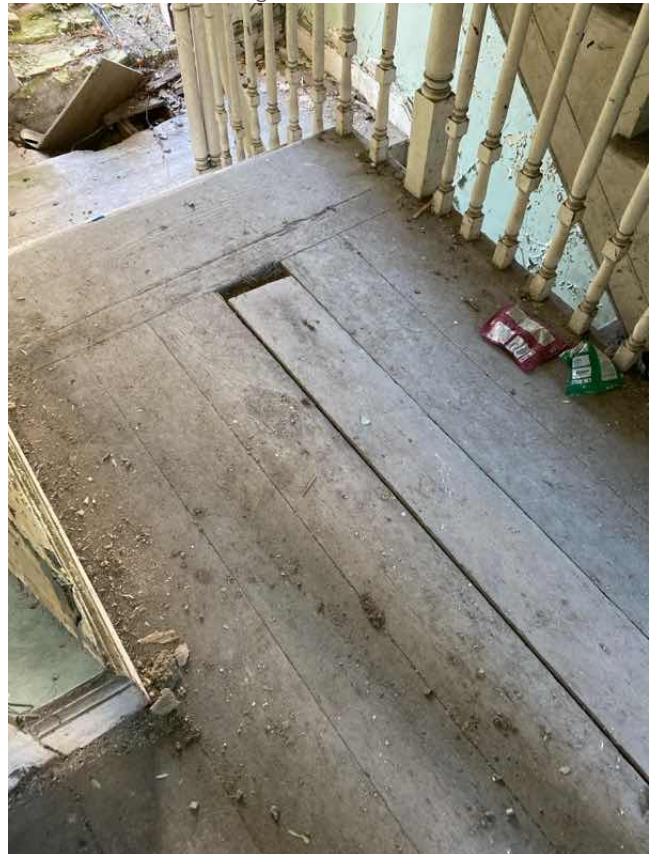
99

Floor boards indicate that all joist on first floor spanning parallel to front wall of building.

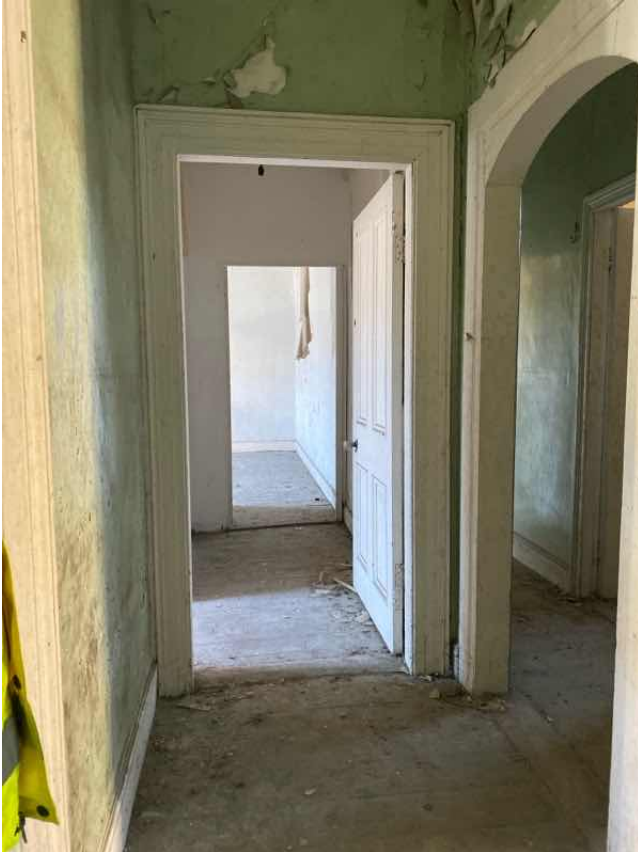
100

Load bearing masonry spine wall on first wall is used to support floor joist above on second floor. Location of this wall coincides with location of cast iron columns and heavier timber joist that will be observed on the ground floor.

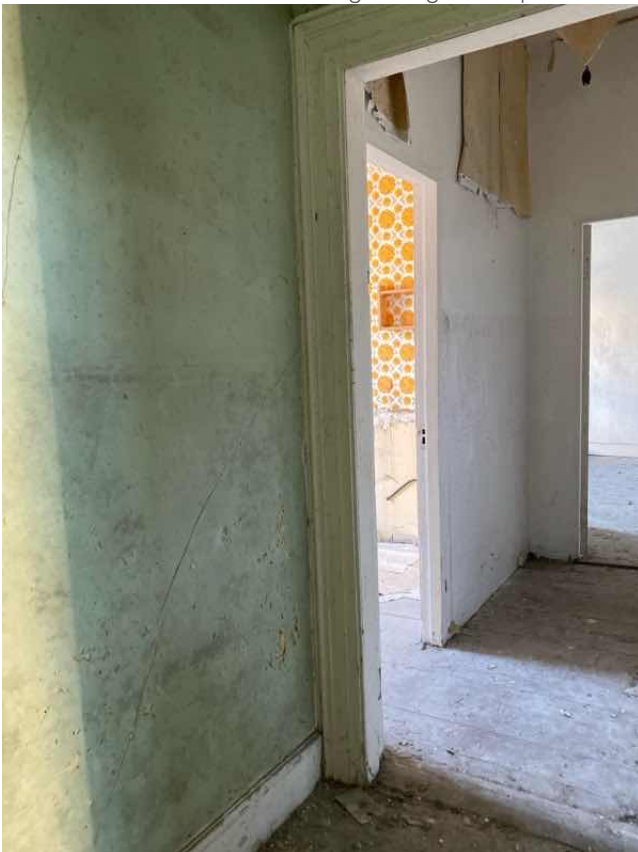
101

All other walls on first floor and light weight stud partition.

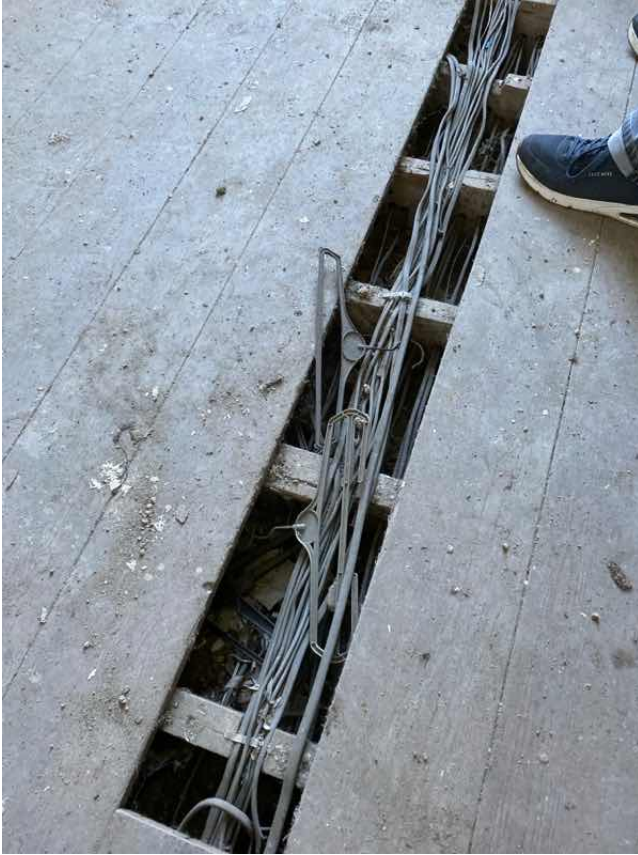
102

Existing timber joist notched for electrical services. Joists are 145x 45 wide @ 300 centres.

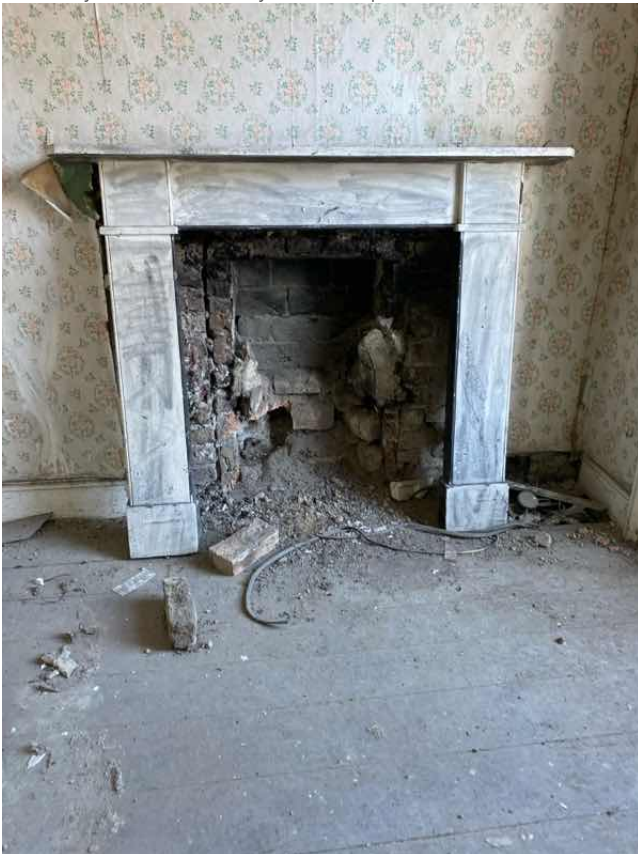
103

Masonry has come away from fire place.

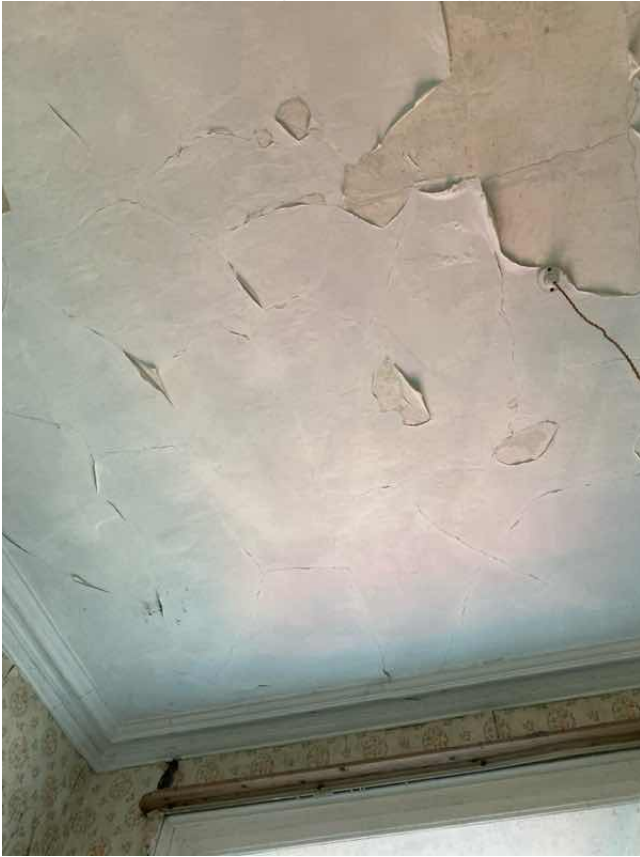
104

Cracking evident in Cieling and paint flaking

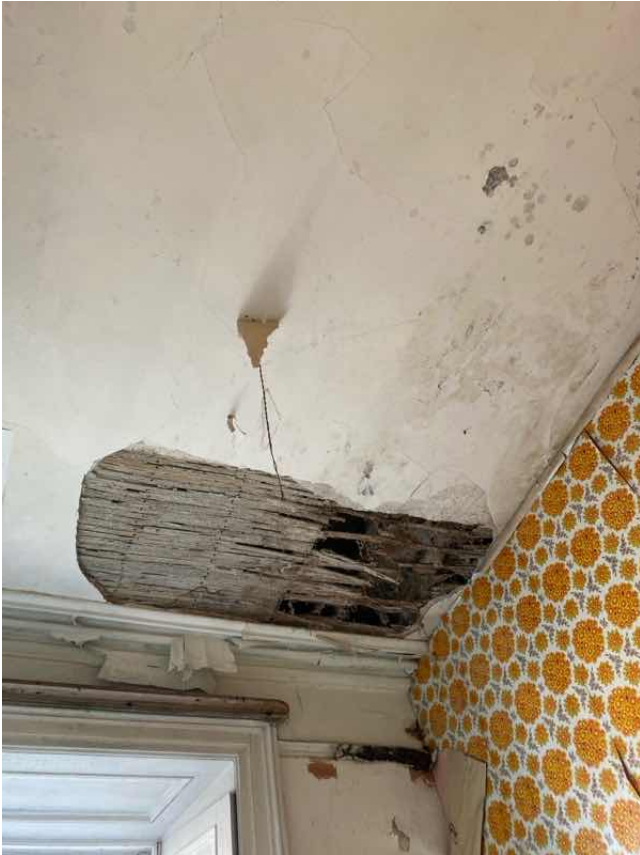
105

Lath and plaster of Cieling has fallen away, revealing badly deteriorated floor joist spanning on to external wall

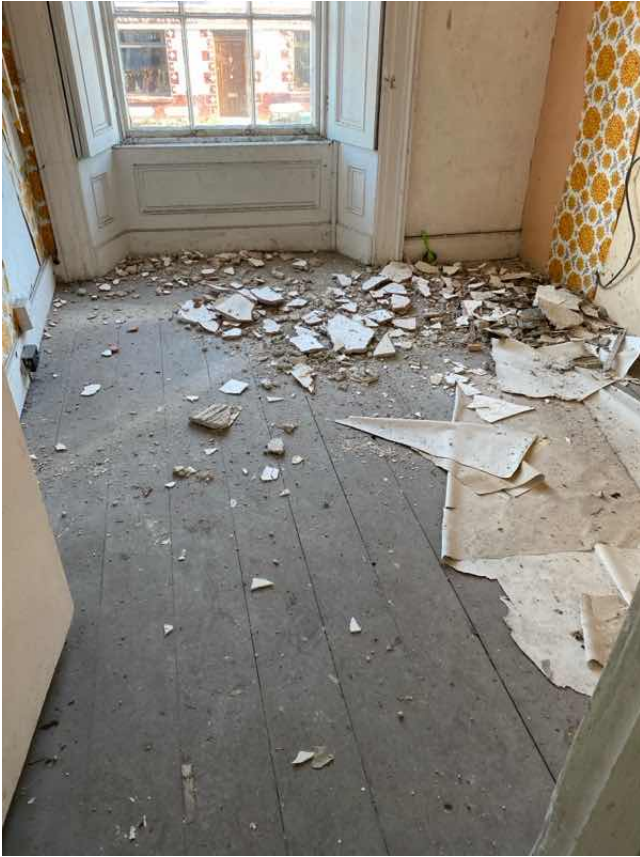
106

Noticeable sagging floor.

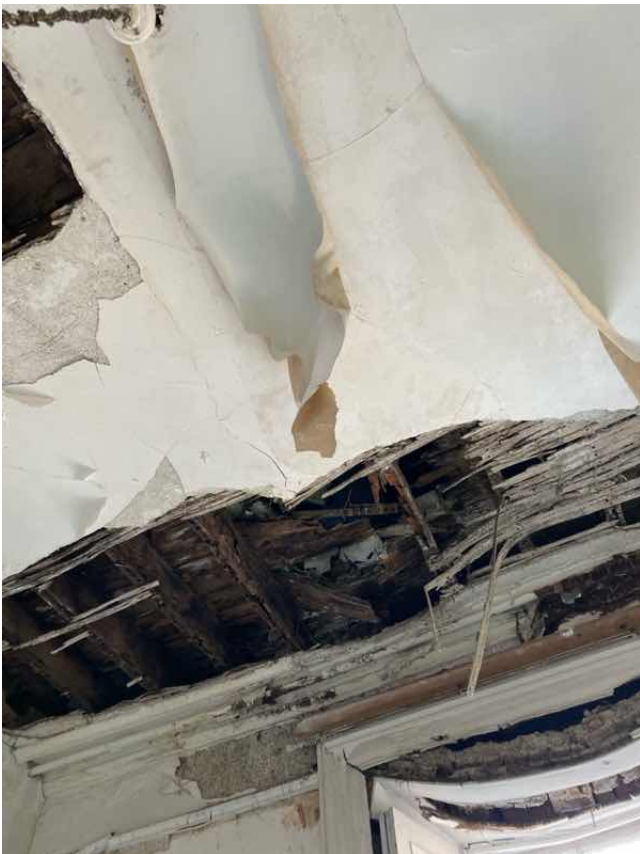
107

Lath and plaster of Ceiling has fallen away, revealing badly deteriorated floor joist spanning on to front exterior wall. This floor above is unsafe to walk on.

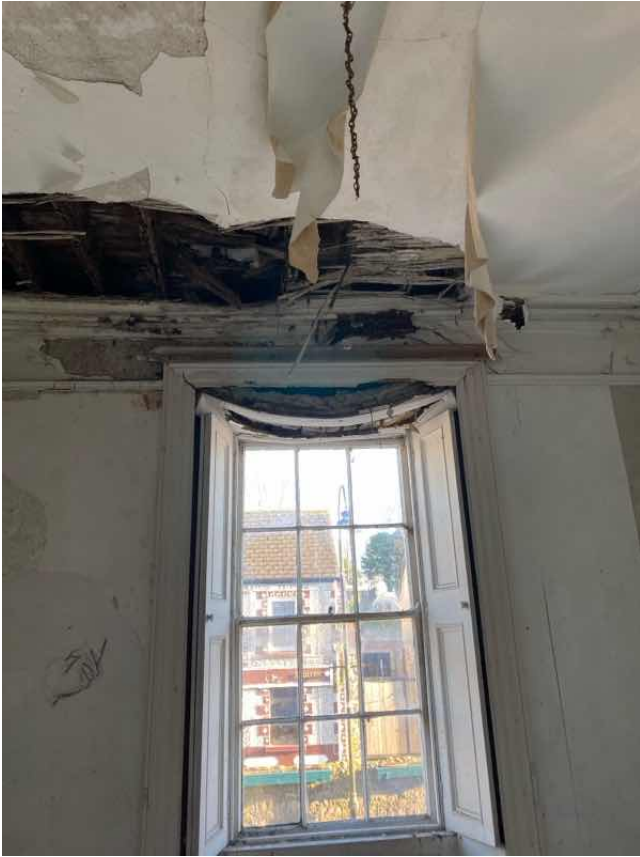
108

Timber lintel over window head has collapsed and it's unsafe.

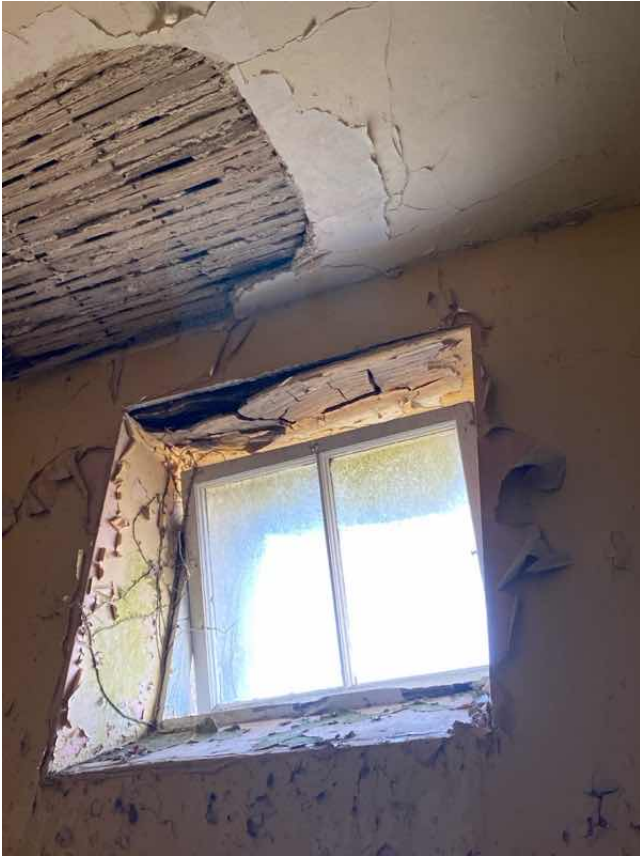
110

Timber lintel badly deteriorated.

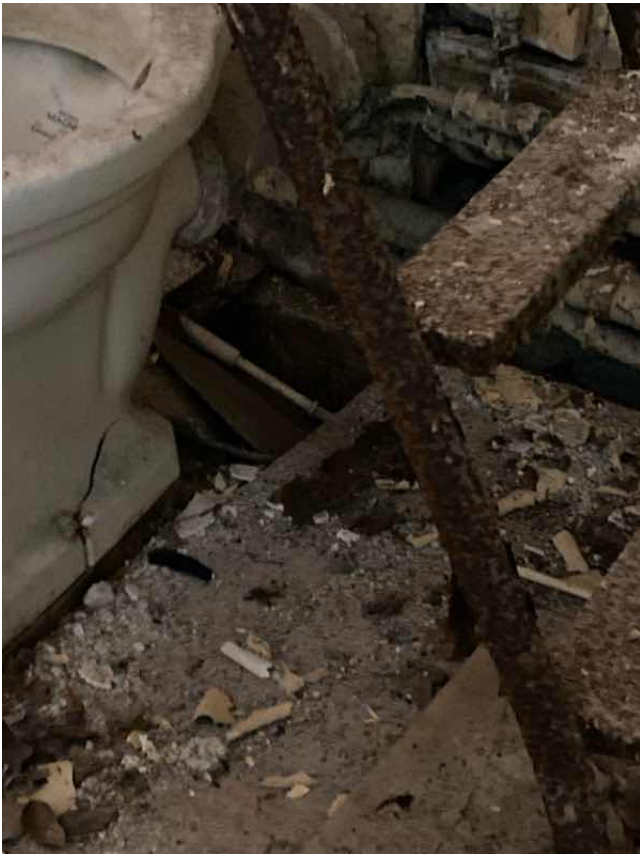
111

Hole in floor to rear of toilet.

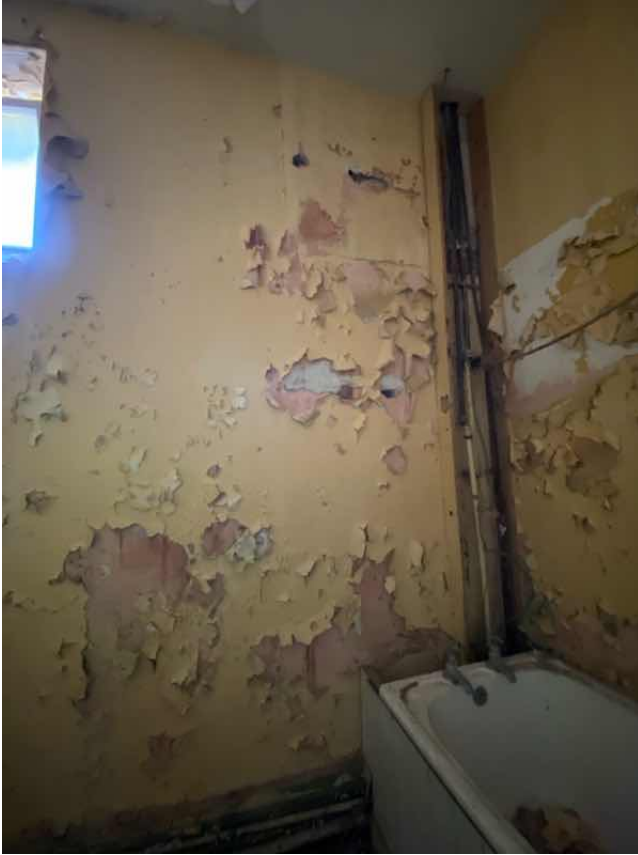
112

Cracks in rear wall possibly indicating blocked up opening.
