## **Drumshanbo Town Centre Regeneration**

# **Structural Assessment Survey and Site Investigation Report**

**for former Bank of Ireland Building, Early's Building  
and Adjacent Derelict Building, Drumshanbo, Co  
Leitrim**

**December 2023**

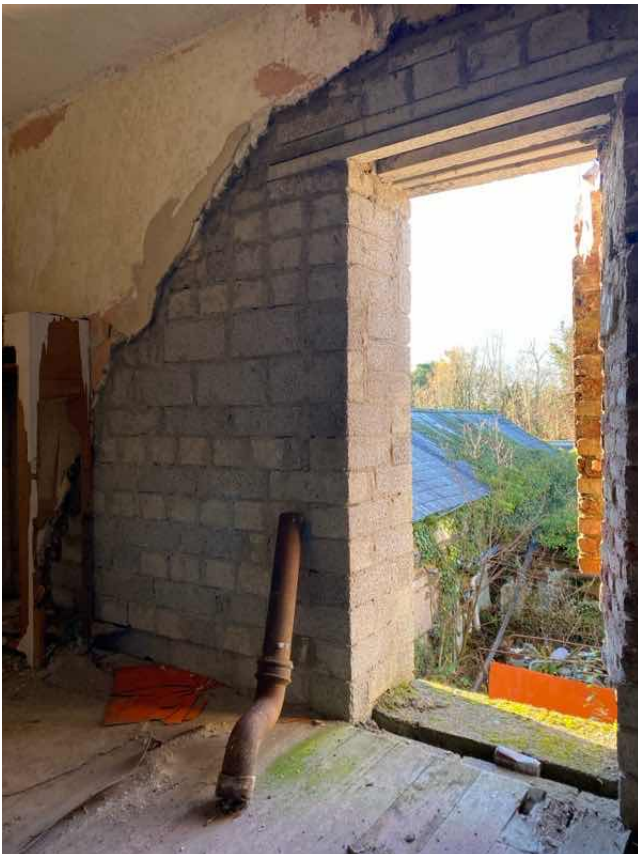
113

Rear wall partially rebuilt in concrete block work with precast lintel over window opening.

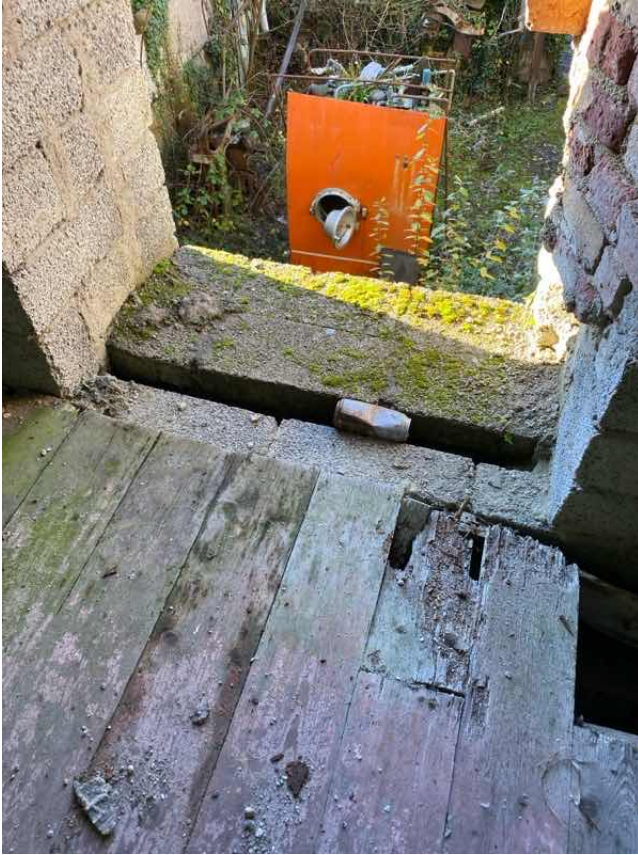
114

Floor joist badly deteriorated and collapsed adjacent to rear wall. Floor boards generally in poor condition with number of holes in same.

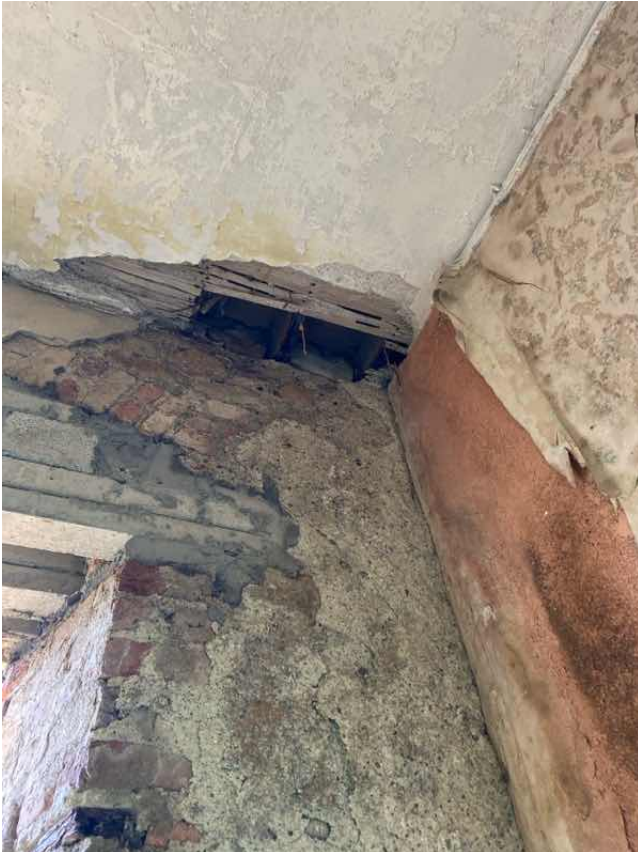
115

Lath and plaster of Ceiling has fallen away, revealing badly deteriorated floor joist spanning on to back exterior wall. This floor above is unsafe to walk on.

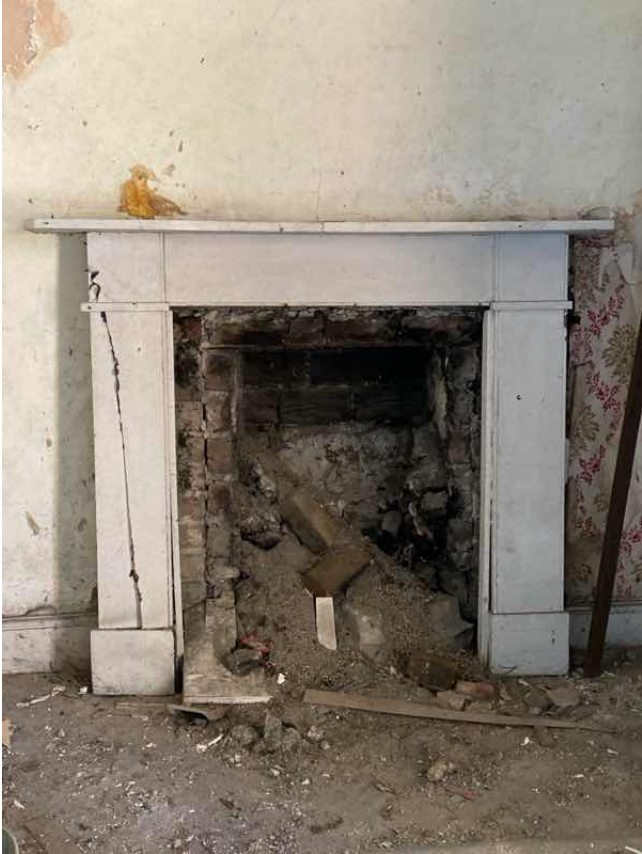
**118**

Evidence of cracking in wall above fire place. Masonry partially collapsed in fire place

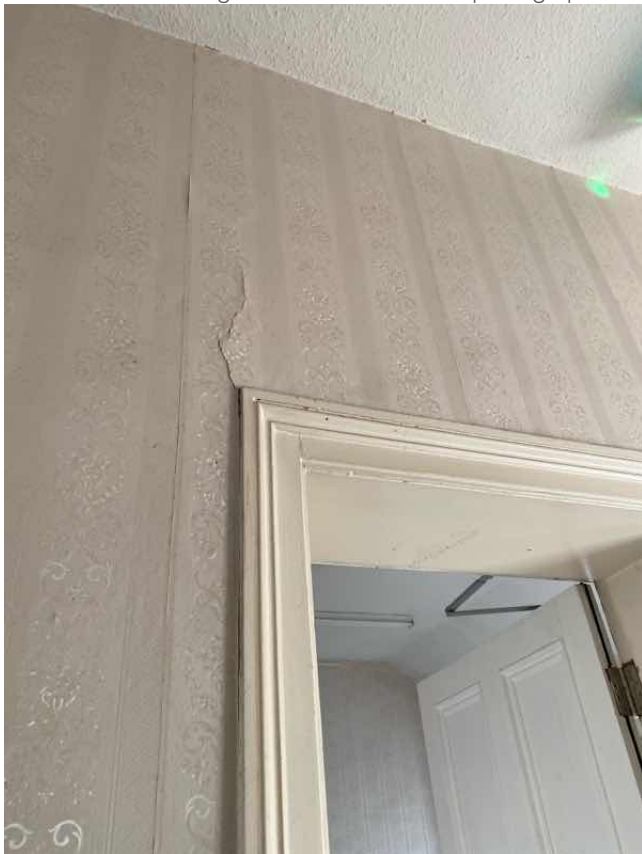
50

Evidence of cracking to the head of door. Opening up will be required to confirm the condition of the existing lintels.

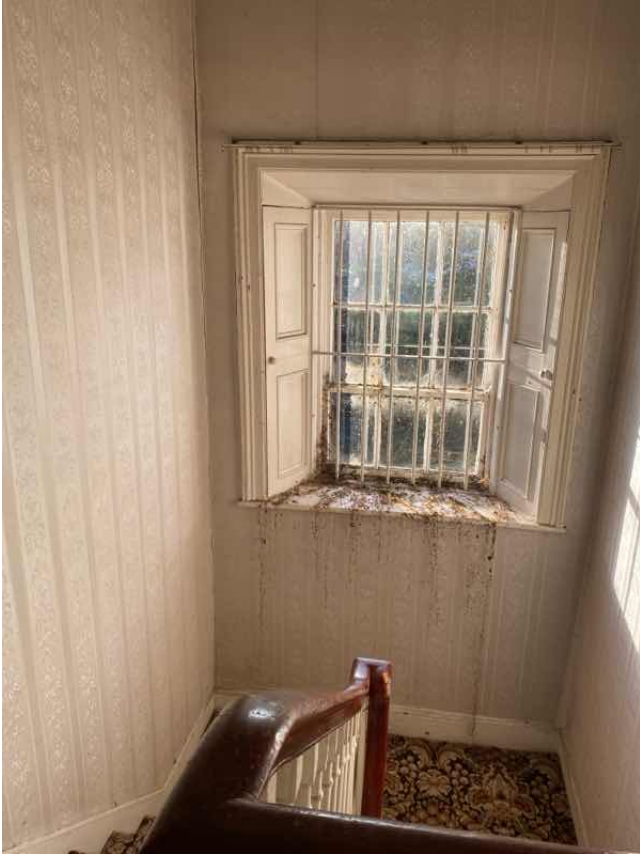
51

Vegetation growing through window in this level and level below.

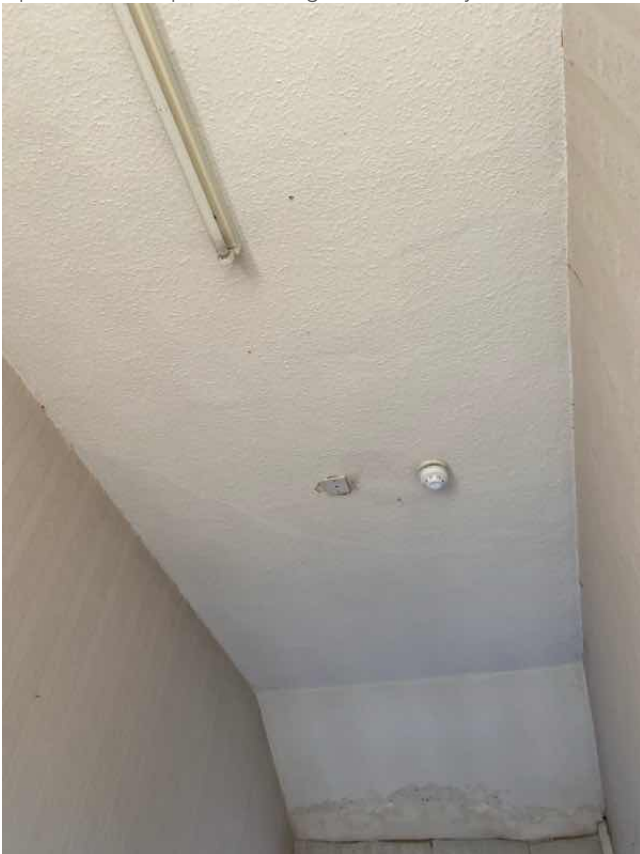
52

Apart from dampness, ceiling in satisfactory condition.

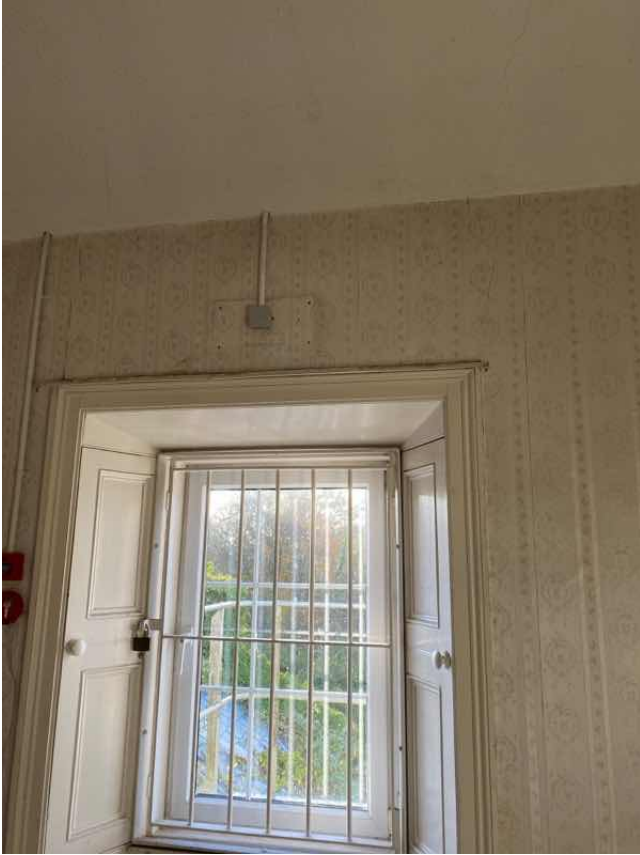
53

Evidence of cracking to the head of window. Opening up will be required to confirm the condition of the existing lintels.

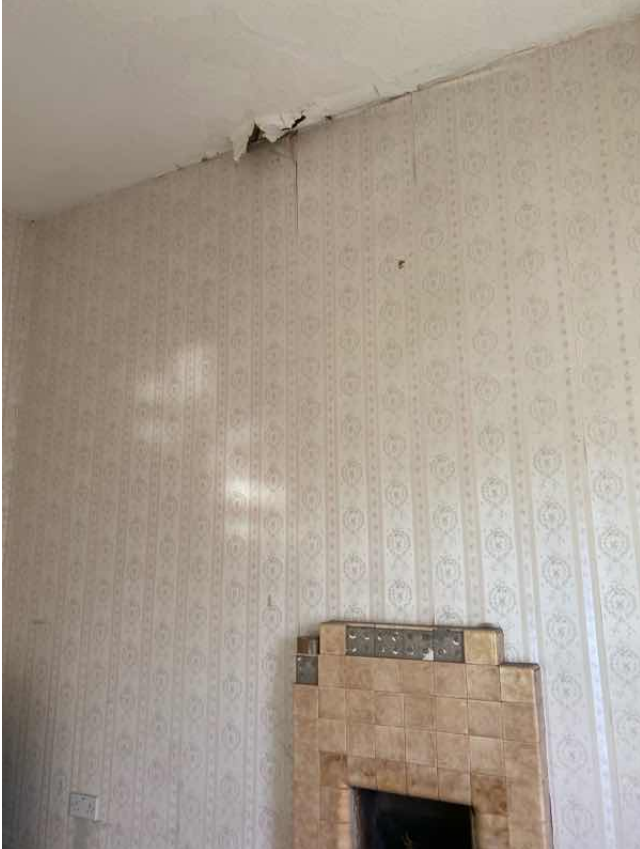
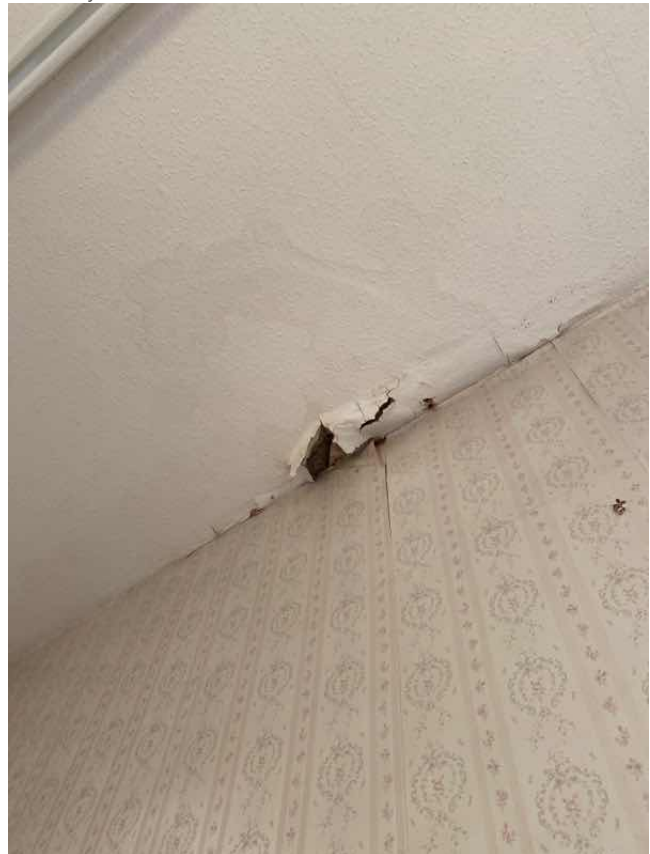
54

Localised damage to ceiling, likely from damp ingress through chimney breast.

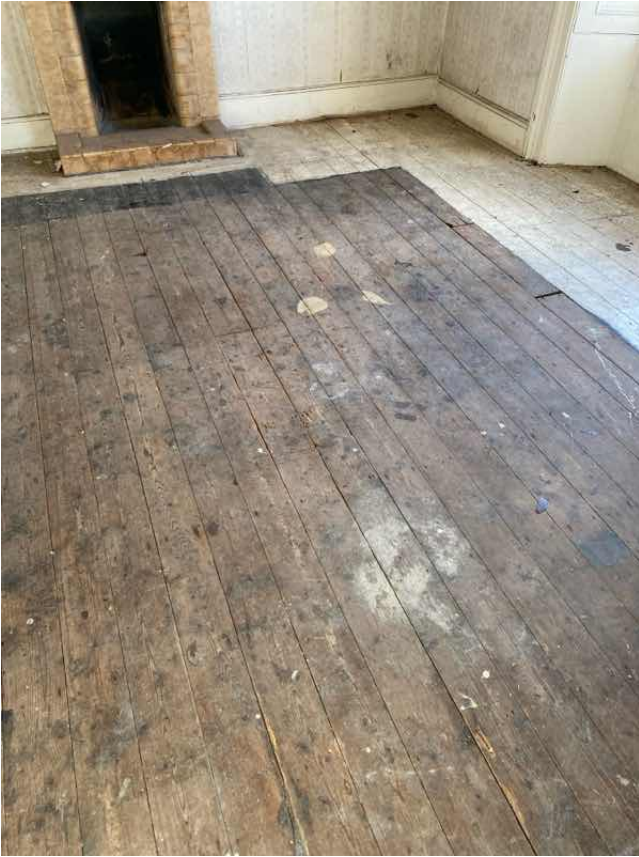
55

Joist span perpendicular to the rear external wall

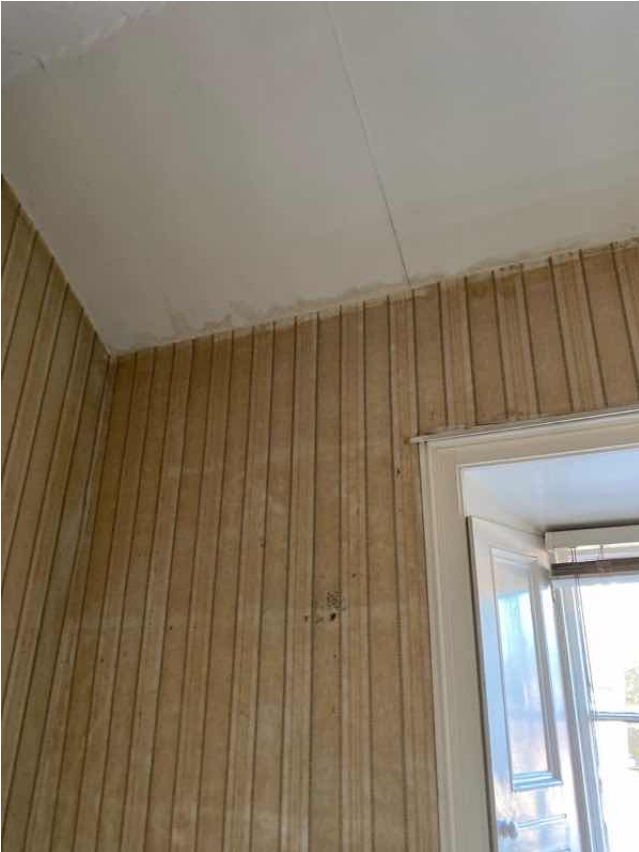
56

Damp ingress at the interface between front wall and ceiling

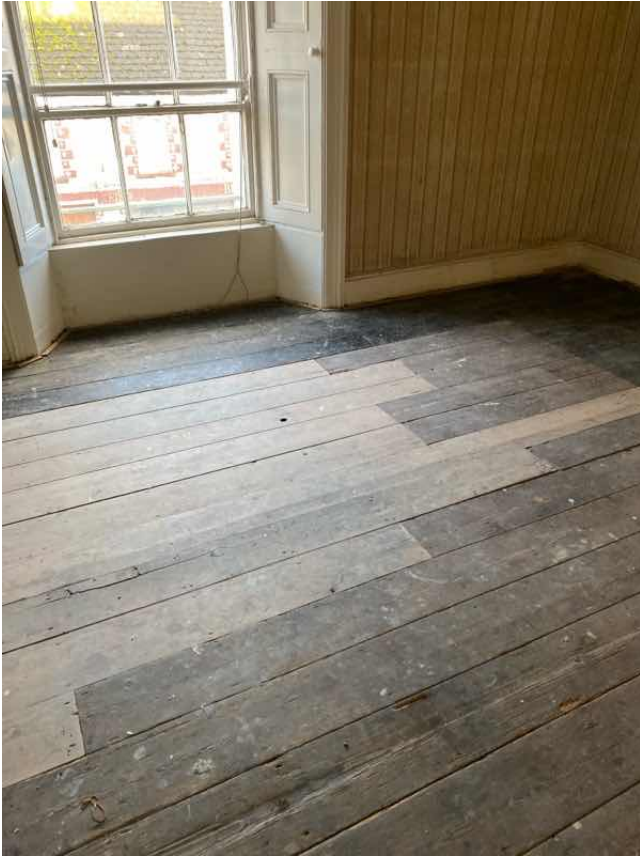
57

Joist spanning perpendicular to the front external wall

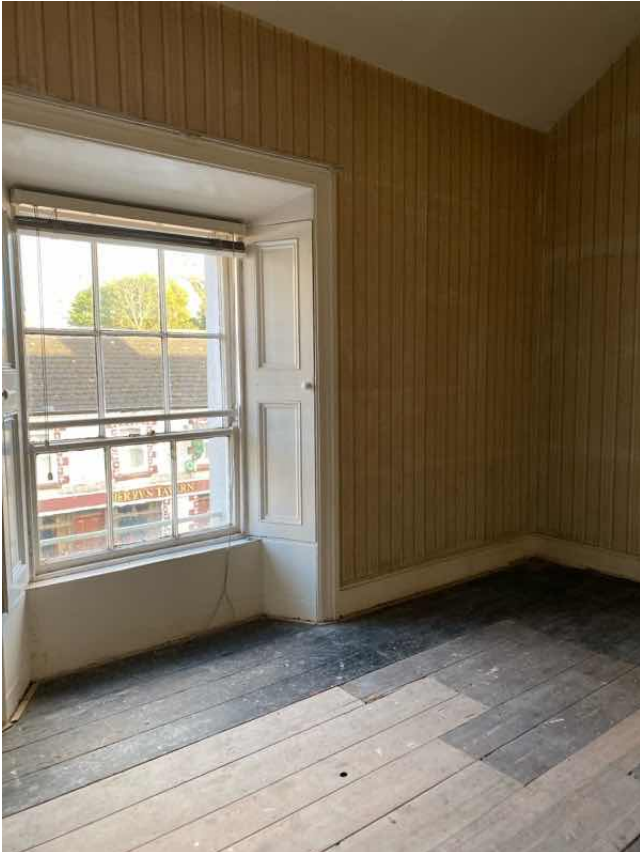
58

Walls fully papered, no sign of any significant structural distress

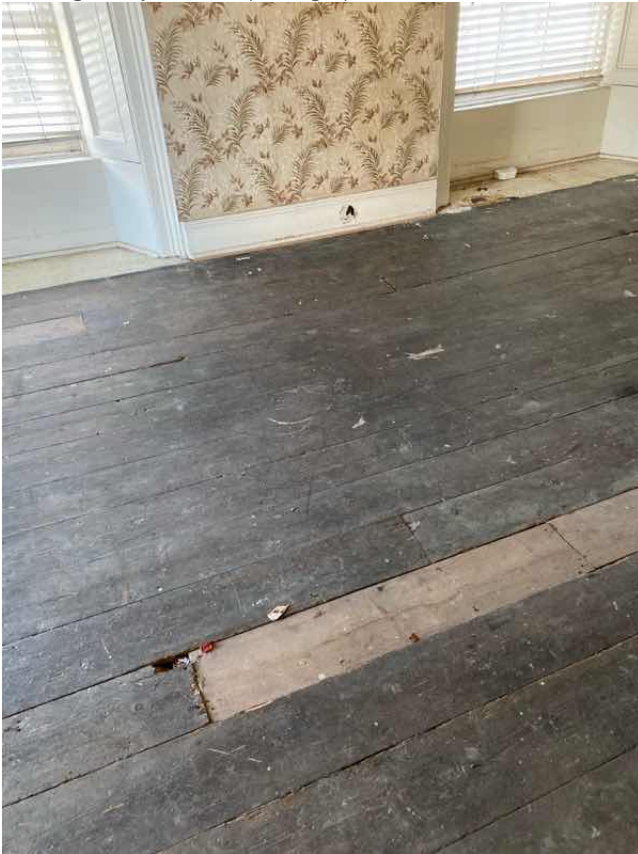
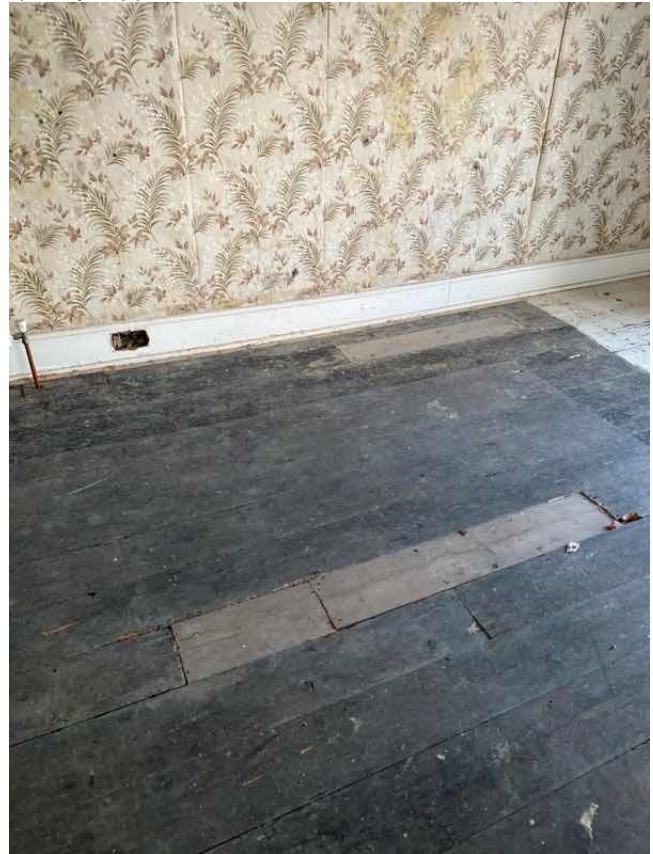
59

Joist spanning perpendicular to the front external wall. Notable sag in floor towards supporting internal wall so need to investigate by further opening up to ensure internal wall is adequately supported at first floor level.

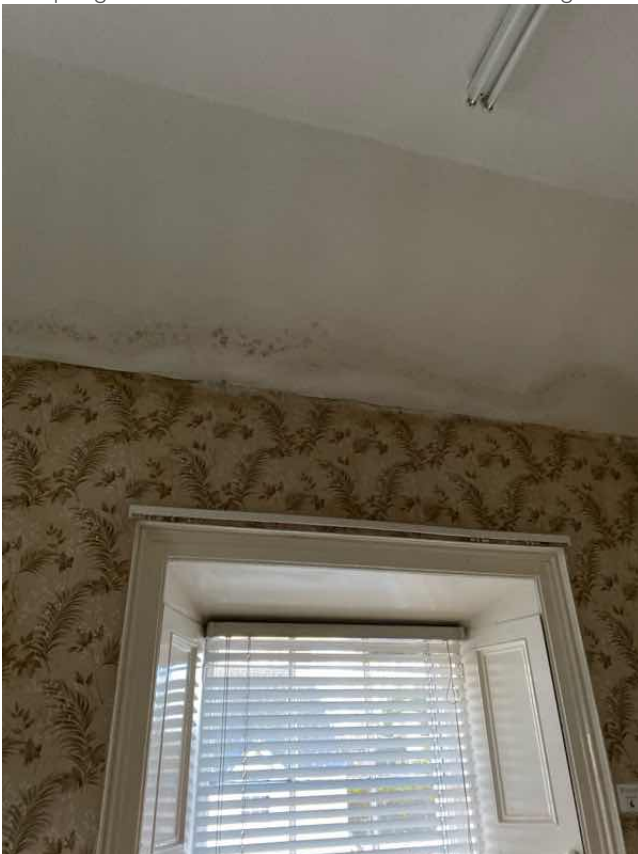
60

Damp ingress at the interface of front wall and ceiling

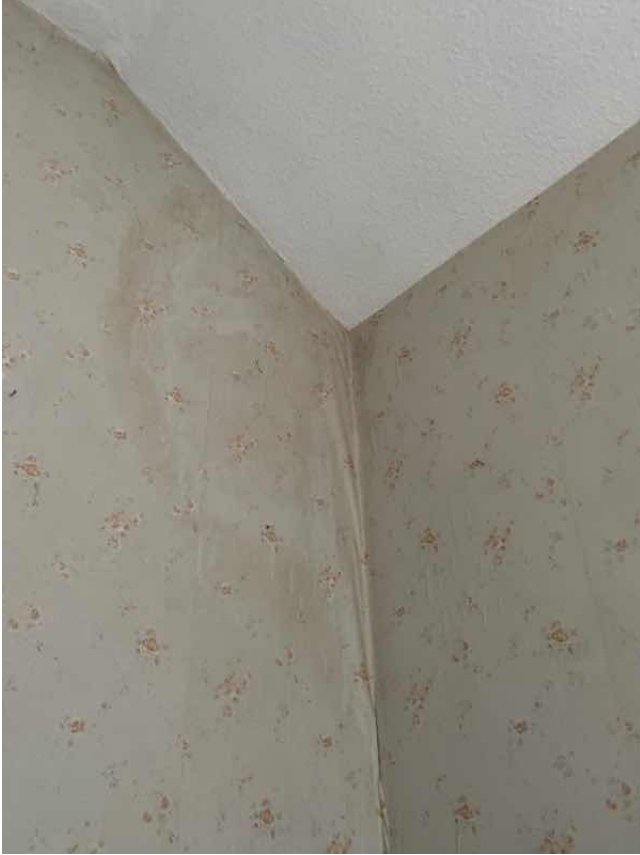
63

Damp ingress from roof, it coincides with the dampness at the first floor level

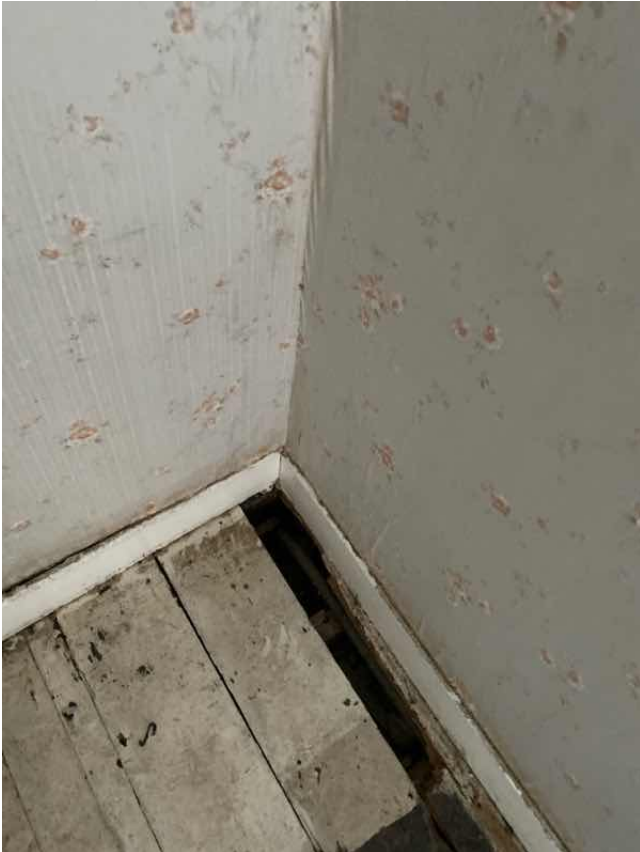
64

Plumping pipes coincides with leaking at first floor, further investigation is needed to identify the source of leaking

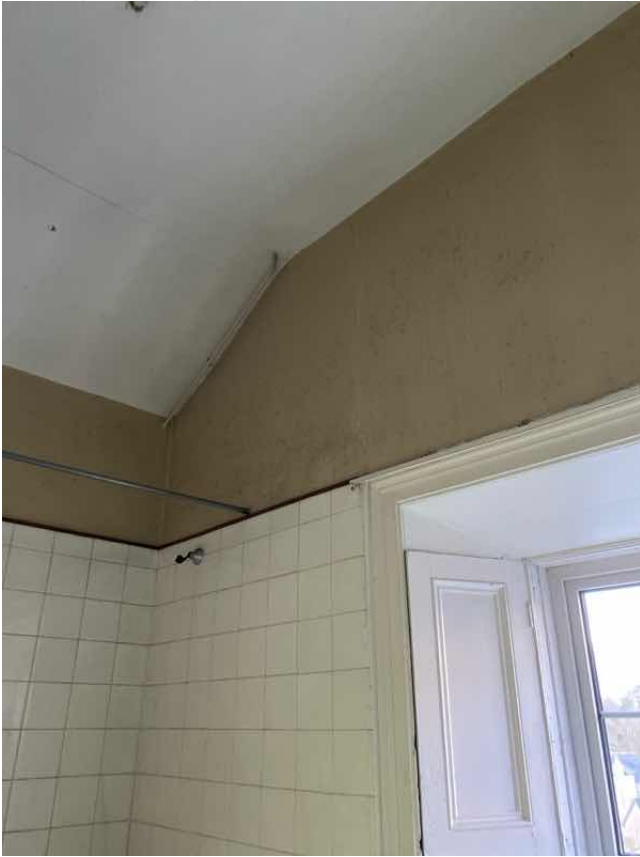
67

Mould growth on gable wall

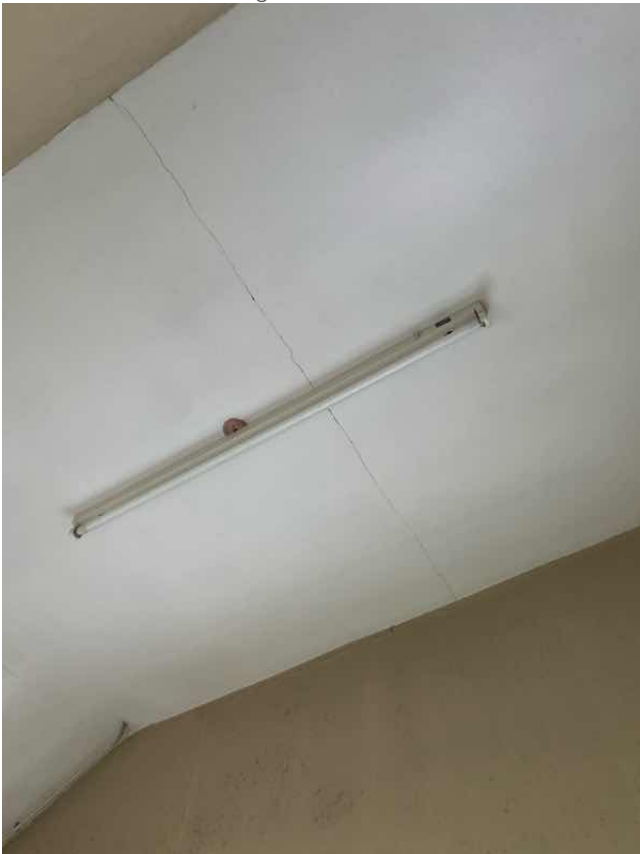
68

Fine cracks in the ceiling

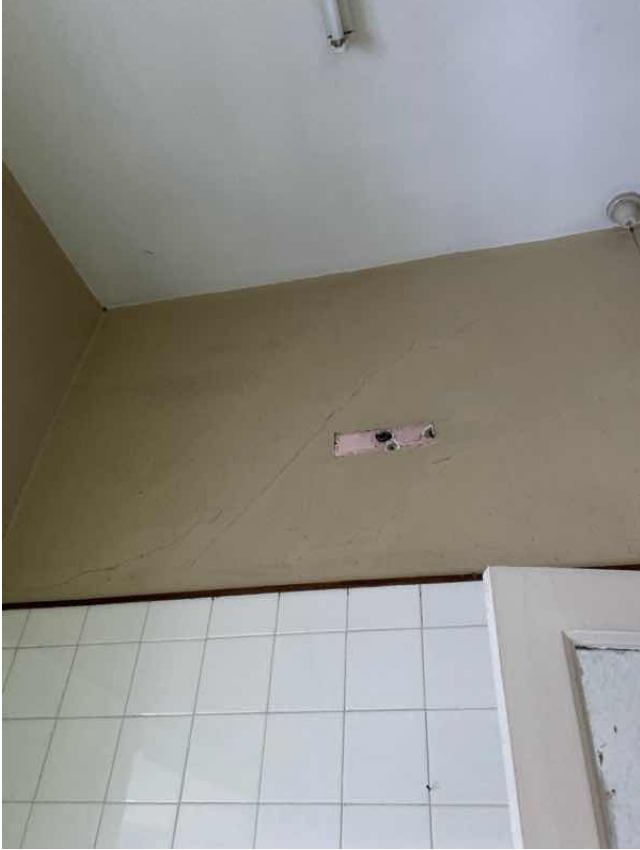
69

Number of fine cracks in internal wall, extends to gable wall

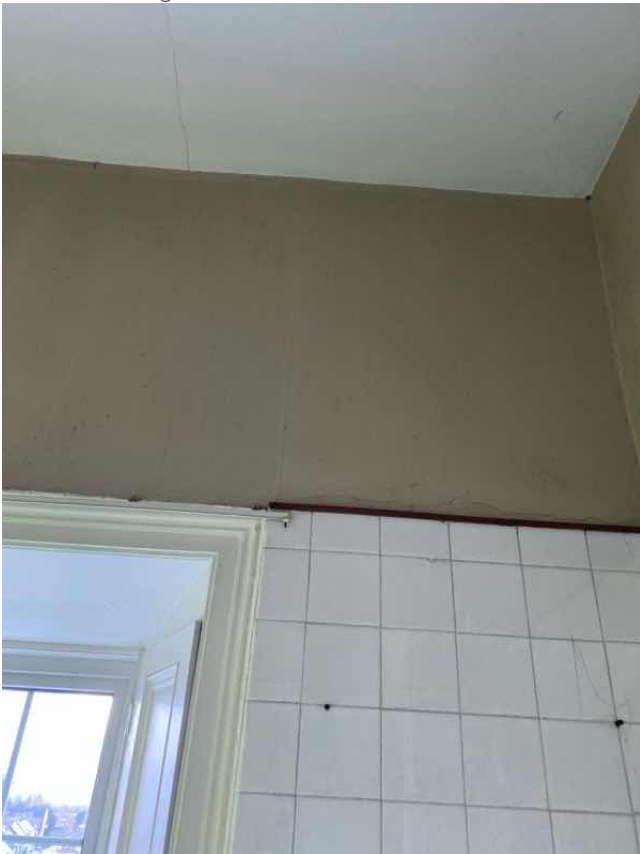
70

Fine cracks in gable wall

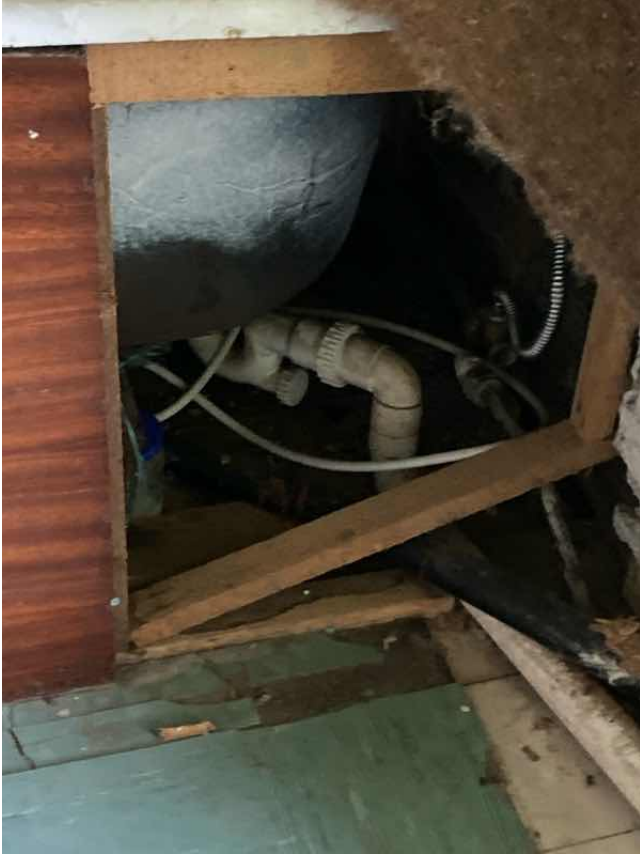
71

Floor boards exposed under the bath tub indicates floor joist spanning parallel to the gable wall

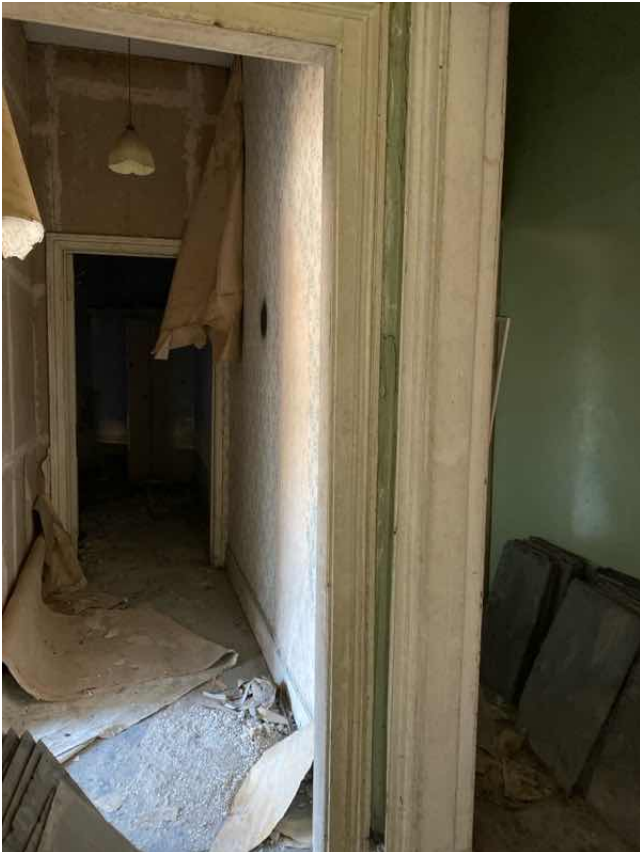
120

Load bearing masonry spine wall continues from first floor to roof ceiling but does not provide any support to roof rafters. Location of this wall coincides with location of cast iron columns and heavier timber joist that will be observed on the ground floor.

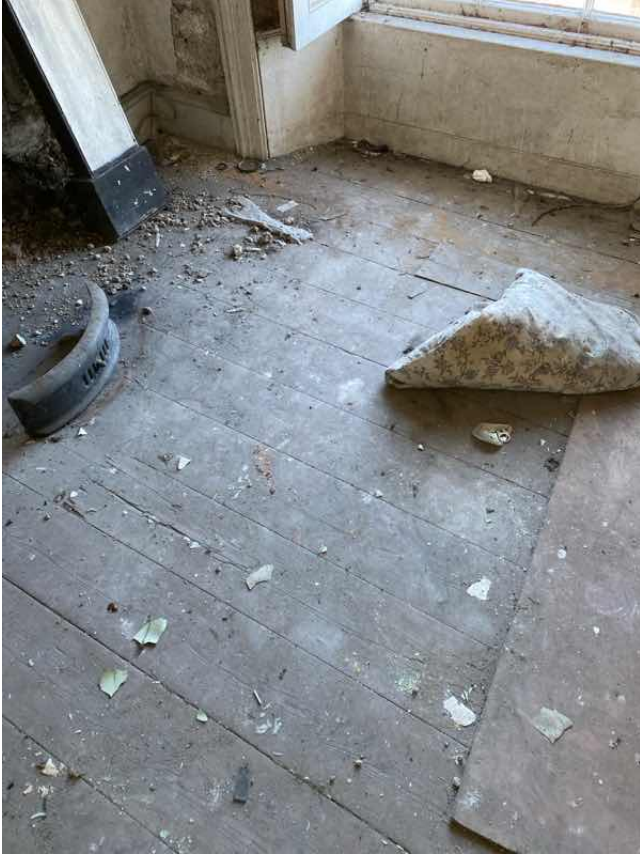
121

Floor joist spanning onto front external wall.

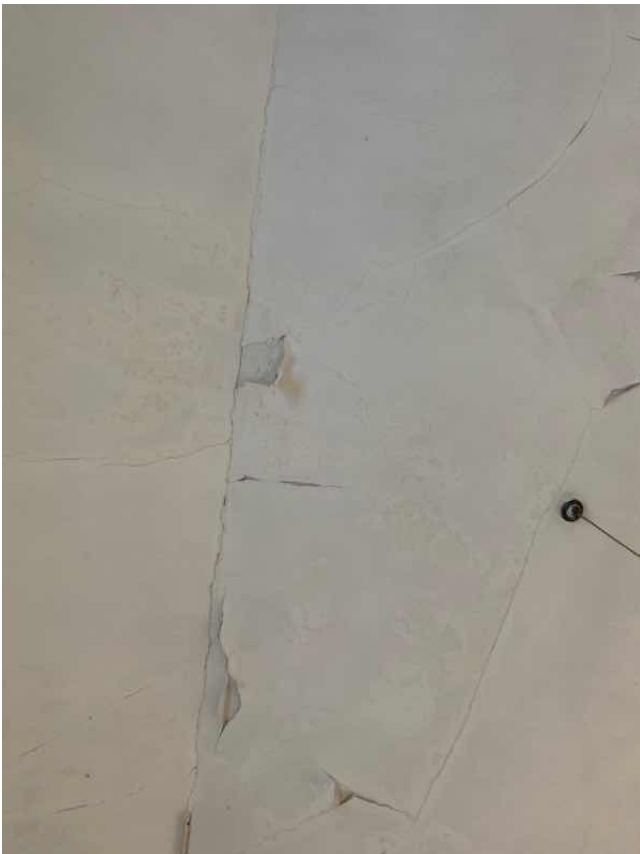
124

Evidence of cracking and paint flaking of plaster in ceiling.

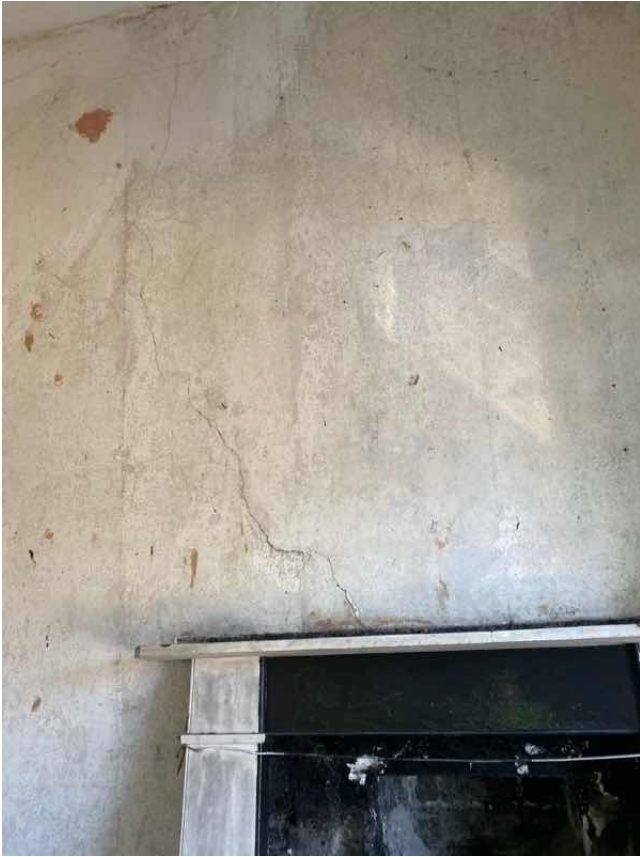
125

Crack in wall above fire place.

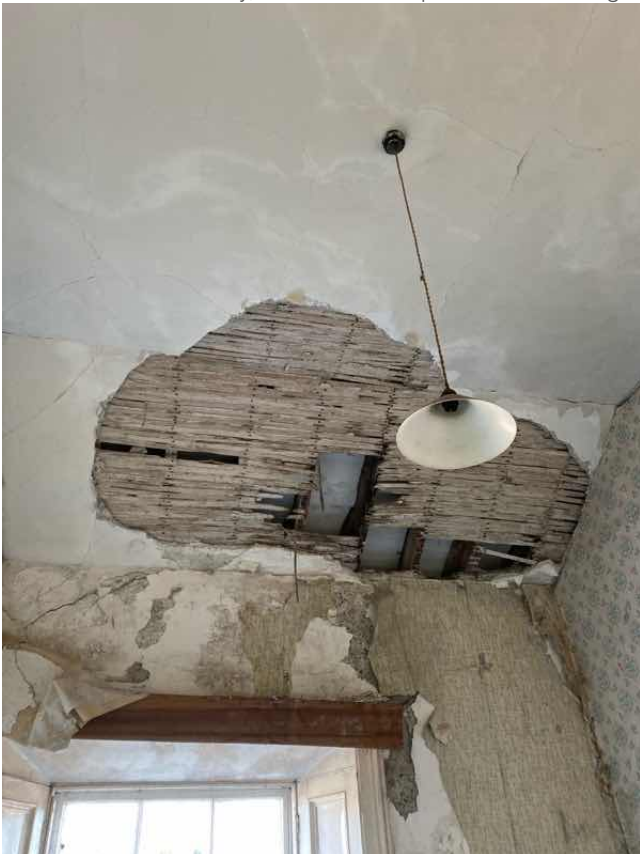
126

Plaster has come away, one rafter is exposed and has signs of deterioration.

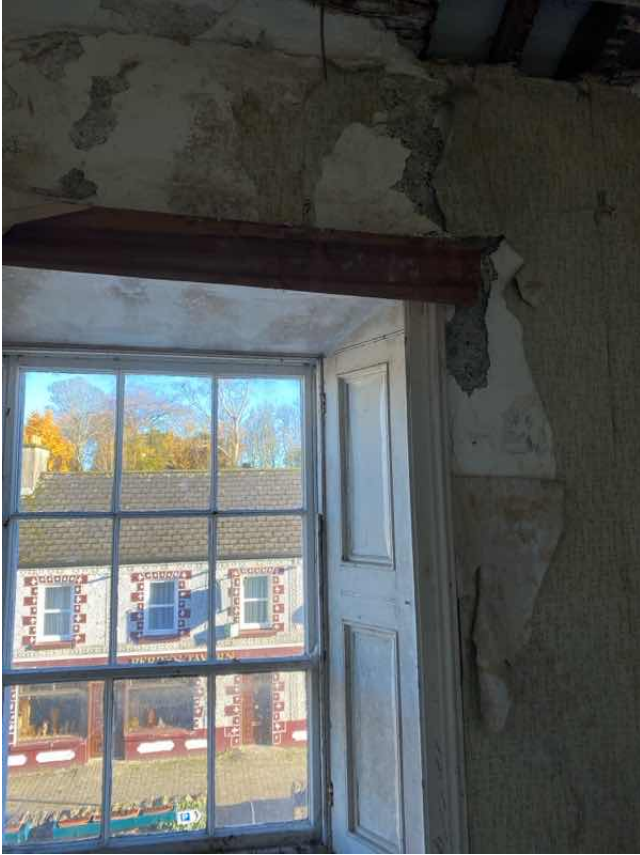
127

Plaster around the window is loose and coming away ,mostly due to damp ingress

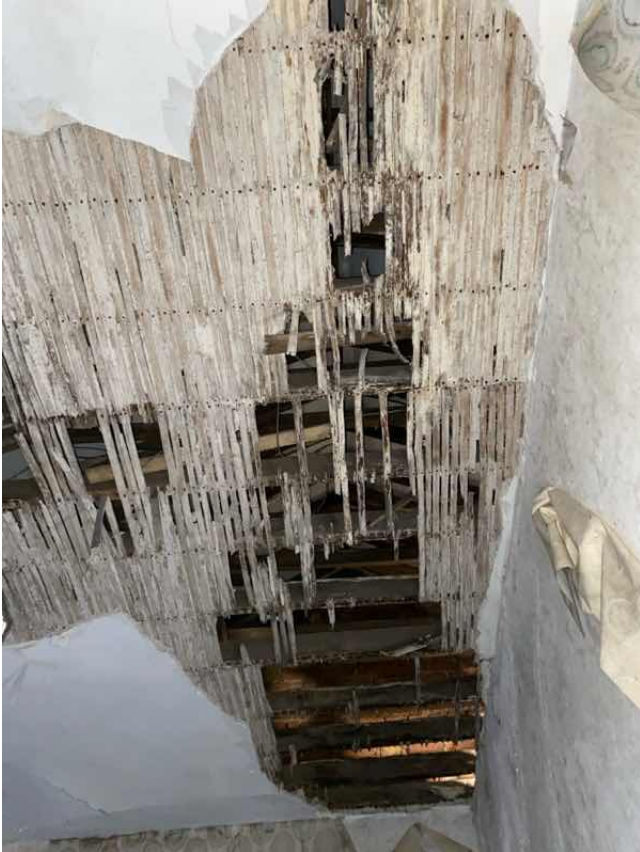
129

Lath and plaster has come away for large area of ceiling. Exposed ceiling joist and rafters appear to be in reasonable condition.

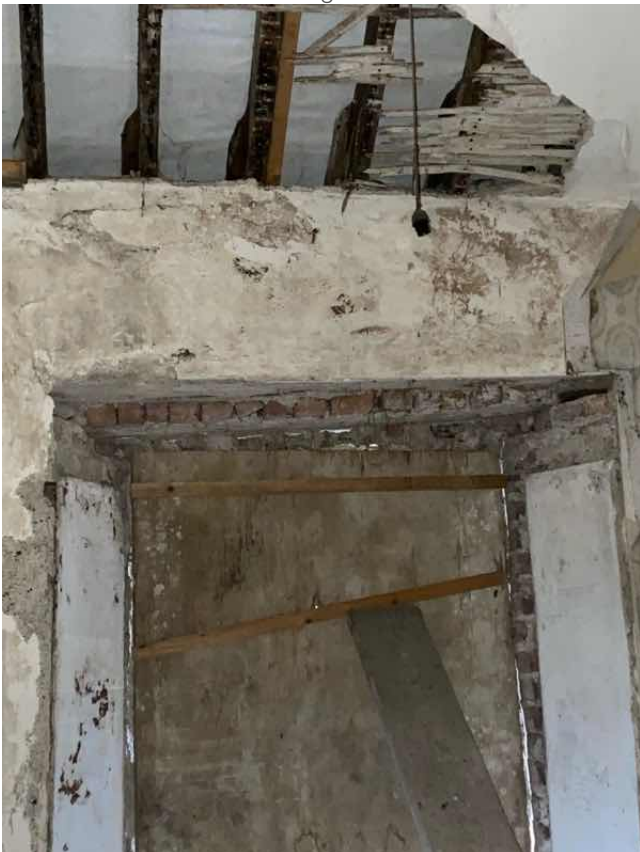
130

Lintel above window is missing

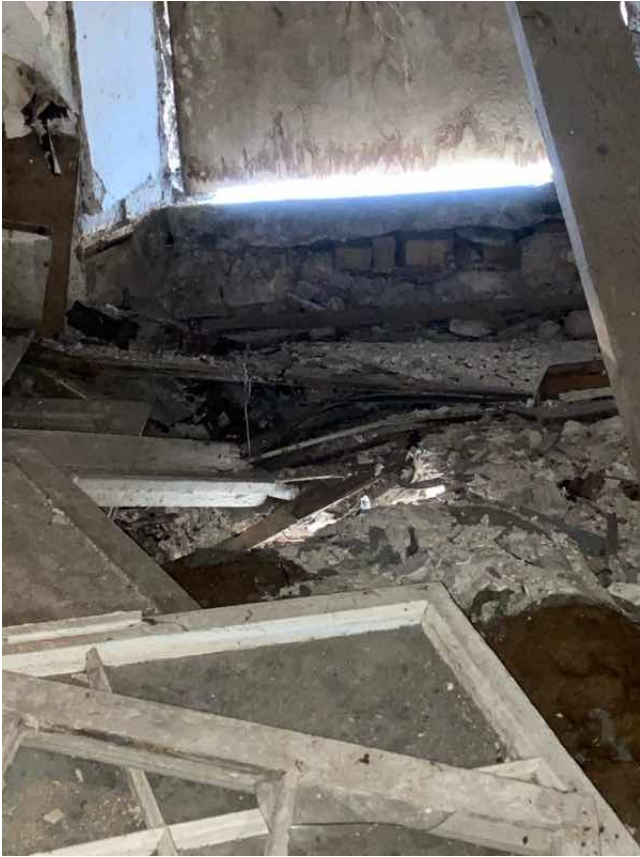
**131**

Large hole in floor, in dangerous condition.

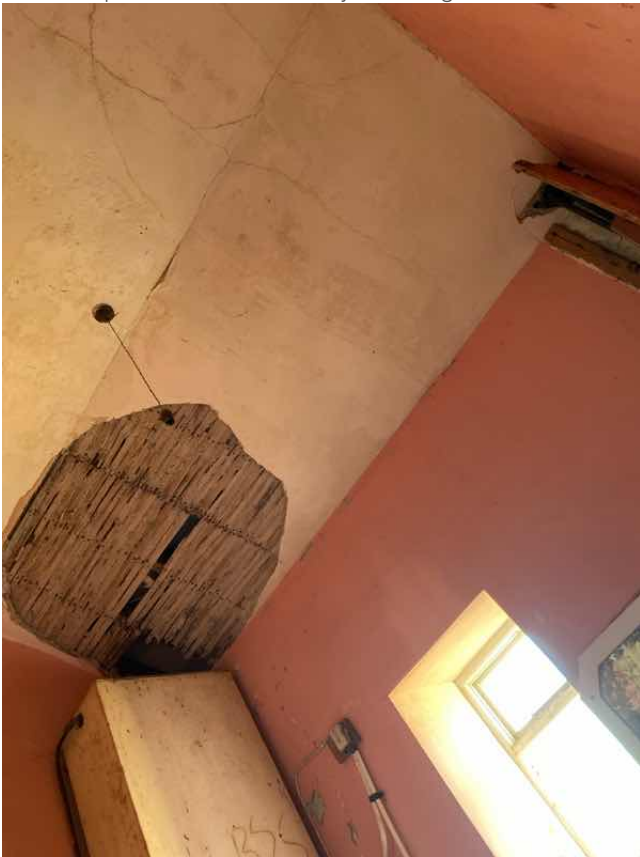
**132**

Lath and plaster has come away in ceiling.

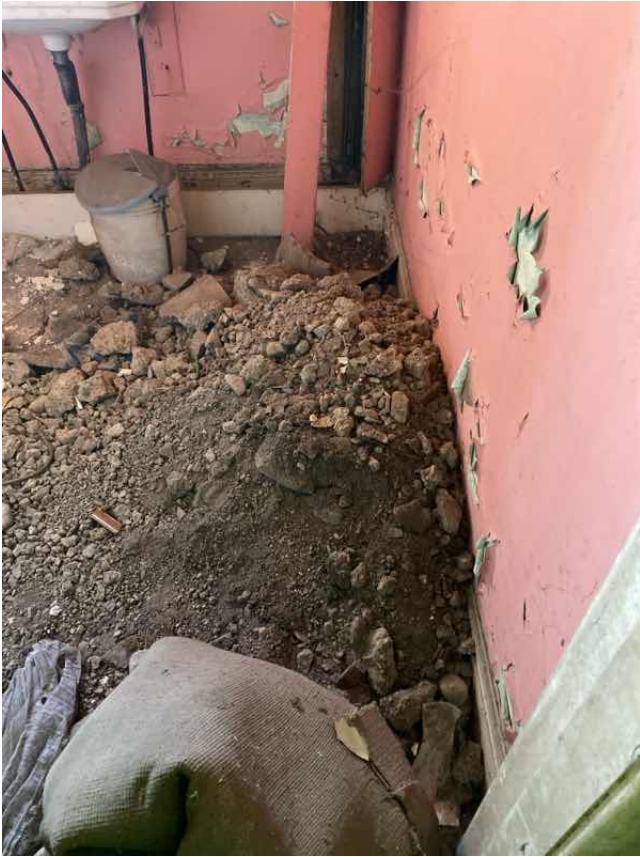
133

Rubble piled on floor.

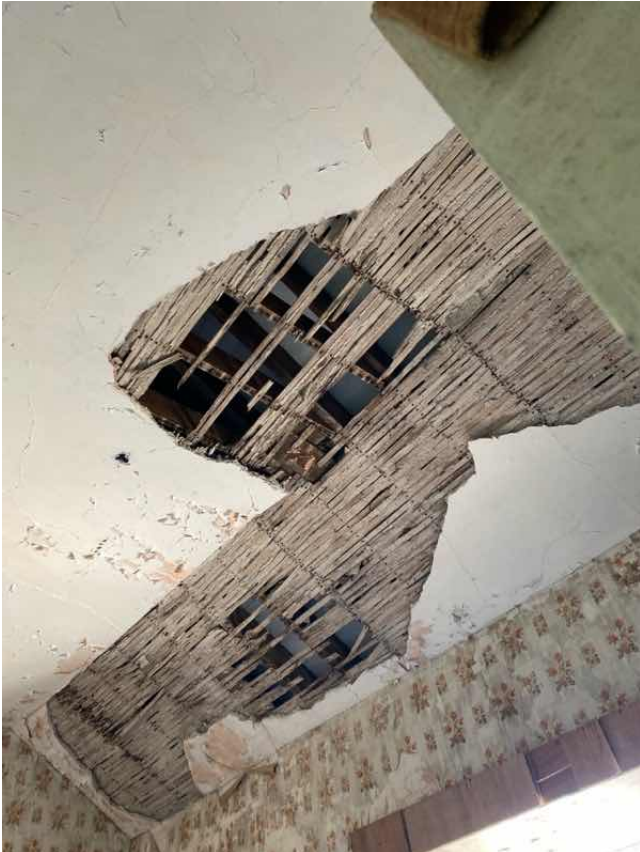
134

Lath and plaster has come away for large area of ceiling. Exposed ceiling joist and rafters appear to be in reasonable condition.

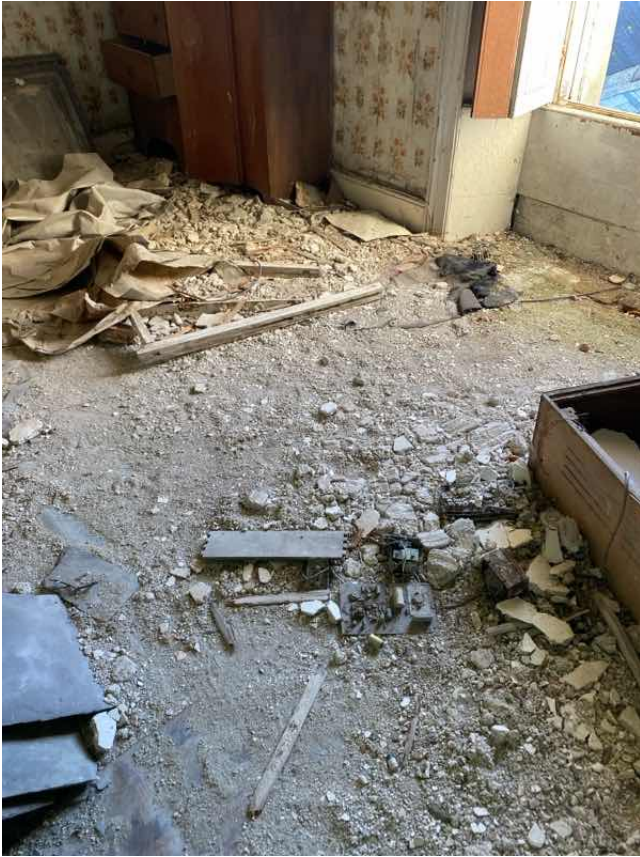
135

Rubble strewn across floor, but floor boards indicate that joists are spanning on to back wall of the building.

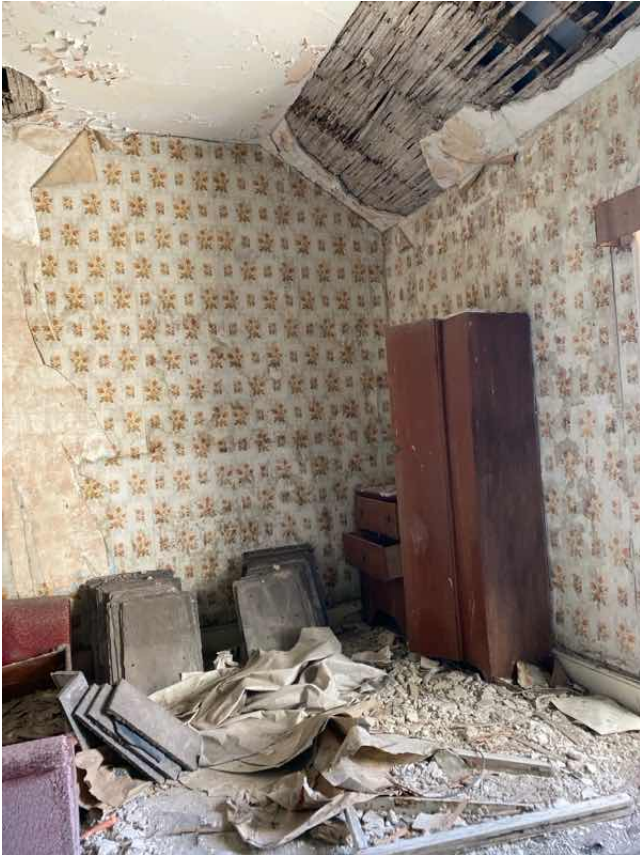
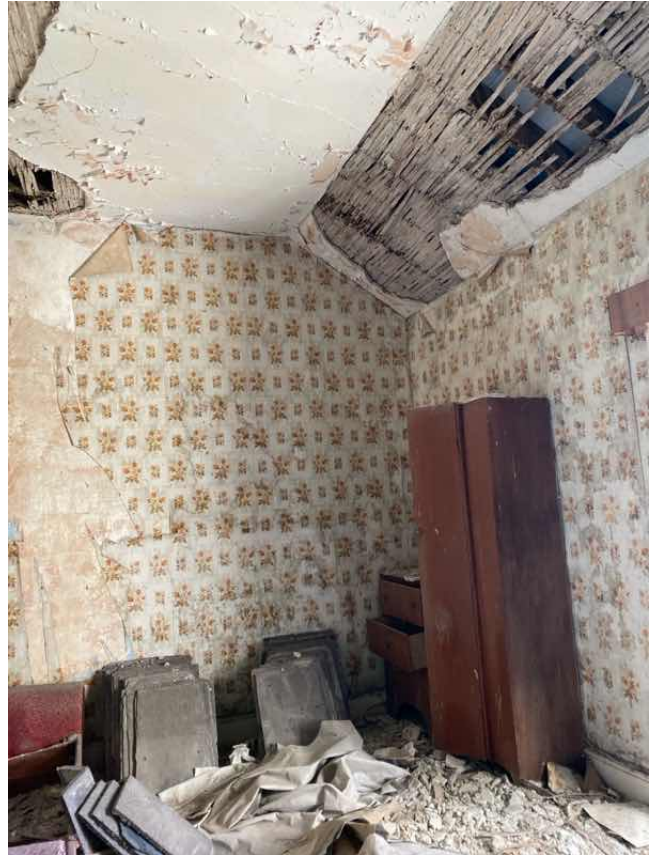
136

Rear wall and gable wall fully papered. No obvious signs of structural distress.
