## **Drumshanbo Town Centre Regeneration**

# **Structural Assessment Survey and Site Investigation Report**

**for former Bank of Ireland Building, Early's Building  
and Adjacent Derelict Building, Drumshanbo, Co  
Leitrim**

**December 2023**

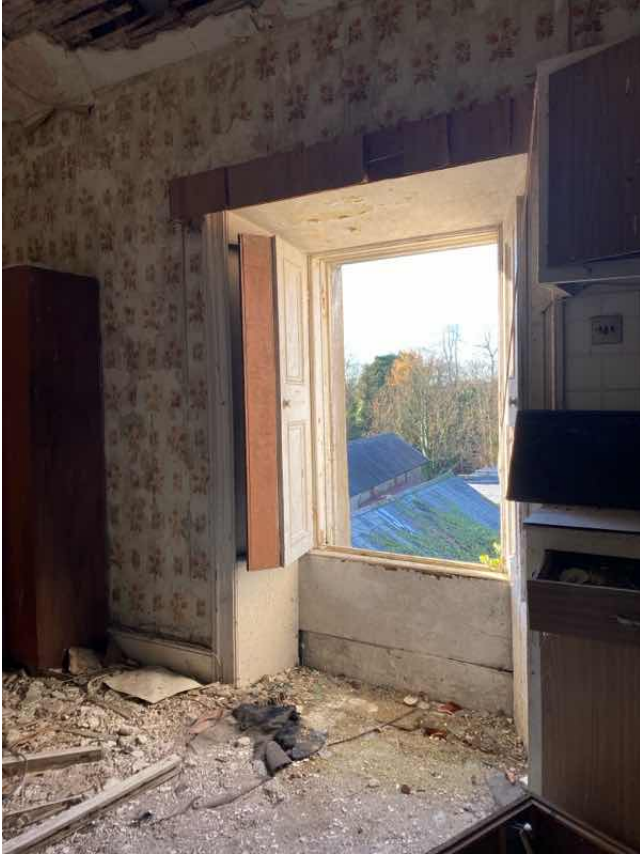
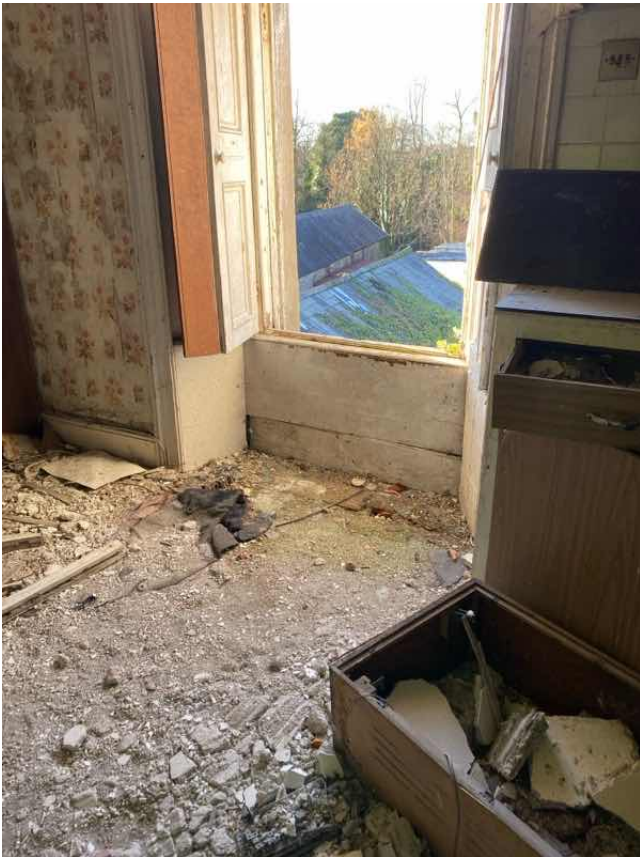
137

Suspect ends of joist (179x45@ 300 c/c) embedded in external walls have deteriorated.

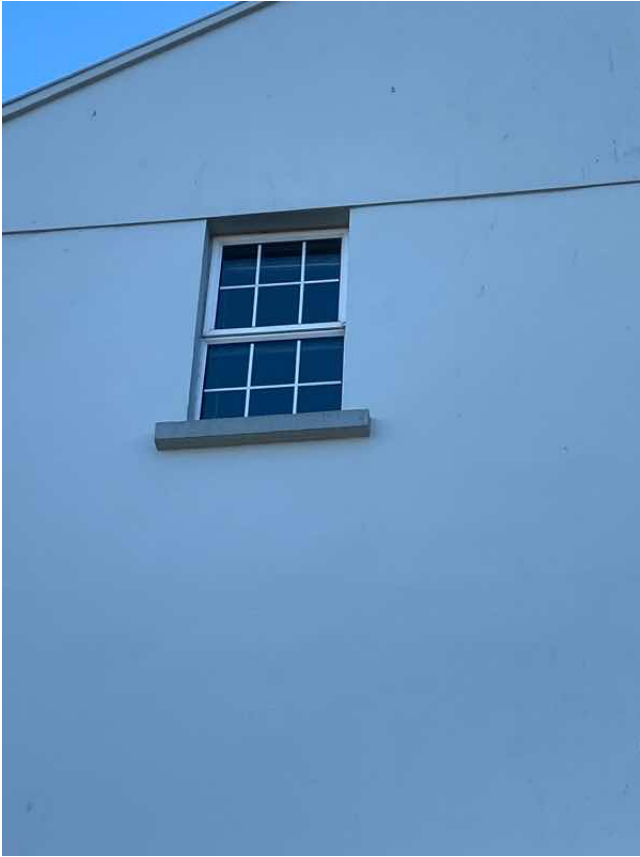
138

Fine crack above window on external face of wall otherwise no signs of any significant structural distress

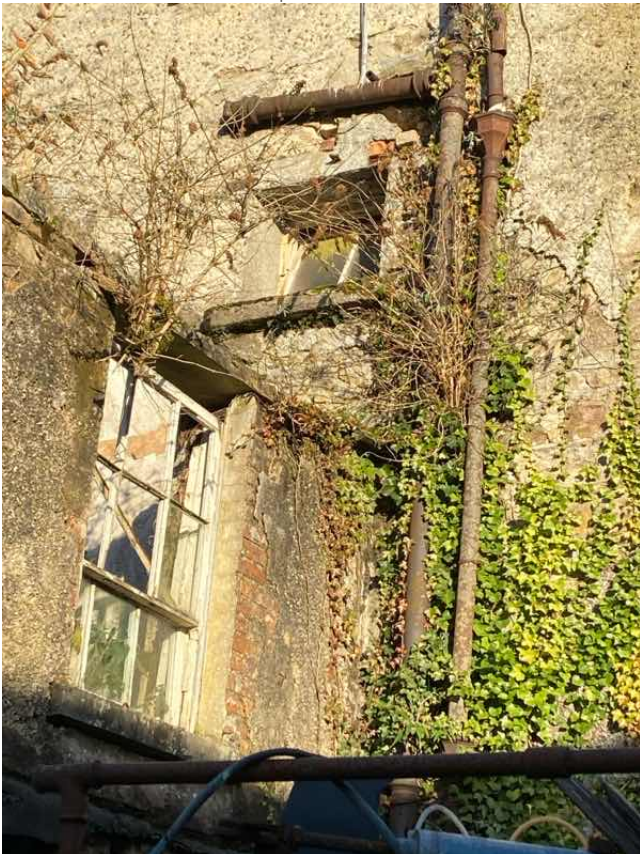
147

Defective timber lintel suspected over small windows

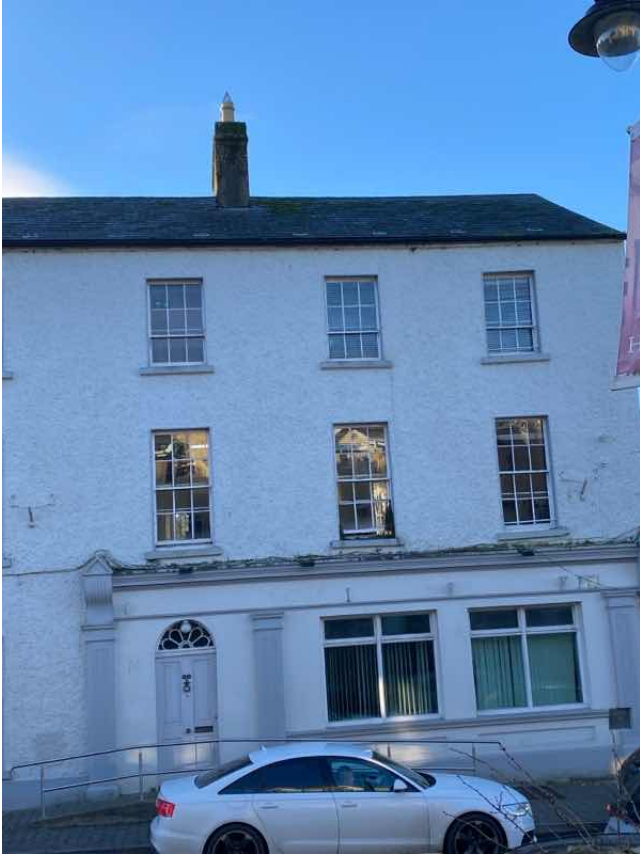
141

Roof appears in satisfactory condition . Vegetation growing on surface would need to be cleaned.

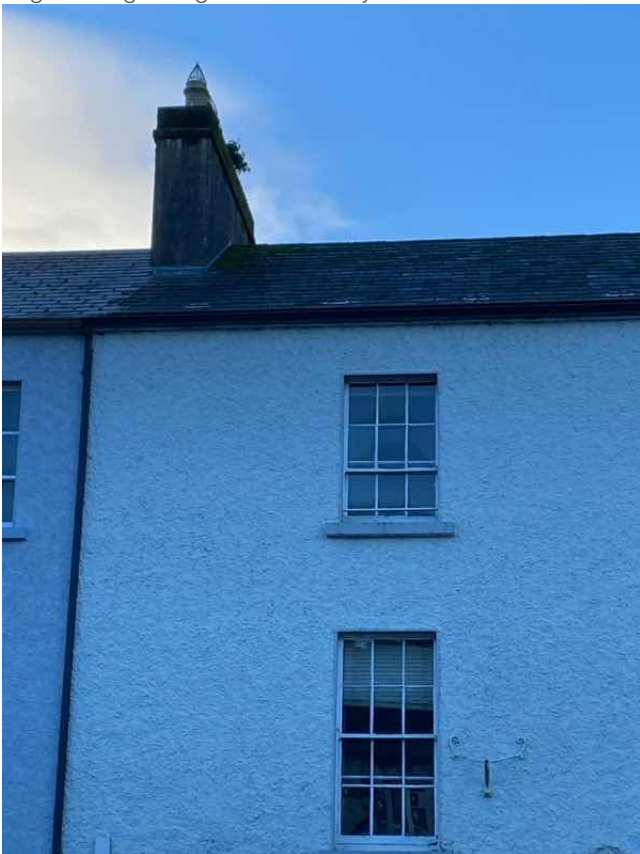
142

Vegetation growing out of chimney

We observed cracking in chimney and vegetation growing on same. Remedial works will be required to repair and re-render chimneys and cap off to prevent moisture ingress if fireplaces are not be re-used as part of the proposed works.

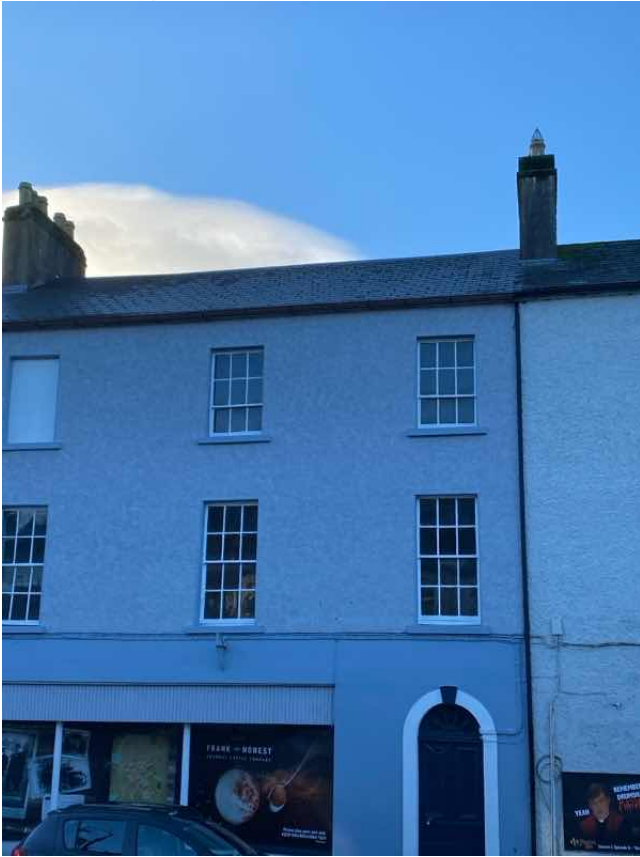
143

Roof finish in good condition

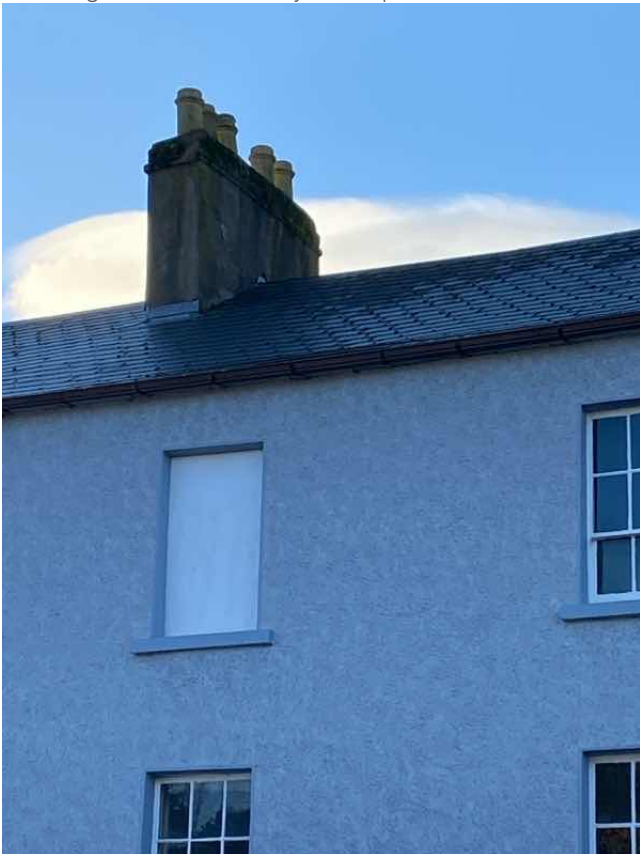
144

Cracking to shared chimney will require remedial works

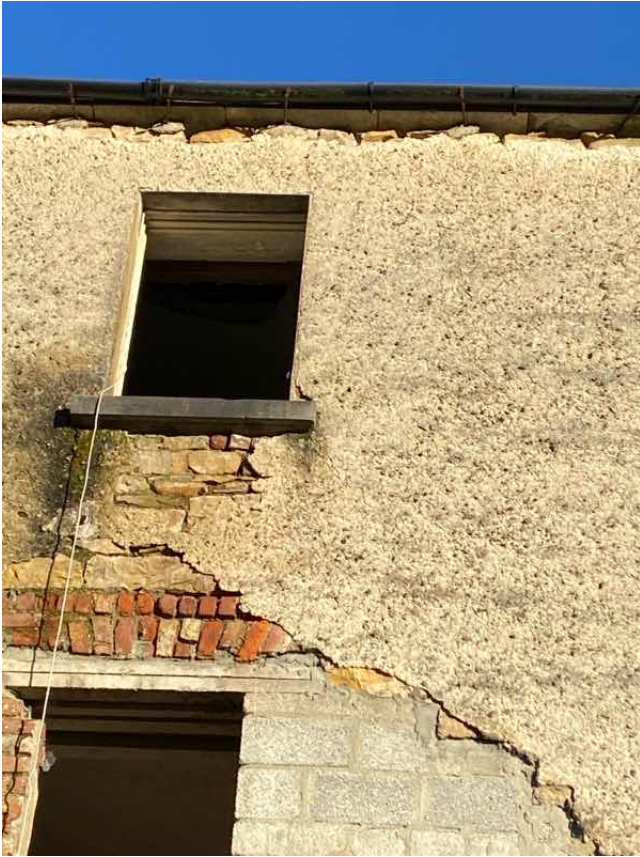
148

Plaster missing below roof gutter

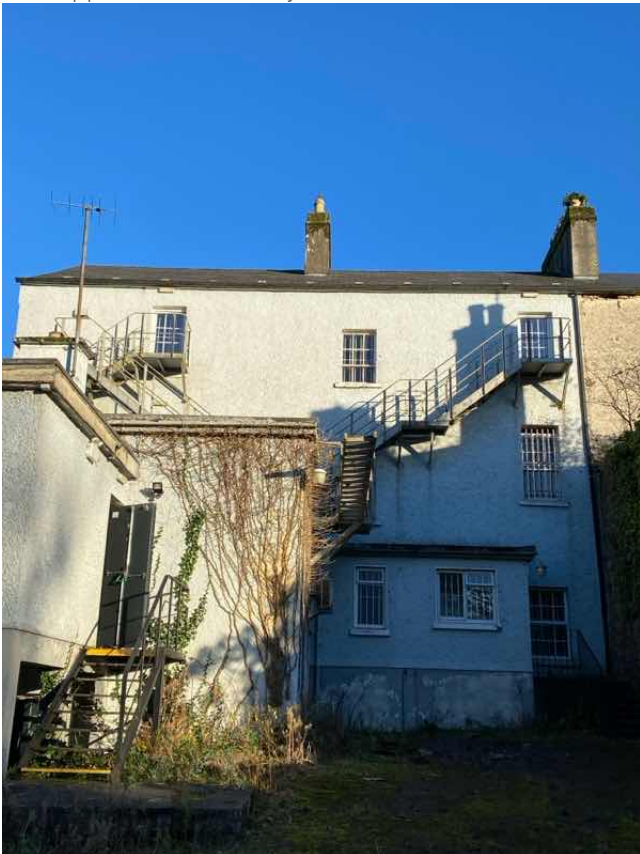
150

Roof appears in reasonably condition

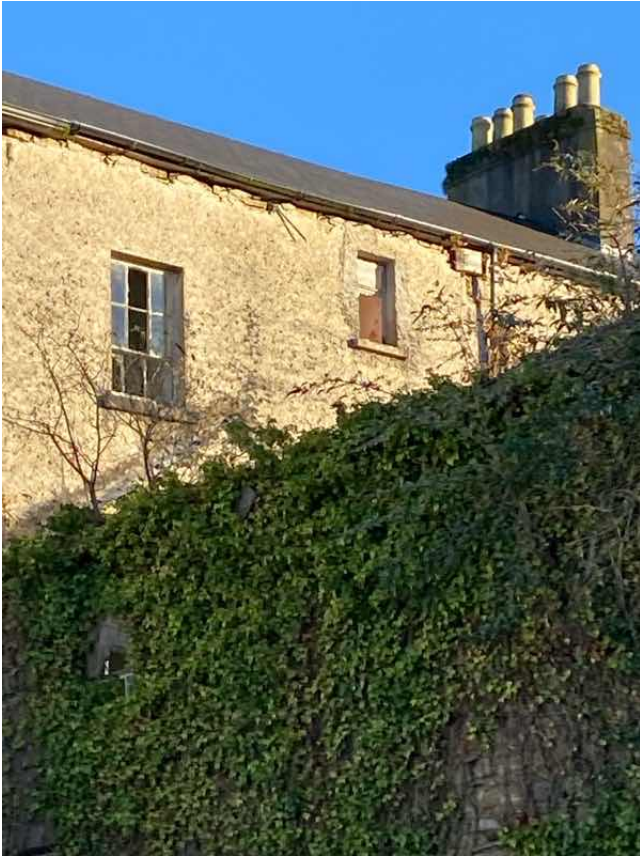
151

Roof finish (slate) appears in reasonable condition

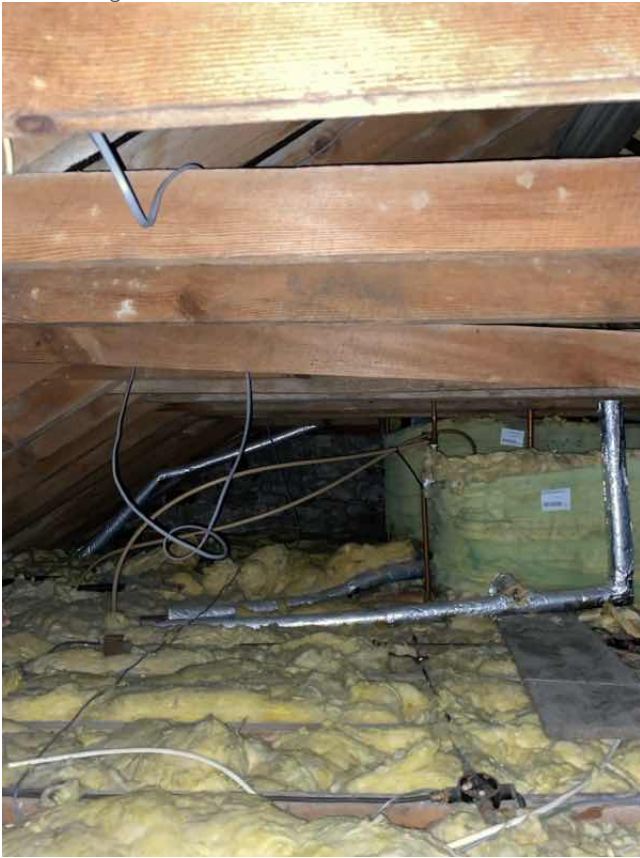
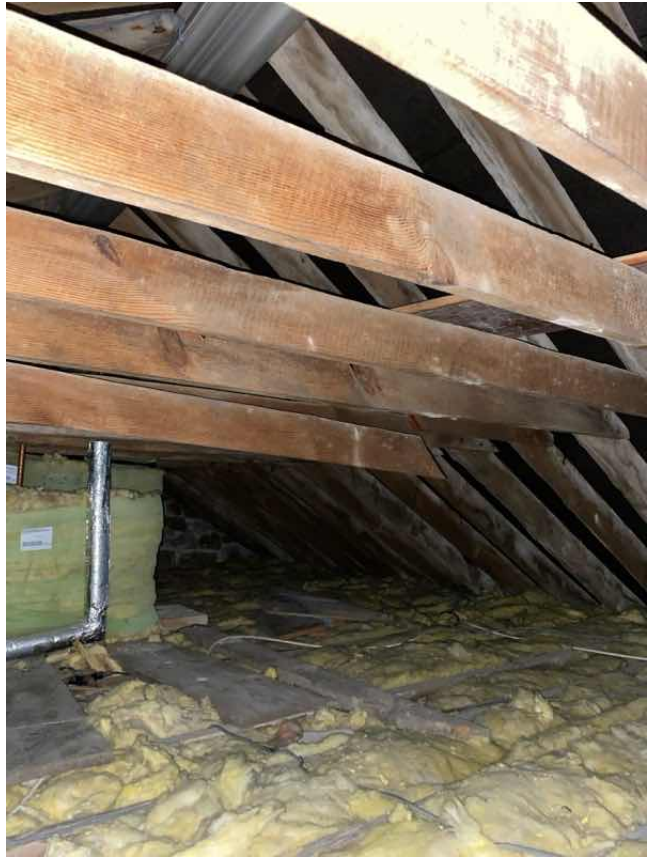
72  
Rafters spanning from front wall to back wall with ceiling joists and collars preventing rafters from spreading . CST to carry out back design check on roof timbers.

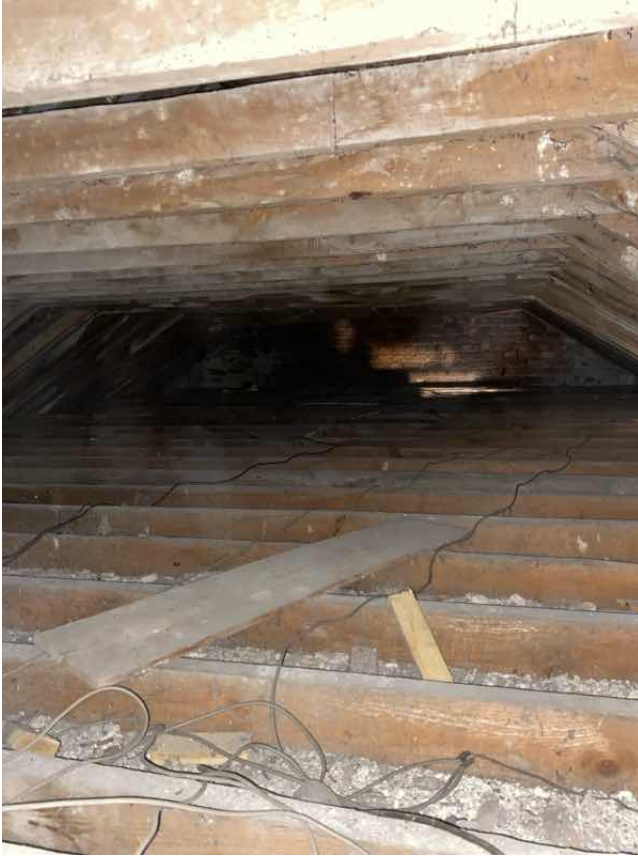
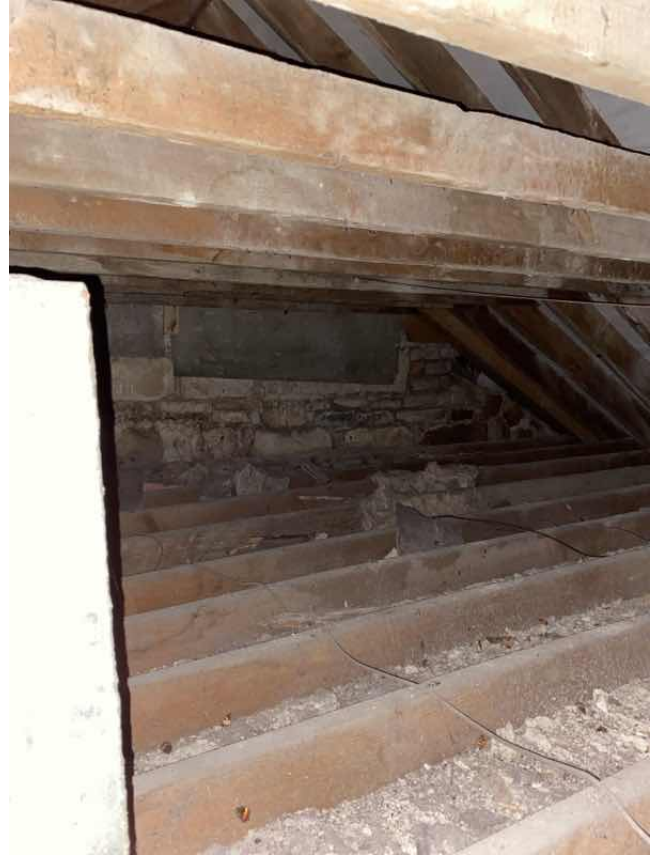
122

140 x 50mm rafters at 300mm centres. Ceiling joists 115 x 40 at 300mm centres.  
Modern, presumed breathable felt, observed on rafters indicating that roof reslated recently .  
Woodworm infestation noted in roof timbers - to be reviewed by Specialist .

Slates vents were installed in Building 1 but we could see no evidence that roof ventilation has been provided for in building 2. This lack of ventilation encourages woodworm infestation. Ventilation ensures that moisture levels in roof timbers are maintained at low safe levels. Provision of adequate roof ventilation will need to be considered at detailed design stage.

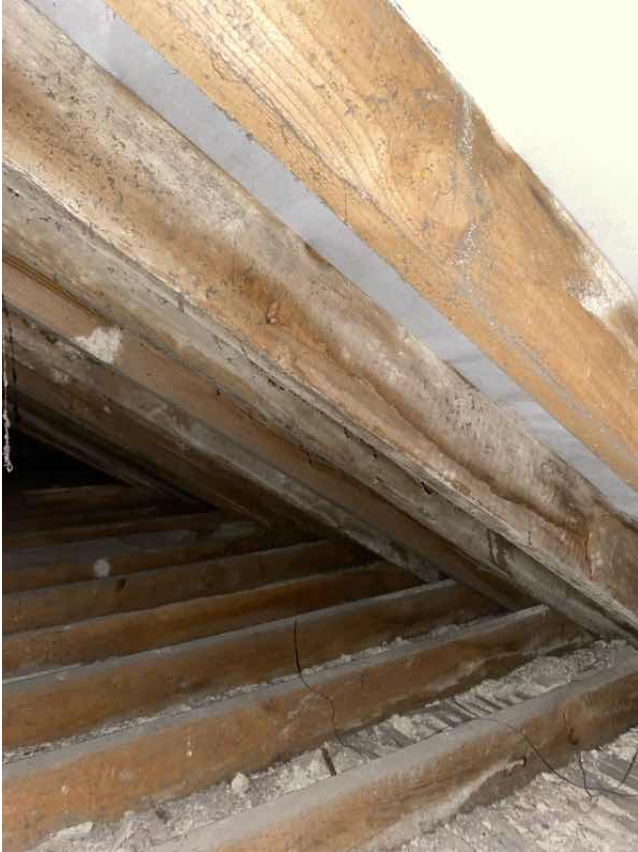
123

Rafters appear to be mixture of new and old which indicates rotten rafters were replaced when reslating carried out .

It appears that both buildings were re-roofed in the last 20 years approximately. Felt has been laid under slates providing an additional barrier against water penetration on both roofs. Original timbers have been retained in both roofs however we noted that modern timber was used where defective rafters had to be replaced or where the rafters had to be packed up to create a level plane for slating. Evidence of woodworm attack was observed in a number of rafters. We would recommend that a wood preservation specialist contractor be engaged to inspect the entire building and make recommendations in relation to the feasibility of retaining and treatment of the damaged timbers.

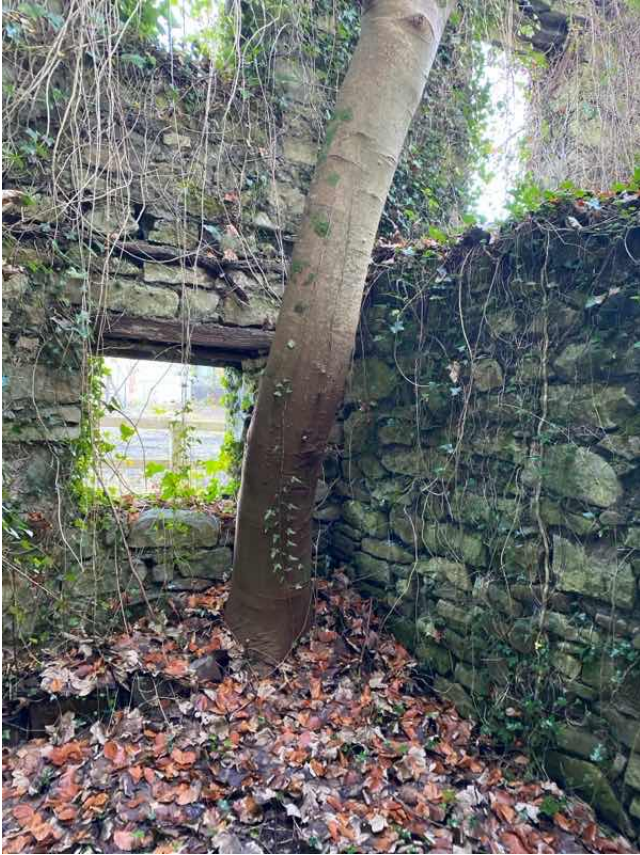
162

Large tree growing beside external wall with roots extending under foundations

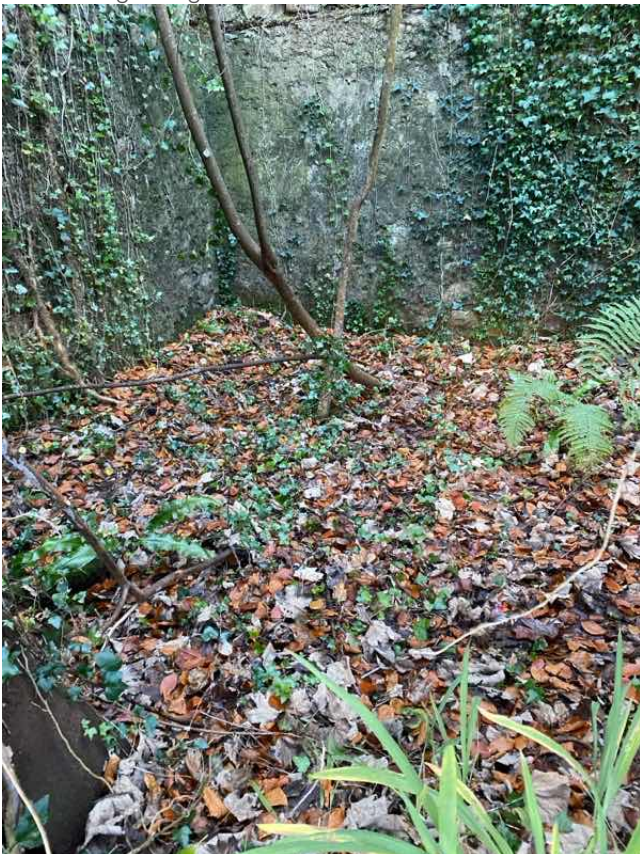
163

Small tree growing in centre of floor

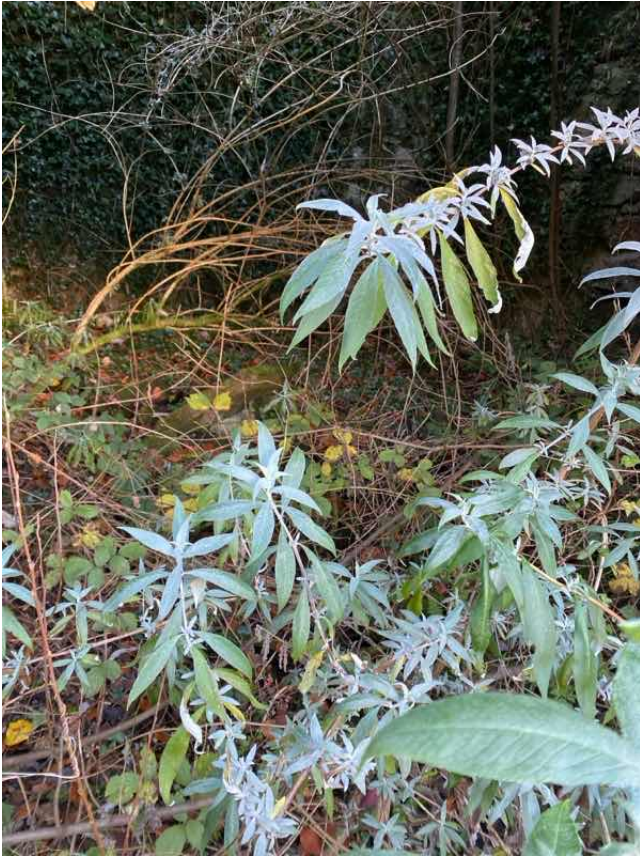
164

Heavy vegetation in floor of room

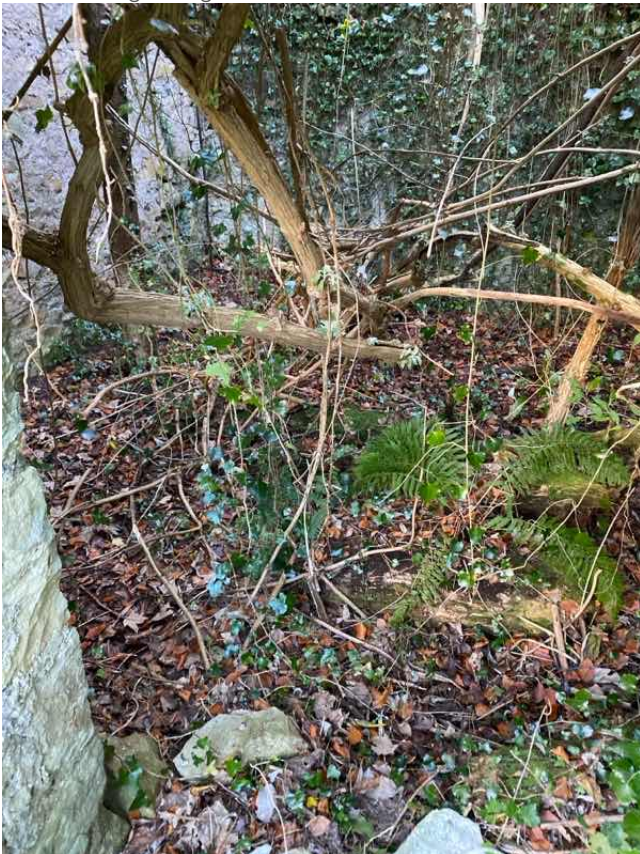
169

Small trees growing on floor

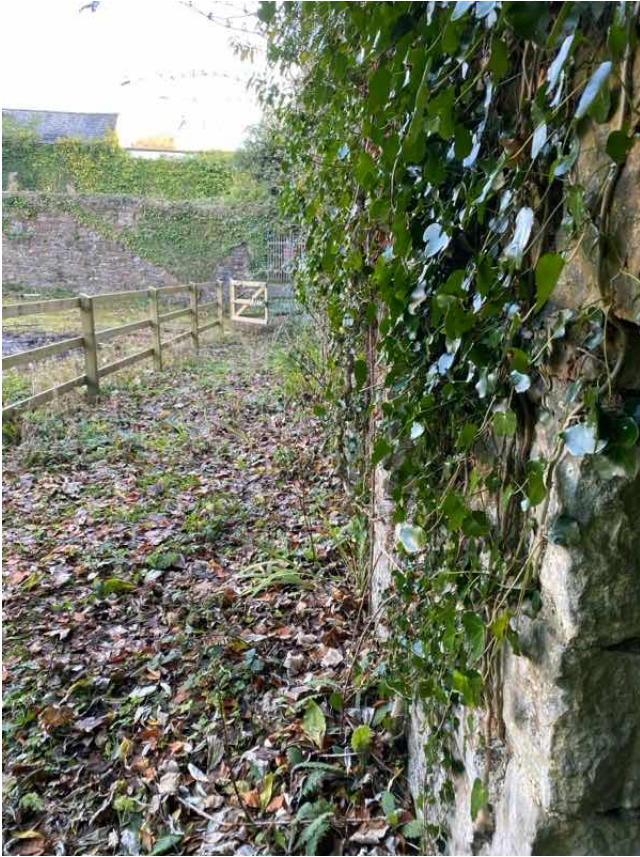
170

Front elevation of masonry appears to lean or bulge outwards

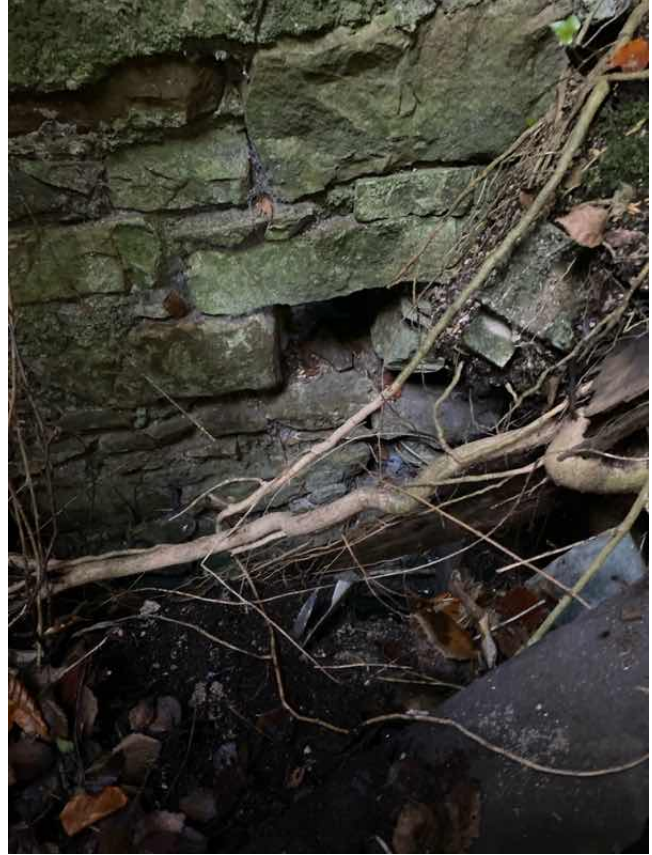
172

Deep pit and drainage hole in wall at back wall

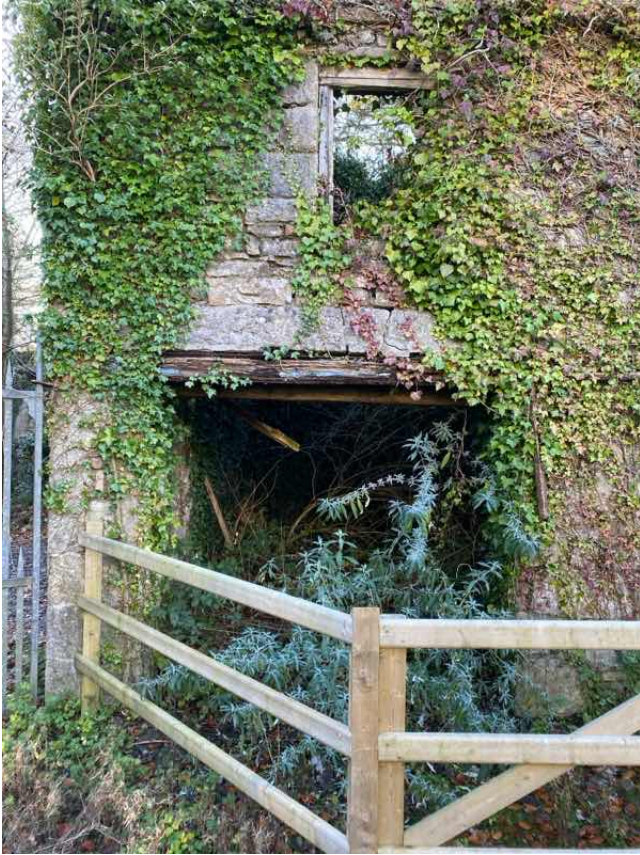
152

Rotten timber lintel over opening. Arch over has started to move.

For both buildings the door and window openings have generally been formed with stone lintels on the outside face and timber lintels on the inside. The stone lintels were generally found to be intact but as both buildings are fully open to the weather (no roofs) the internal timber lintels are either completely rotten or collapsed (which in turn has caused masonry to partially collapse). It is likely that all stone lintels can be retained and reused, and all timber lintels will need to be replaced.

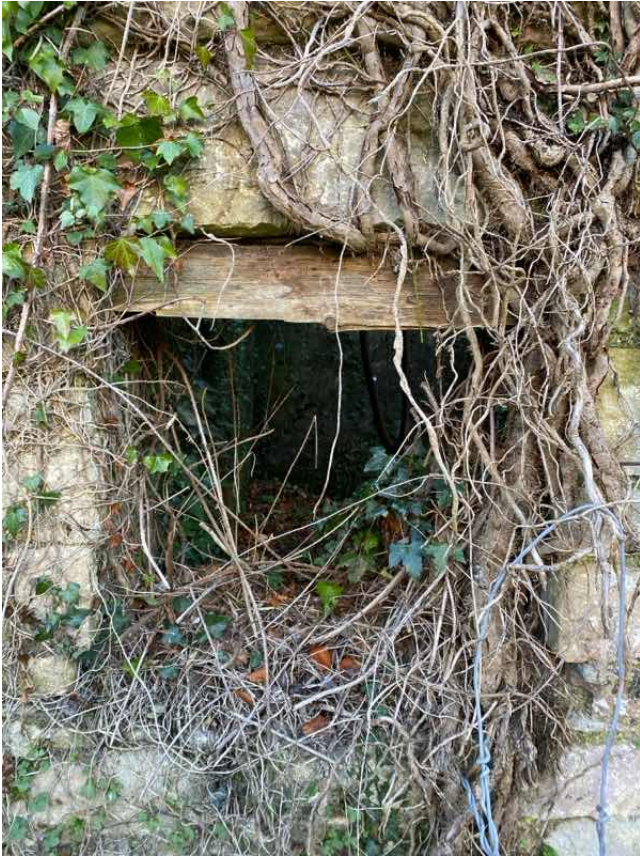
154

Stone lintel intact on outside but defective timber lintel on inside

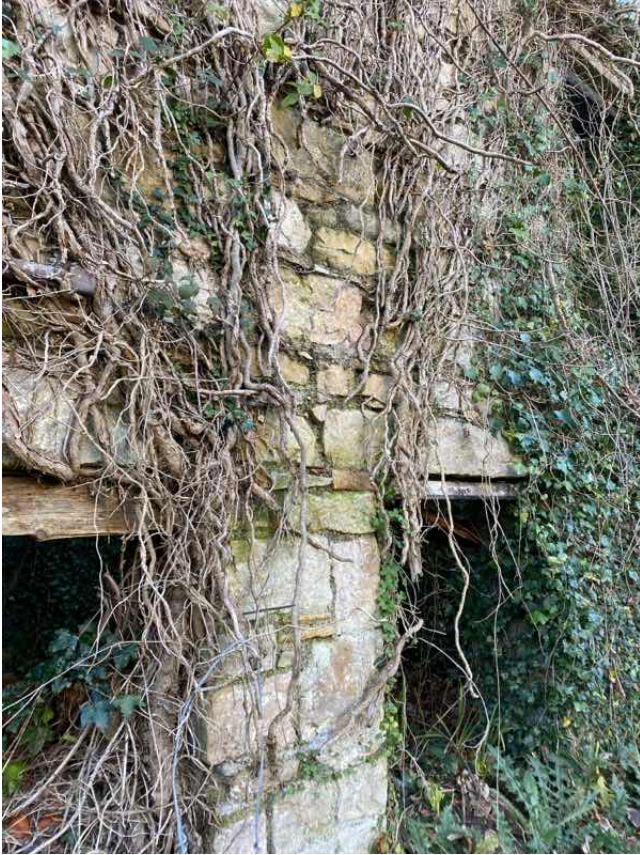
156

Significant amount of Ivy growth on walls

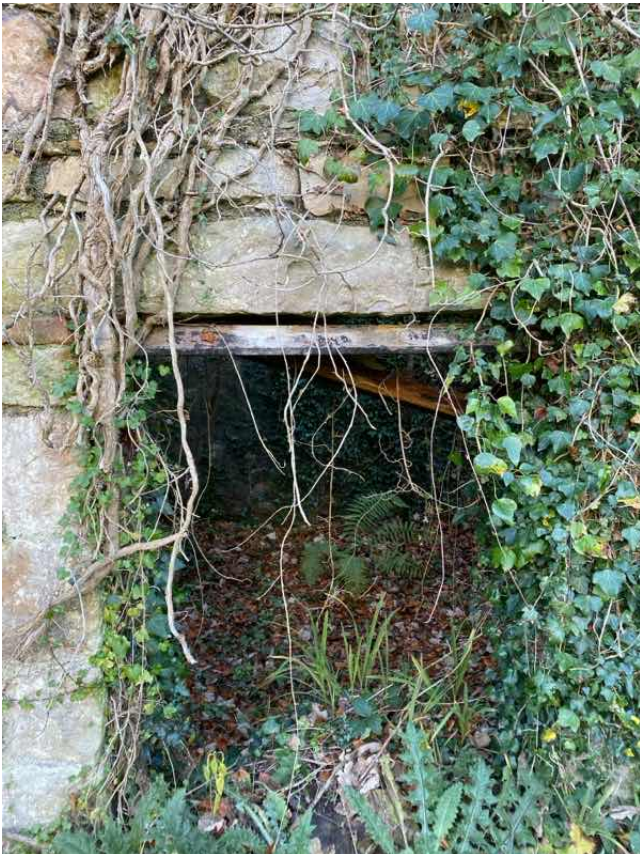
157

Stone lintel in tact on outside but timber lintel collapsed on inside face

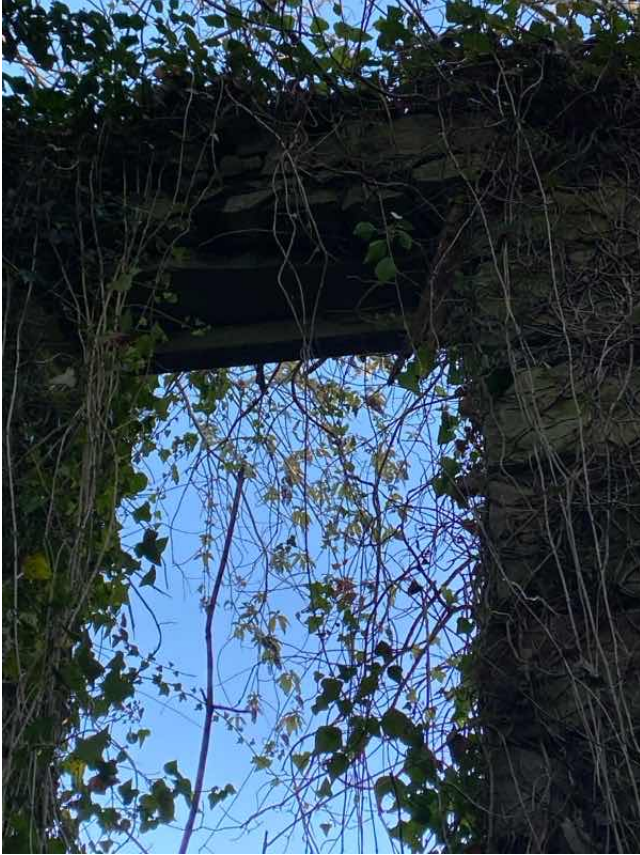
158

Timber lintel collapsed on inside . Stone lintel intact on outside

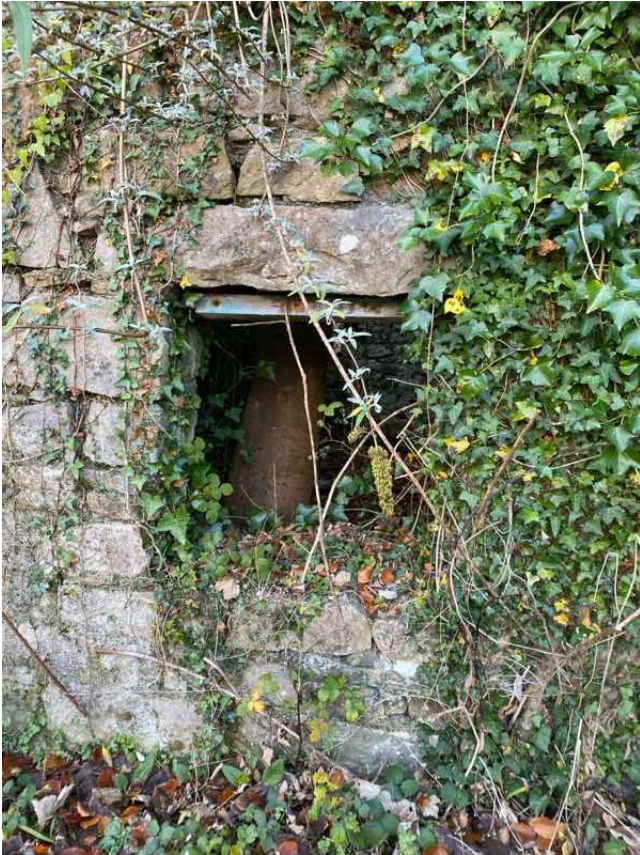
159

Stone lintel intact on outside but defective timber lintel on inside

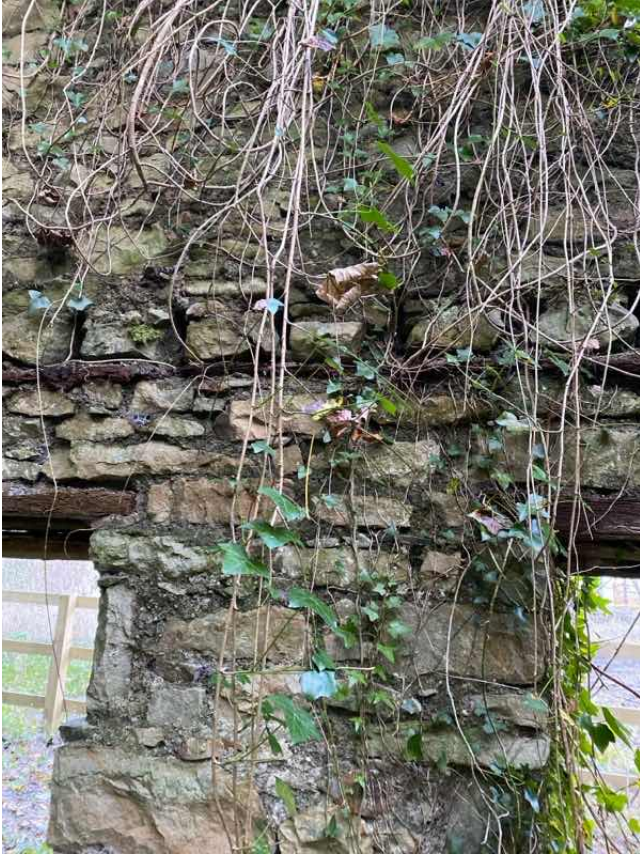
160

Rotten timber embedded in wall on inside face

We observed bonding timbers embedded in the external walls that are badly deteriorated, some of which can be removed and broken by hand. All defective bonding timbers will need to be removed and gaps (which weaken wall) should be filled in with new masonry.

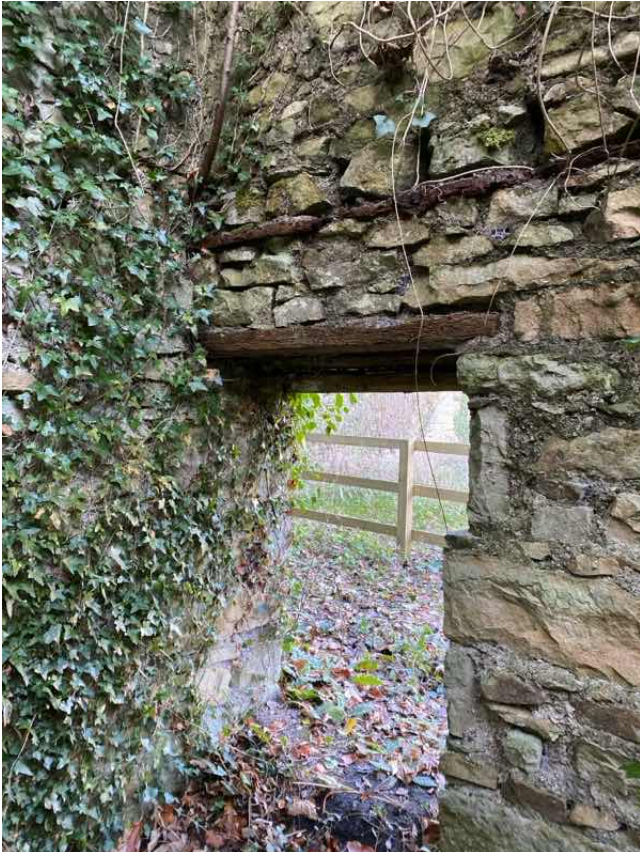
161

Defective timber lintel on inside face . Stone lintel intact on outside

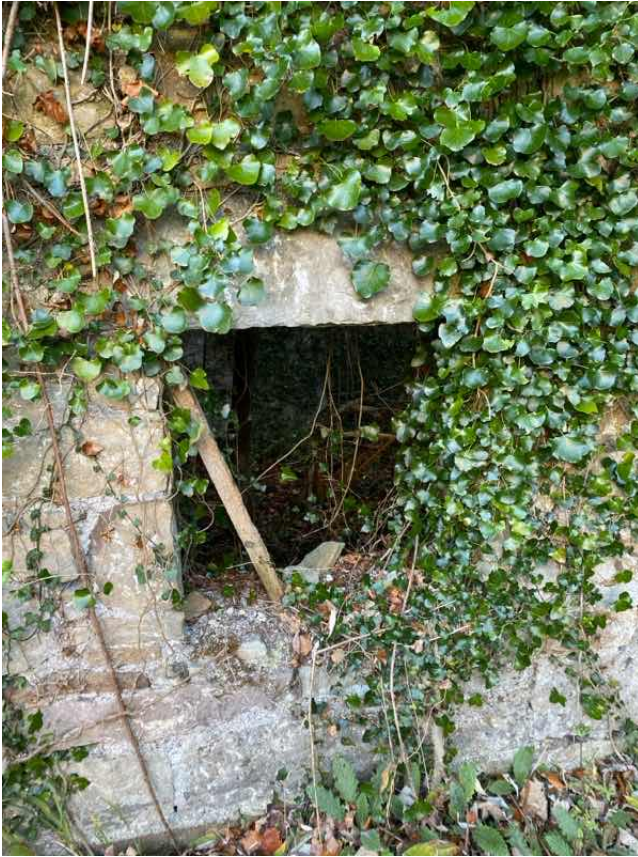
165

Stone lintel intact but defective timber lintel on inside

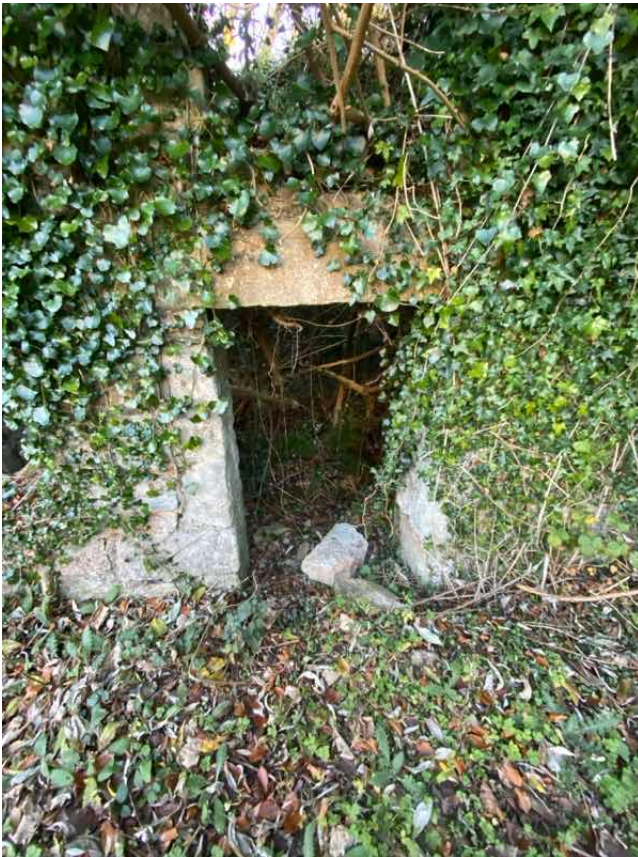
166

Stone lintel intact on outside but no lintel on inside

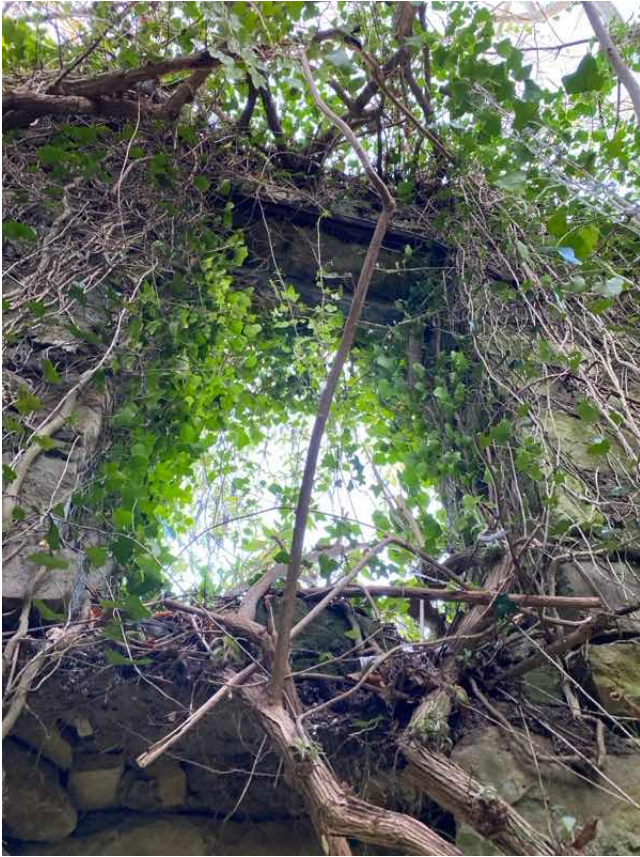
167

Lintel missing on inside face . Stone lintel in outside

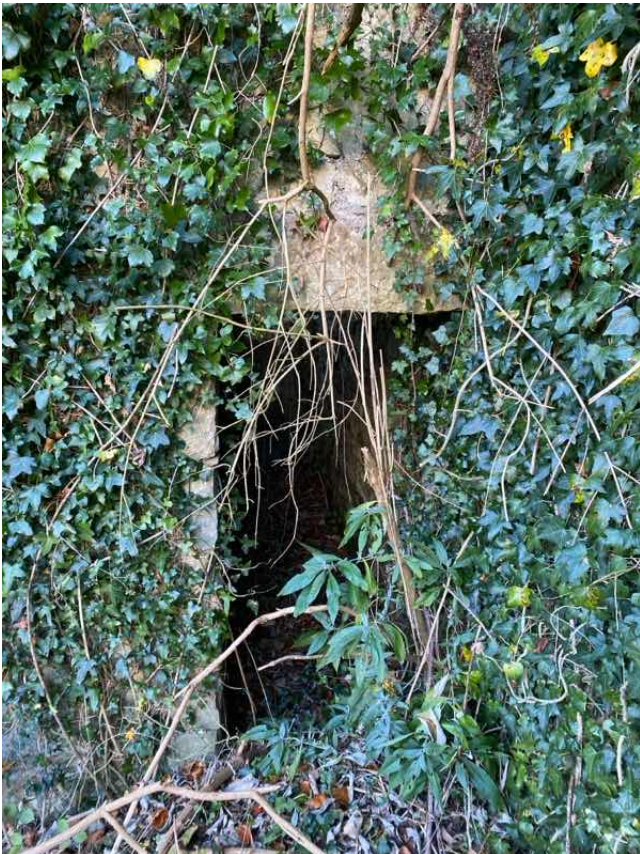
168

Stone lintel on outside. Defective timber lintel on inside

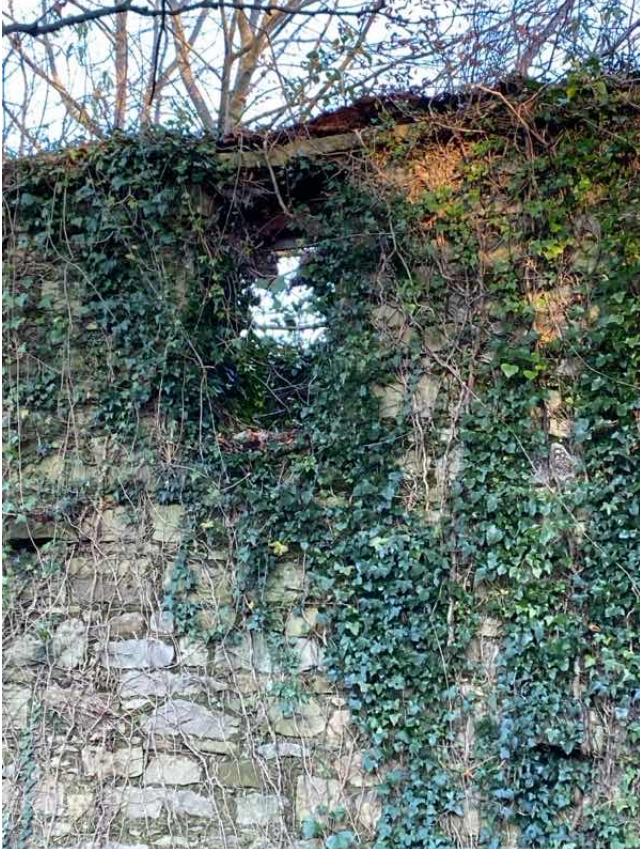
174

Lintels missing over window . Stone corbel runs along top of wall

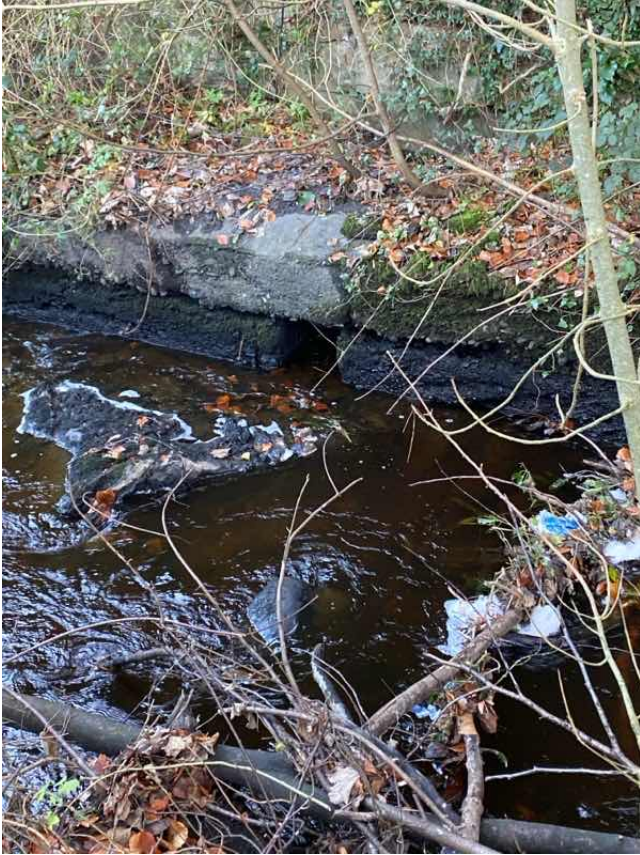
177

Possible outlet from drain observed in house

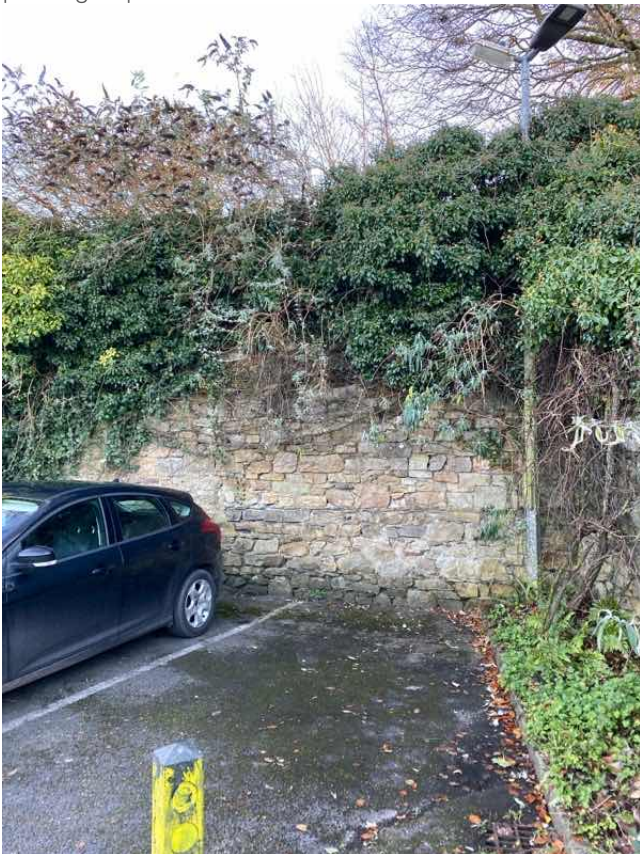
178

Gable wall covered in ivy to top of wall . Exposed masonry at bottom of wall appears in feasible condition. Some raking out and pointing required.

The walls existing walls appeared to be reasonably straight and plumb although some bulging may become evident when all ivy growth has been removed. The masonry joints will need to be raked out and repointed throughout with line mortar as large areas of existing mortar has perished or is missing.

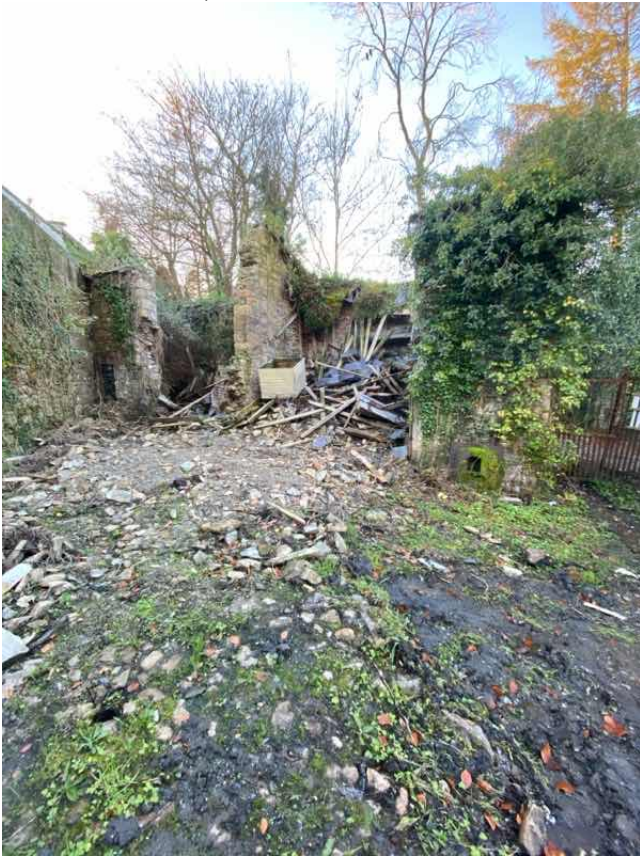
179

Front walls and steps and roof have been demolished

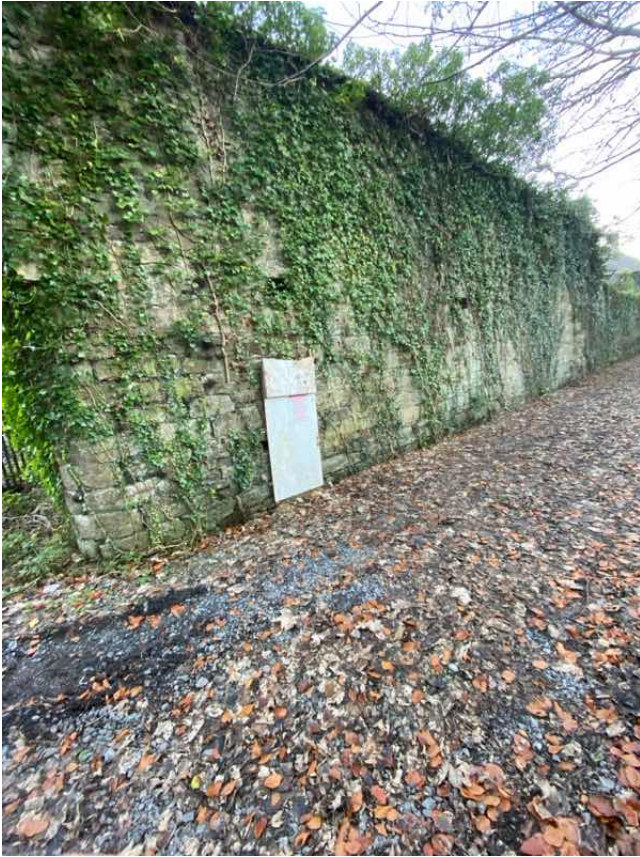
183

Elevation covered in ivy but no obvious signs of structural distress . Wall appeared plumb .
