## **Drumshanbo Town Centre Regeneration**

# **Structural Assessment Survey and Site Investigation Report**

**for former Bank of Ireland Building, Early's Building  
and Adjacent Derelict Building, Drumshanbo, Co  
Leitrim**

**December 2023**

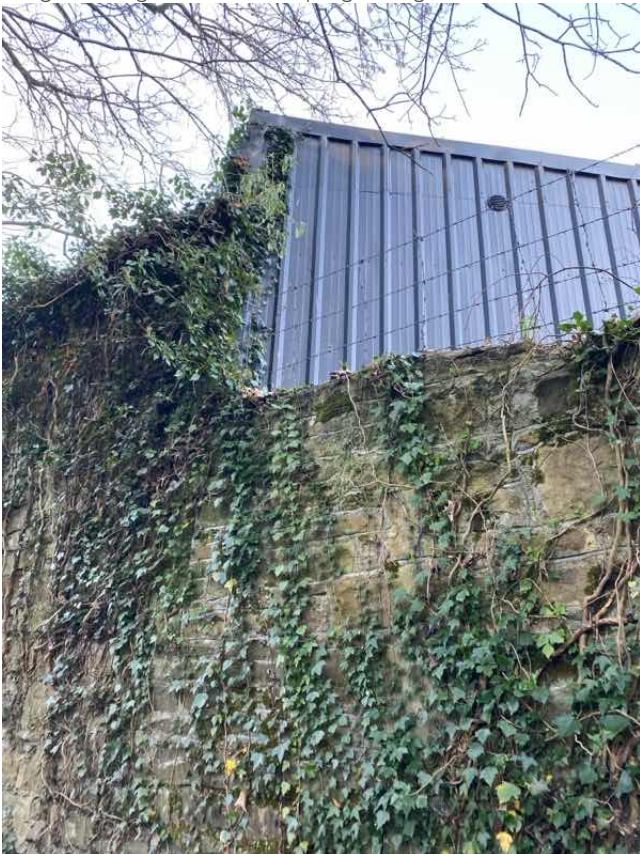
184

Neighbouring shed is built up against gable

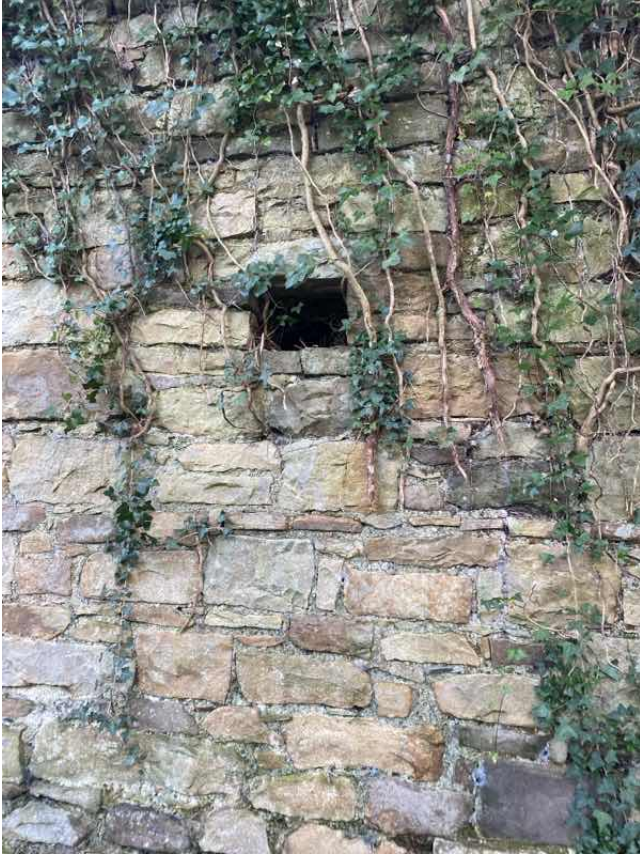
185

Small opening in wall

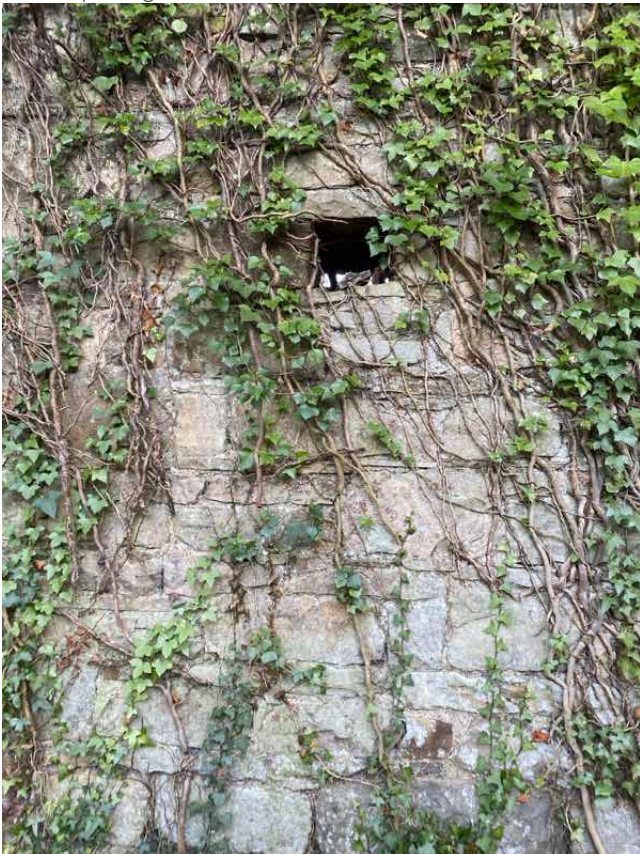
186

Small opening in wall
